R. Pearce & Co.

HULL STRUCTURAL CONDITION REPORT

1	NAME	:	EXCELLENT
	Class	:	Wooden Fishing Vessel
	Type	:	Netter
	Gross Tonnage	:	75
	Registered length	:	23.18m
	Built	:	1931

16th December 2014 Afloat at Newlyn, Cornwall.

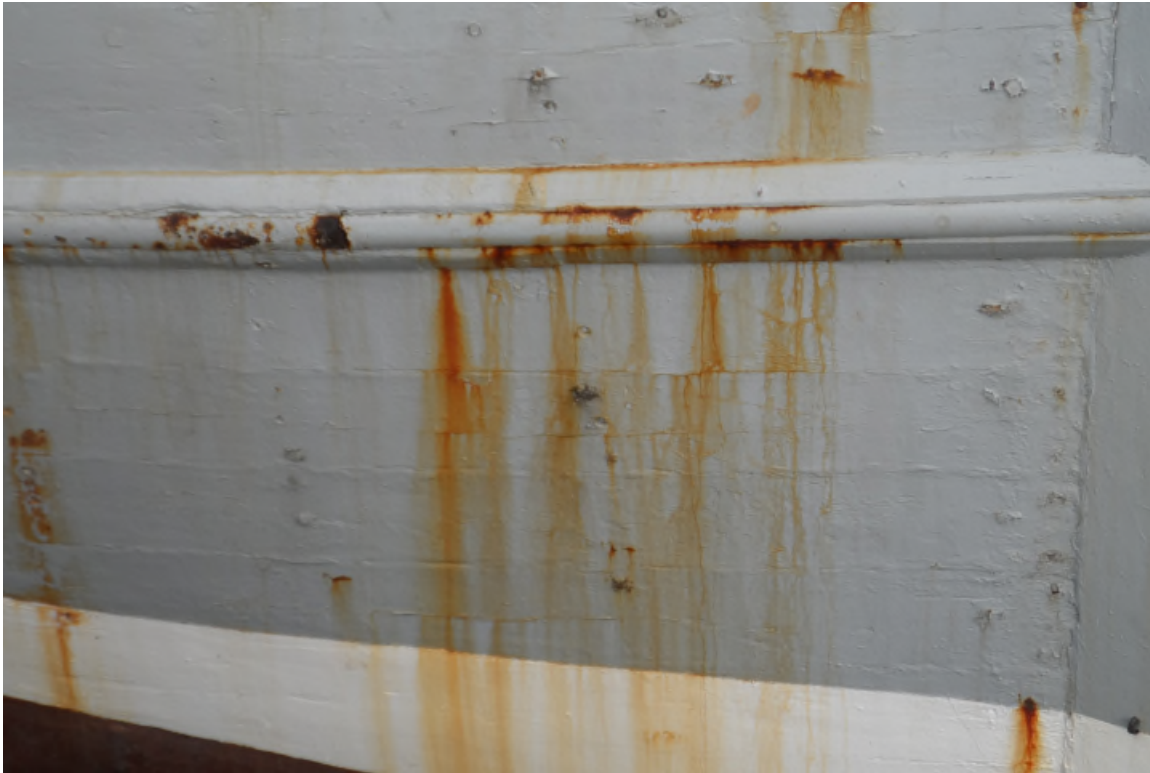
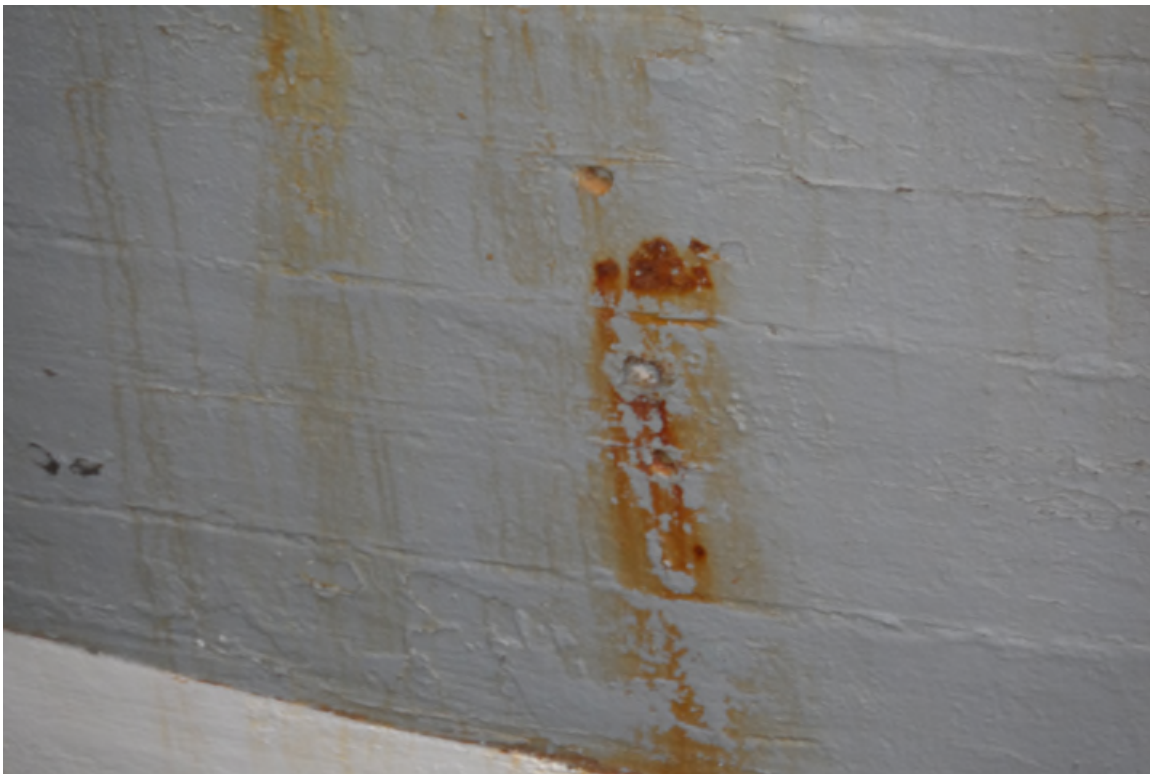
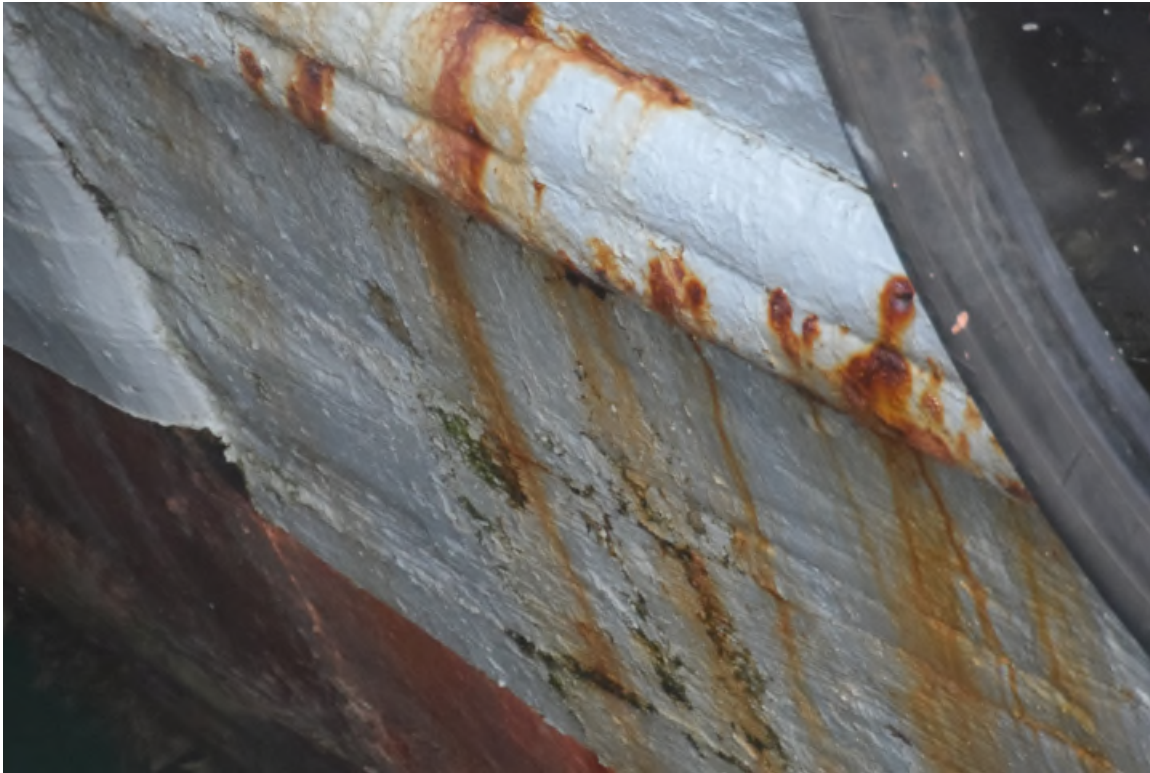
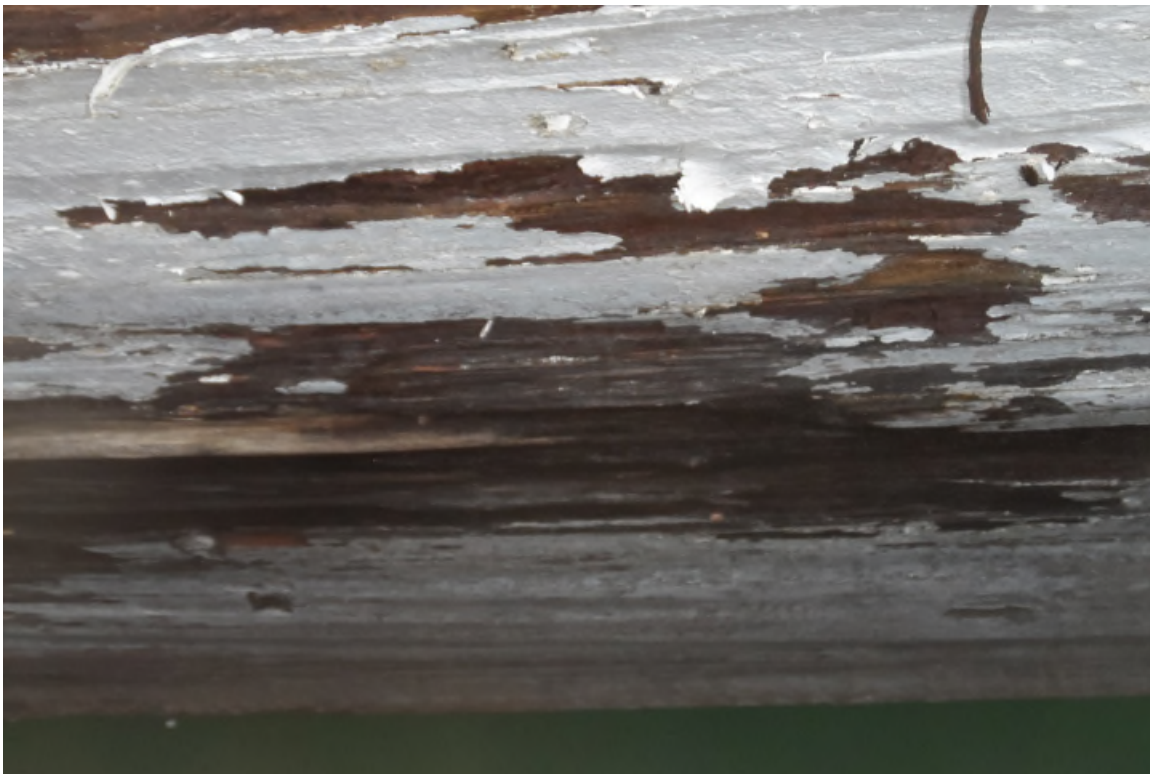
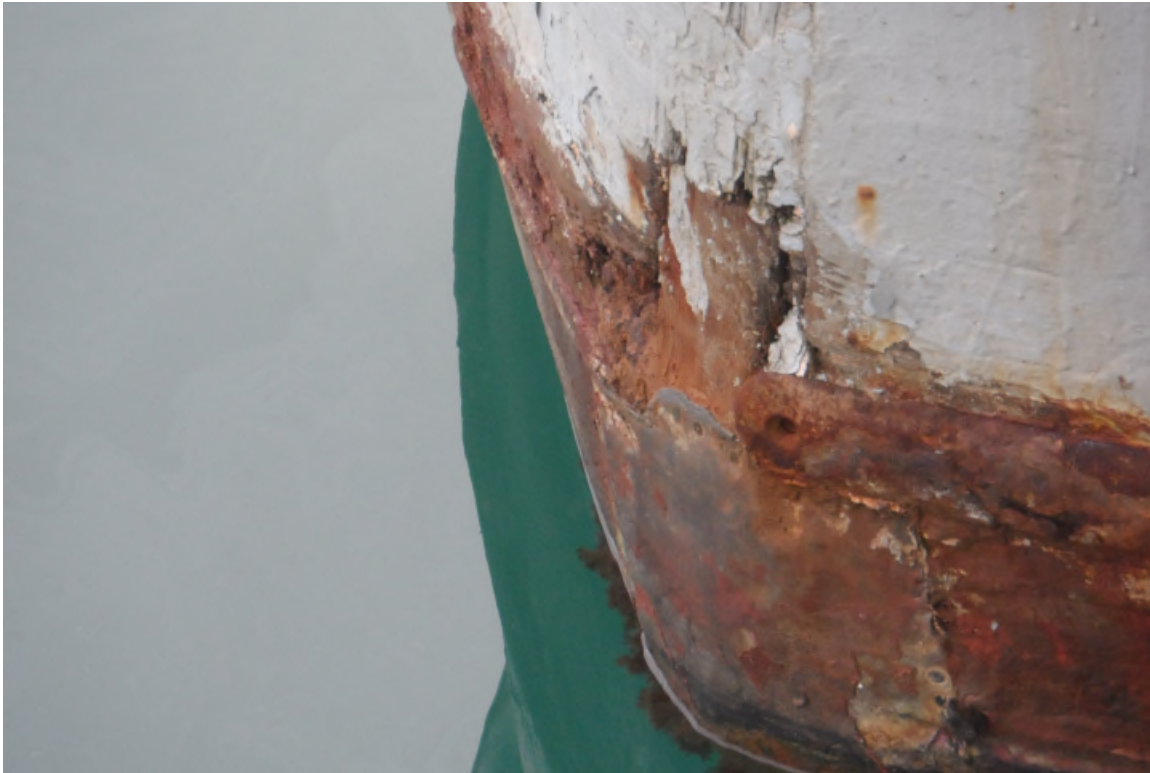
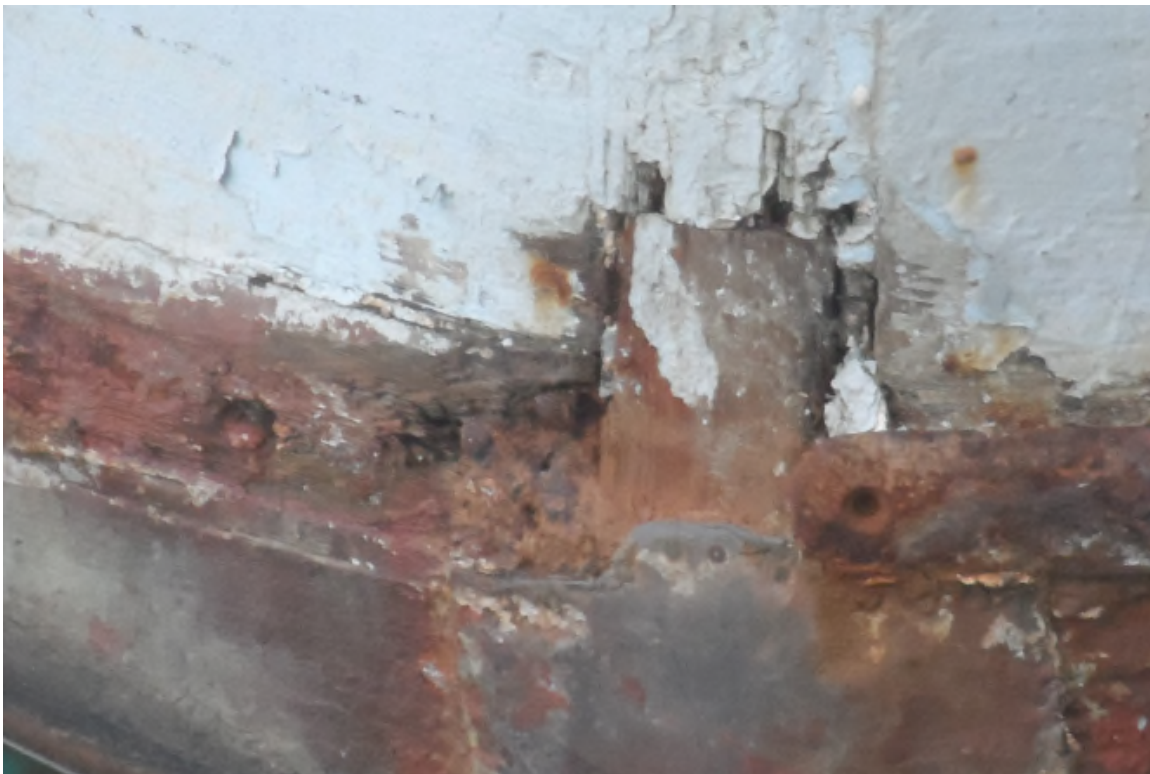
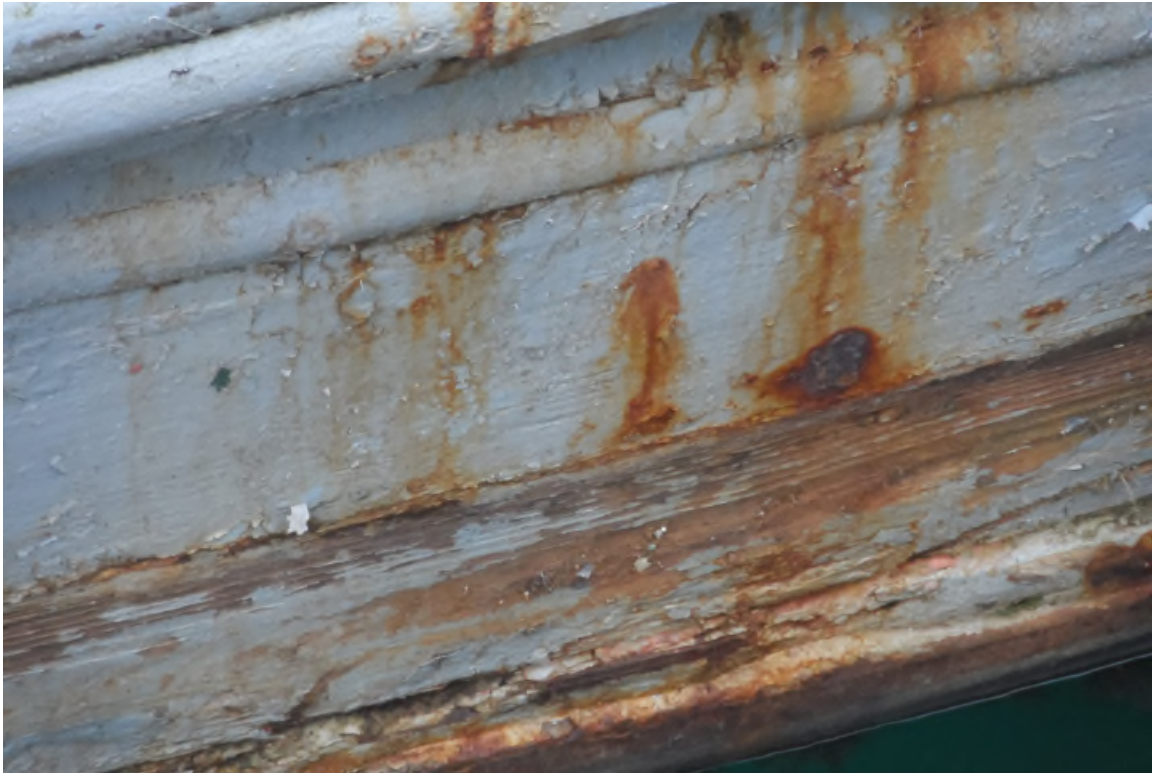
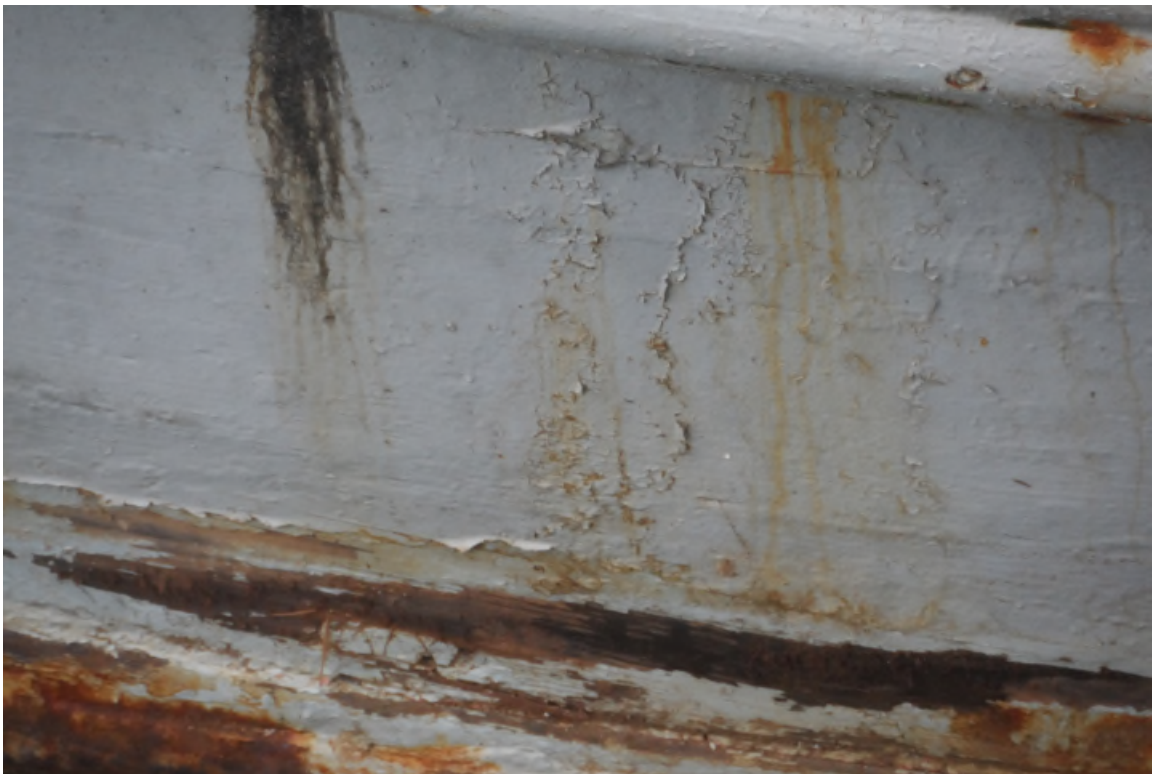
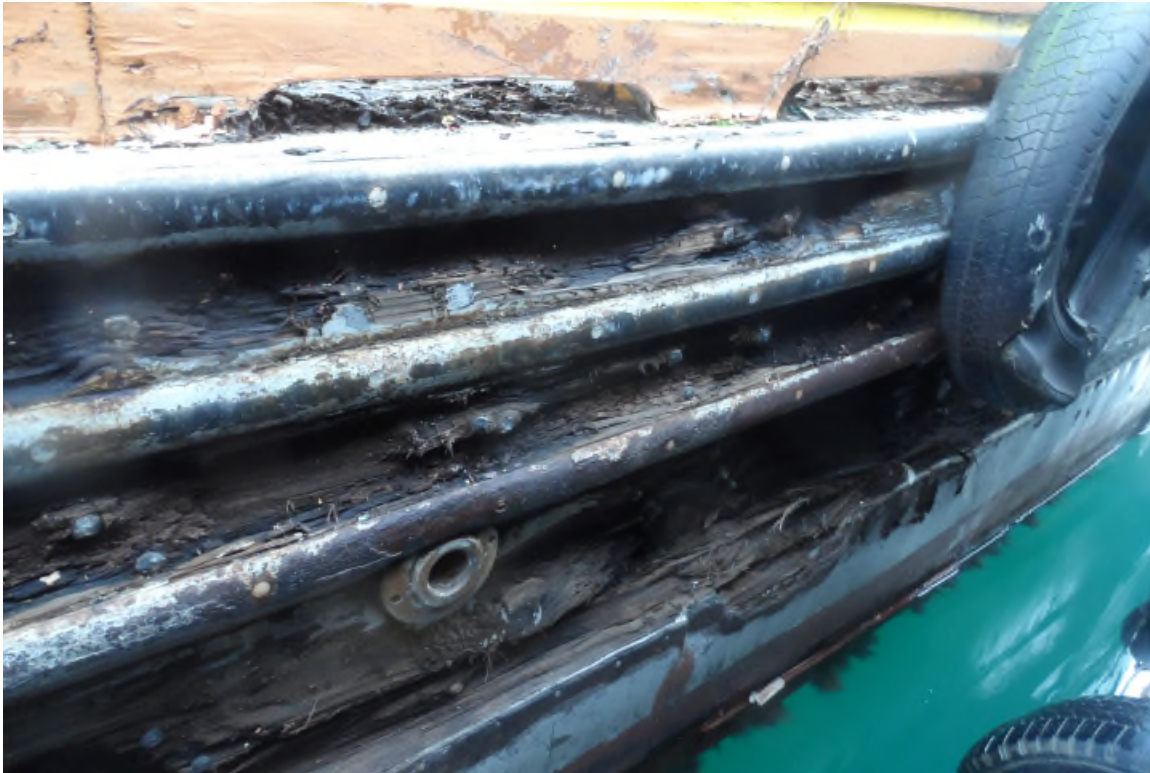
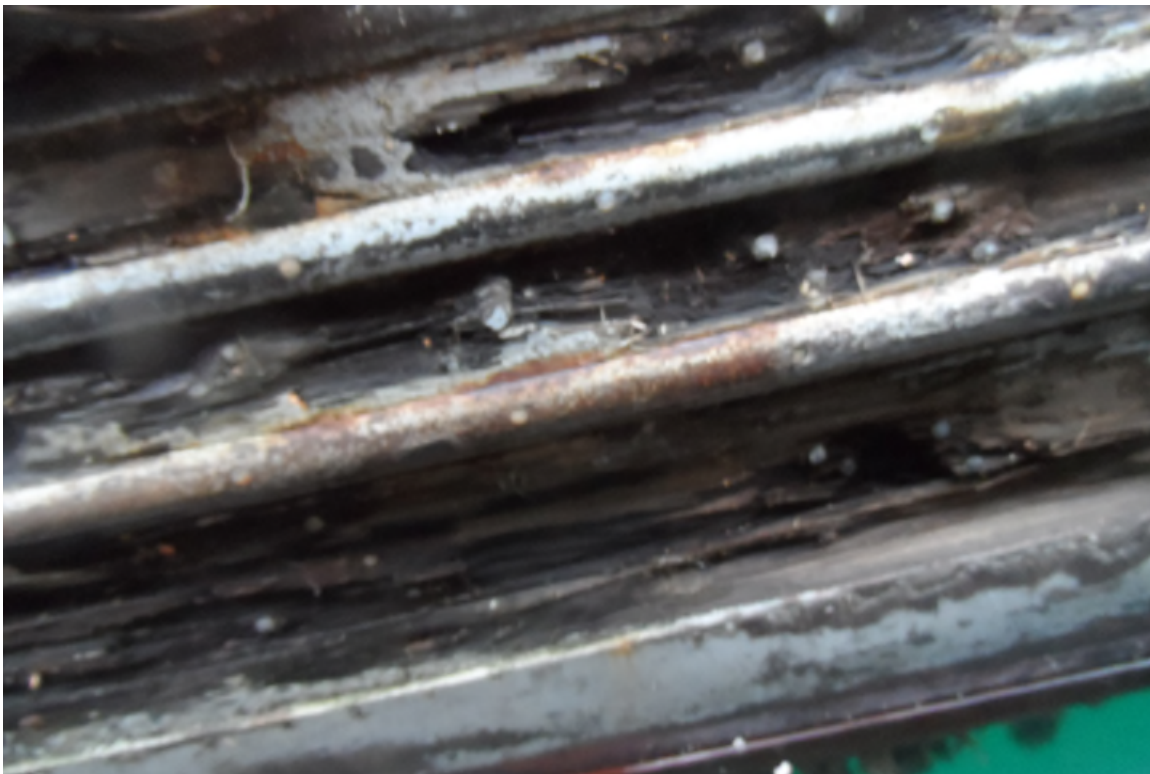
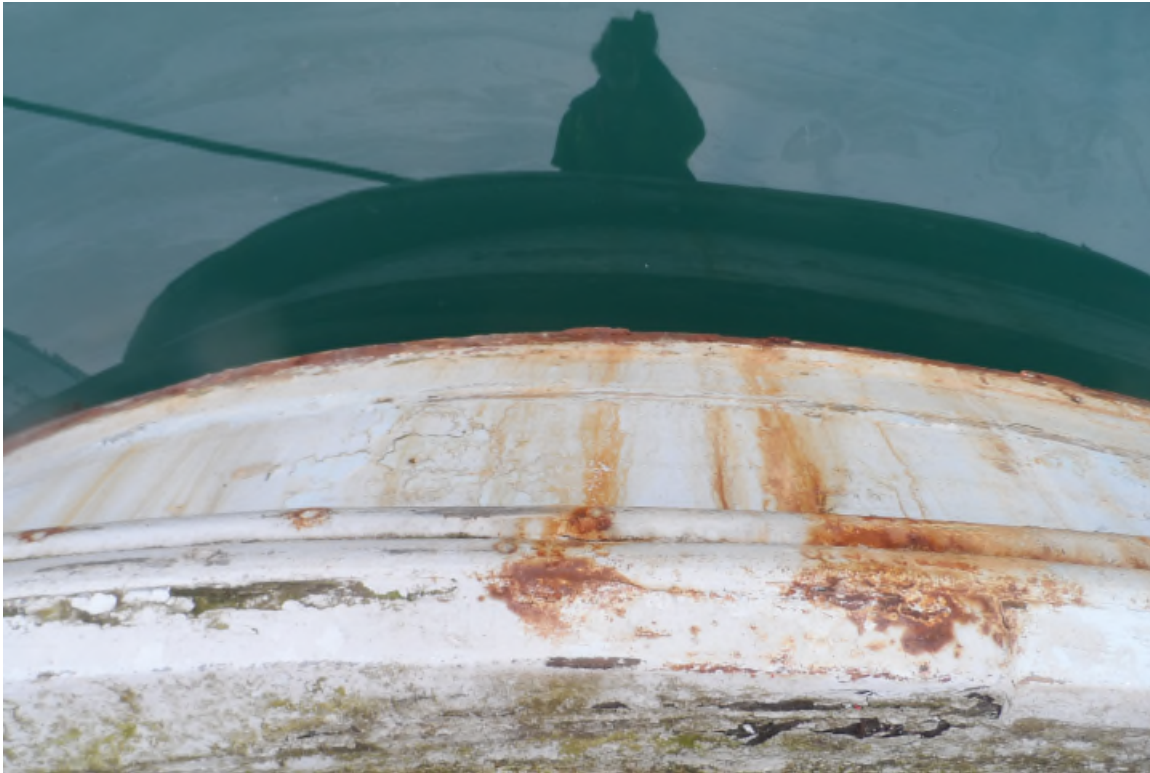
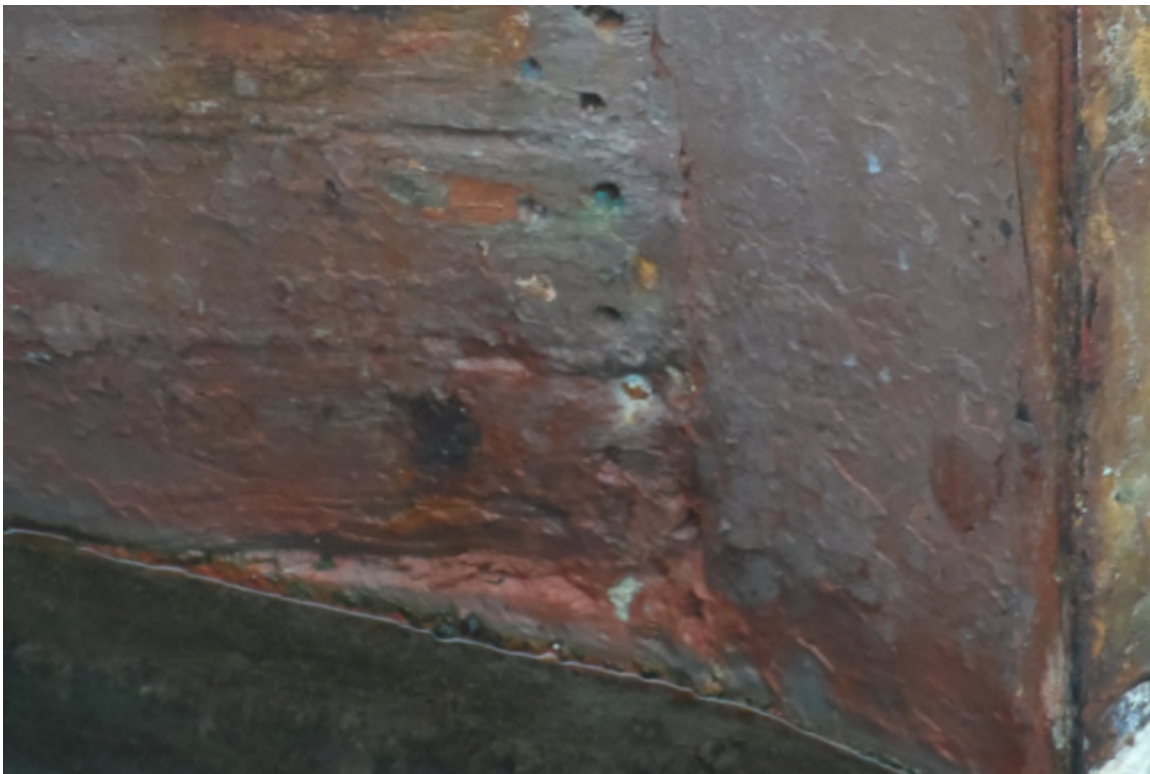
11.1 A limited inspection of the outer hull above the waterline was carried out and the following found:-

- i) Areas of rust staining over large area of the upper and lower hull indicating deterioration of the plank fastenings.
- ii) Heavy contact and rubbing damage, starboard side amidships, with exposed heads of fastenings and a large amount of the planking rubbed away.
- iii) Port side transom just above the waterline - hole through the planking with daylight visible inside the vessel.
- iv) Transom centre at change of section just above the waterline plank ends visibly damaged.
- v) Several sections of the belting just below the main deck very soft with large areas of rot.

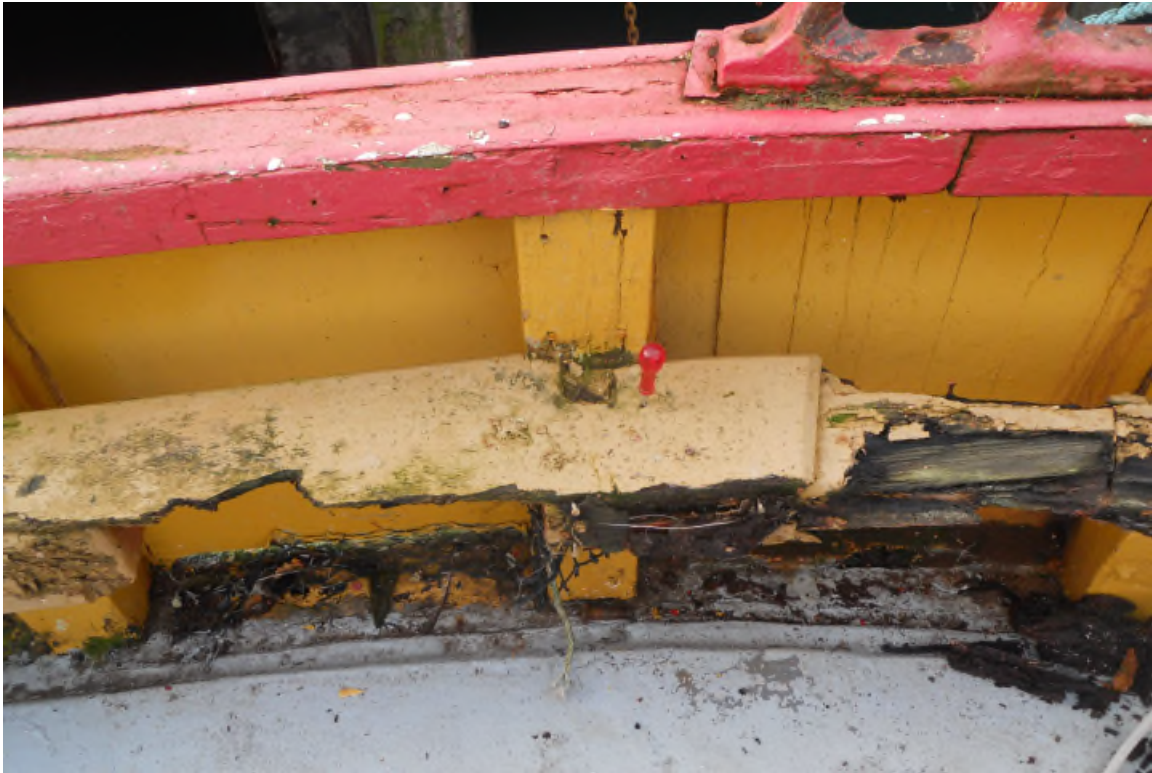
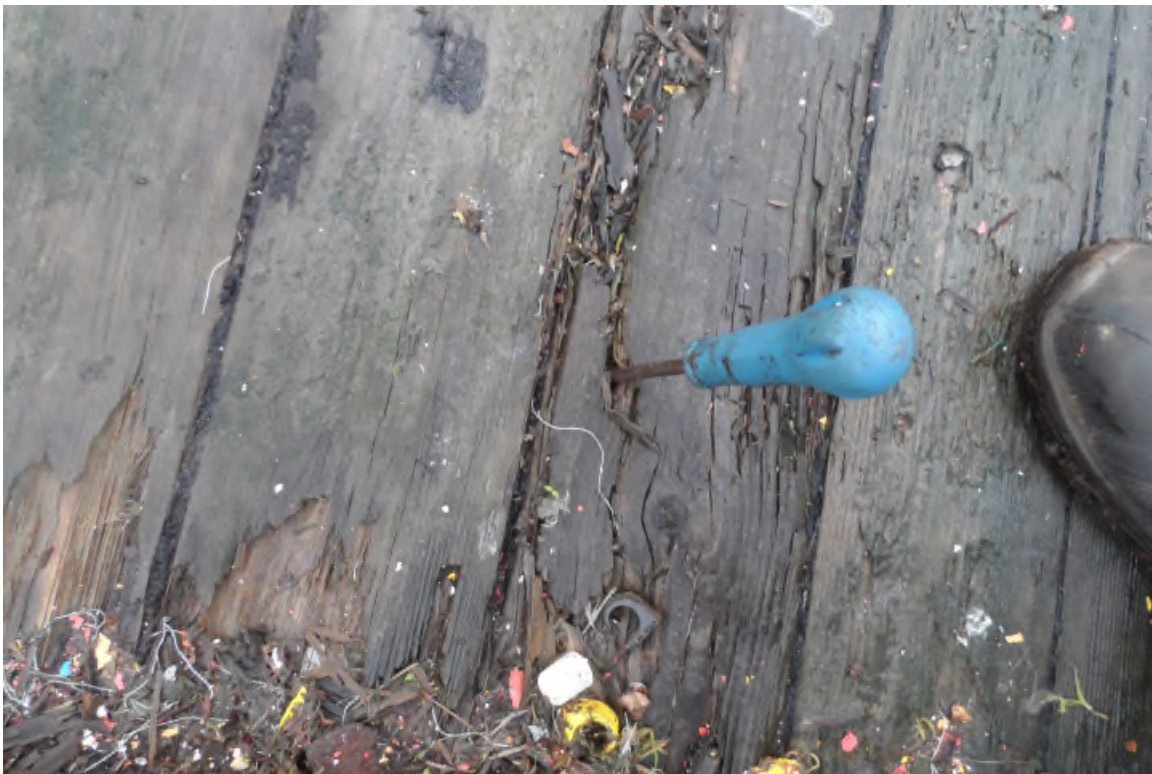
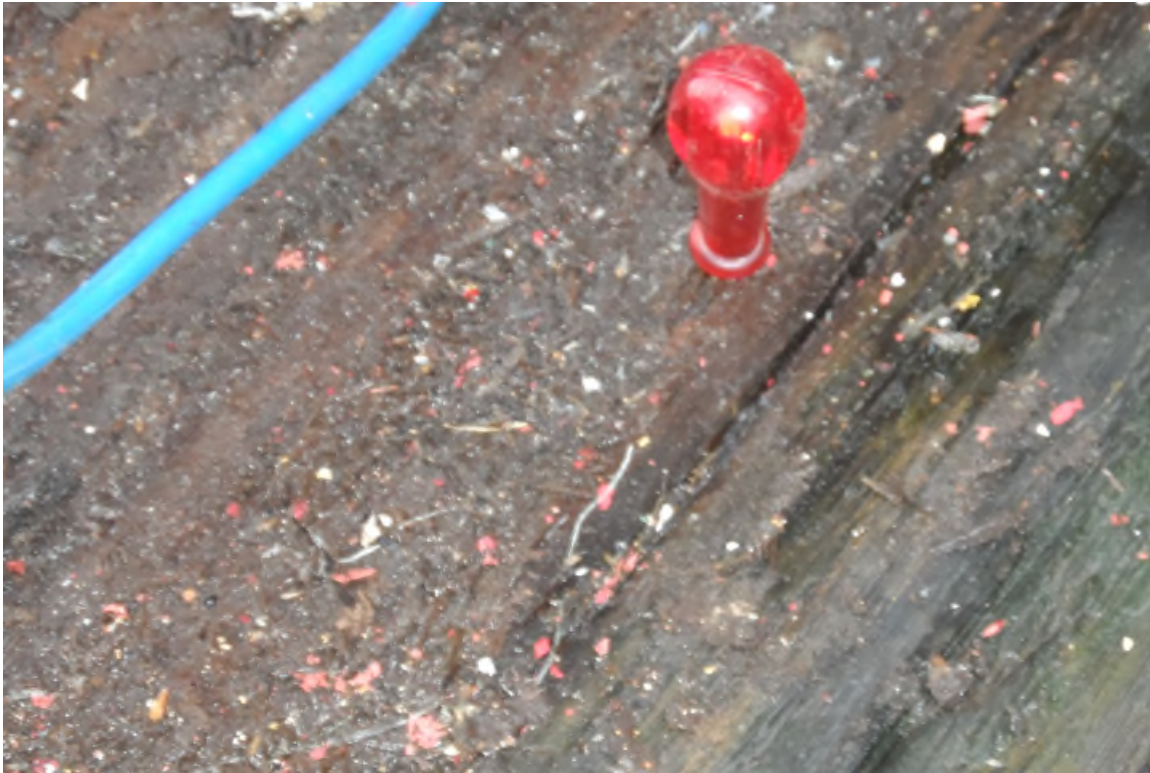
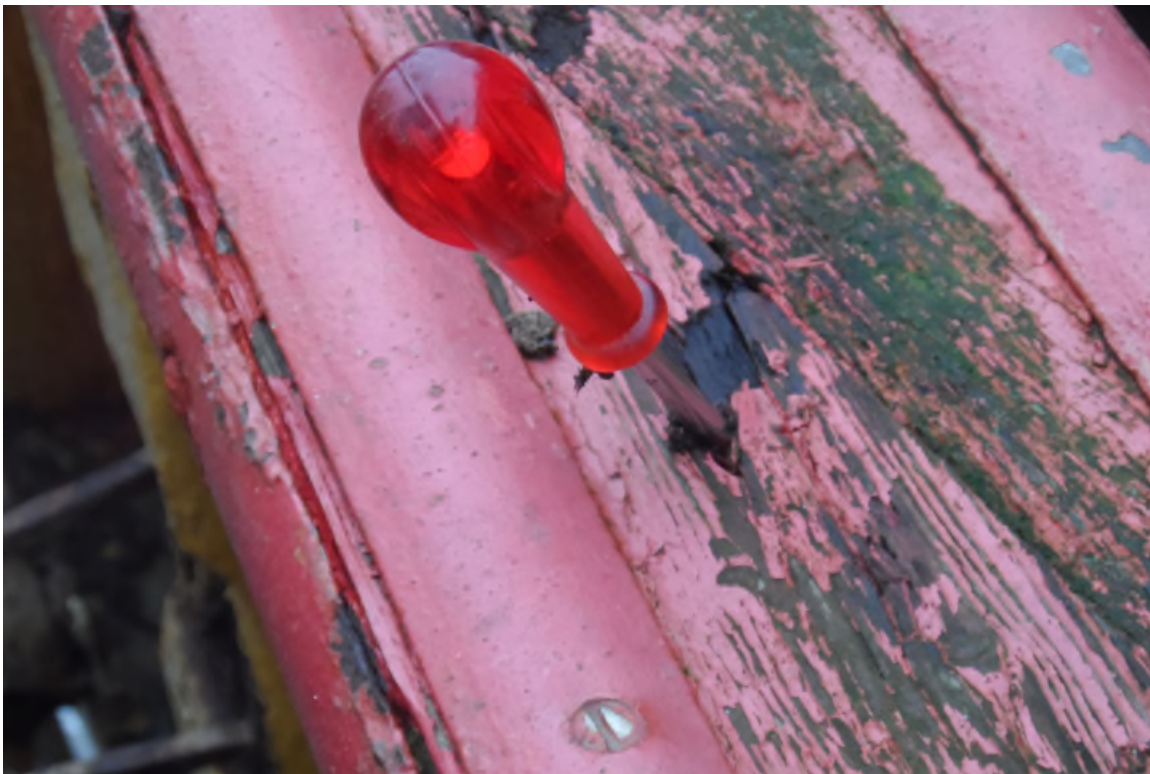
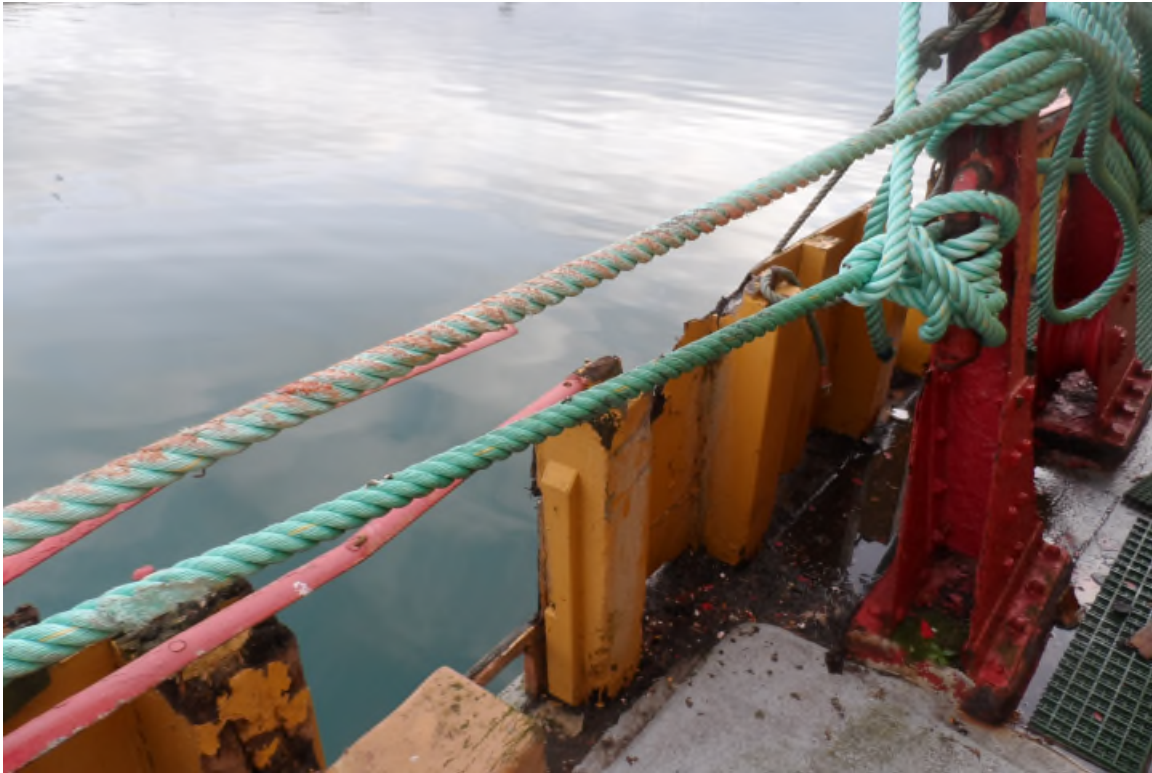
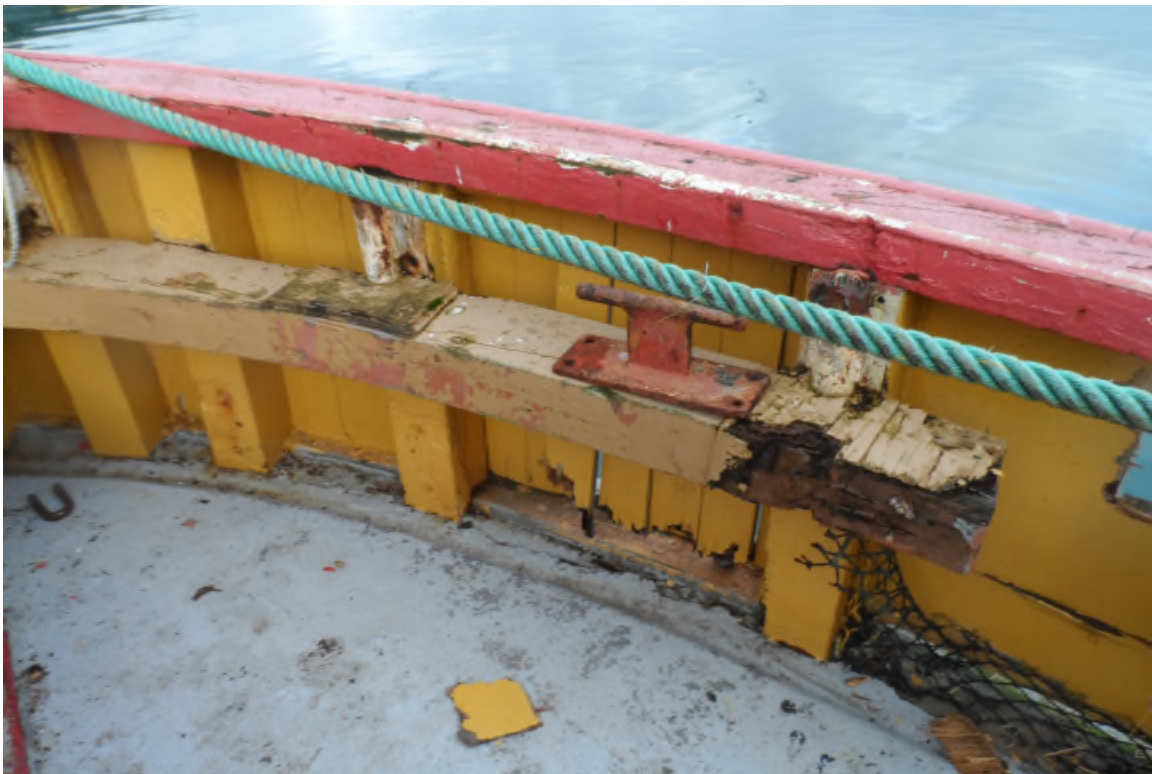
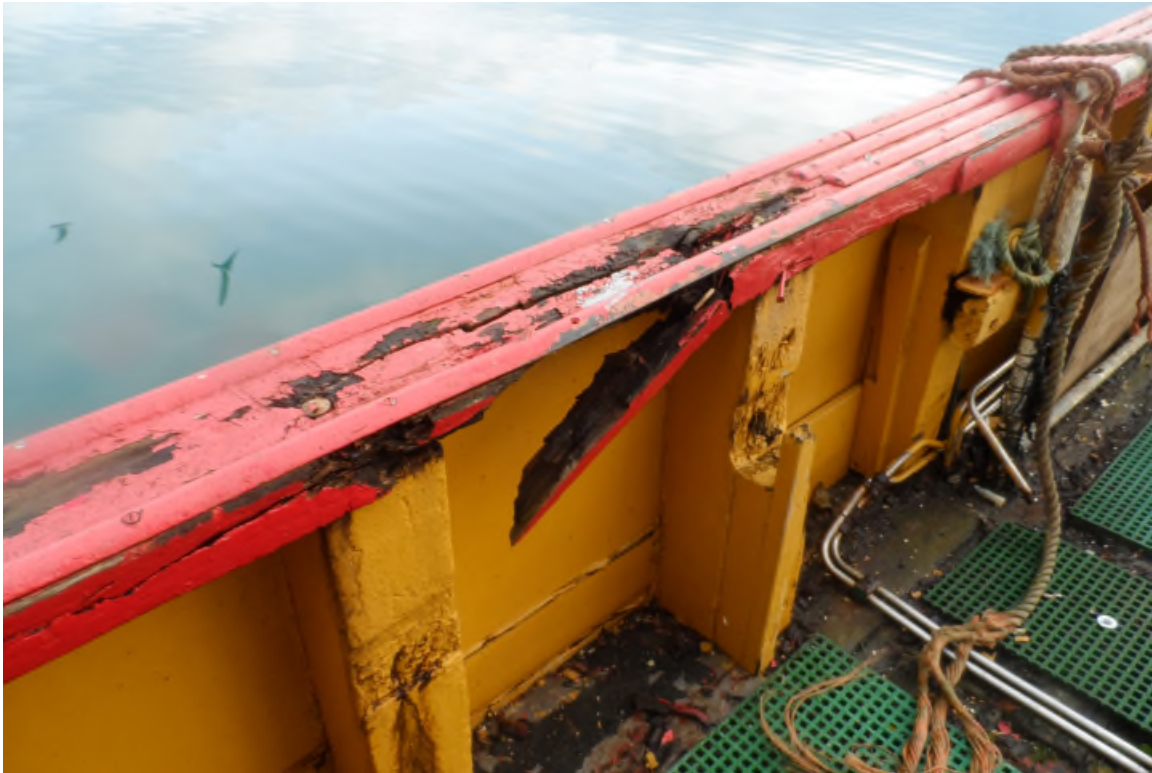
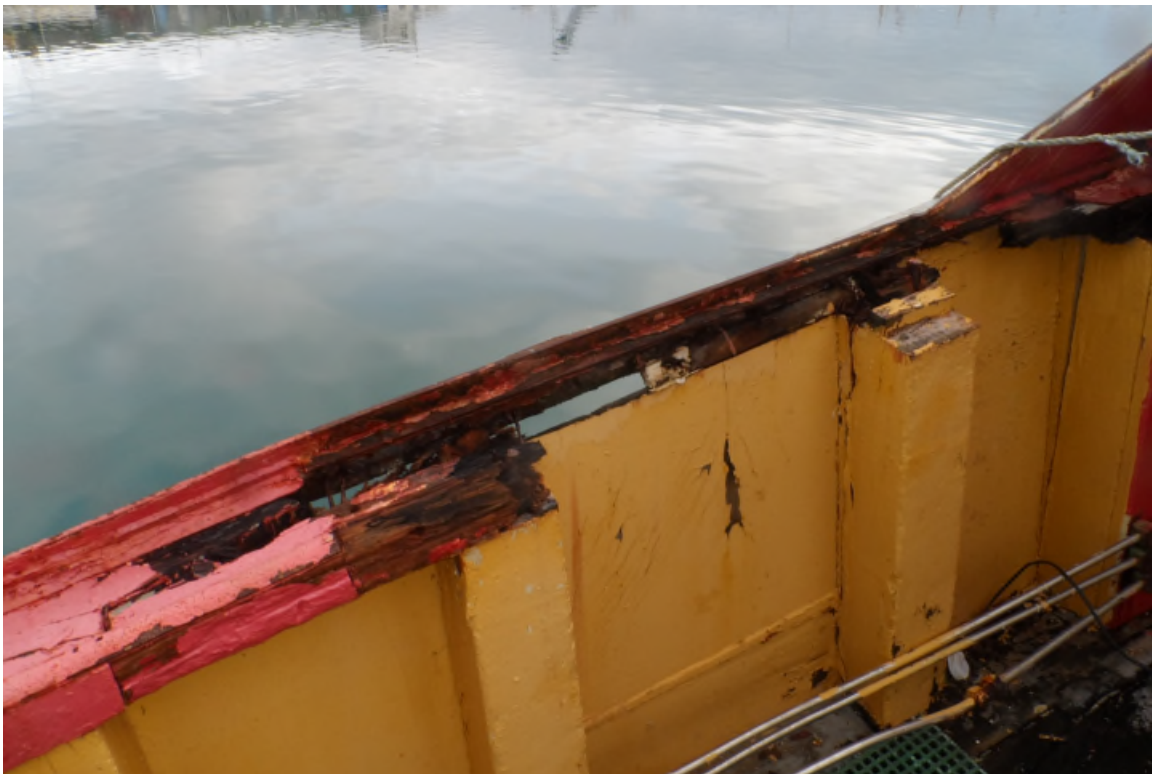
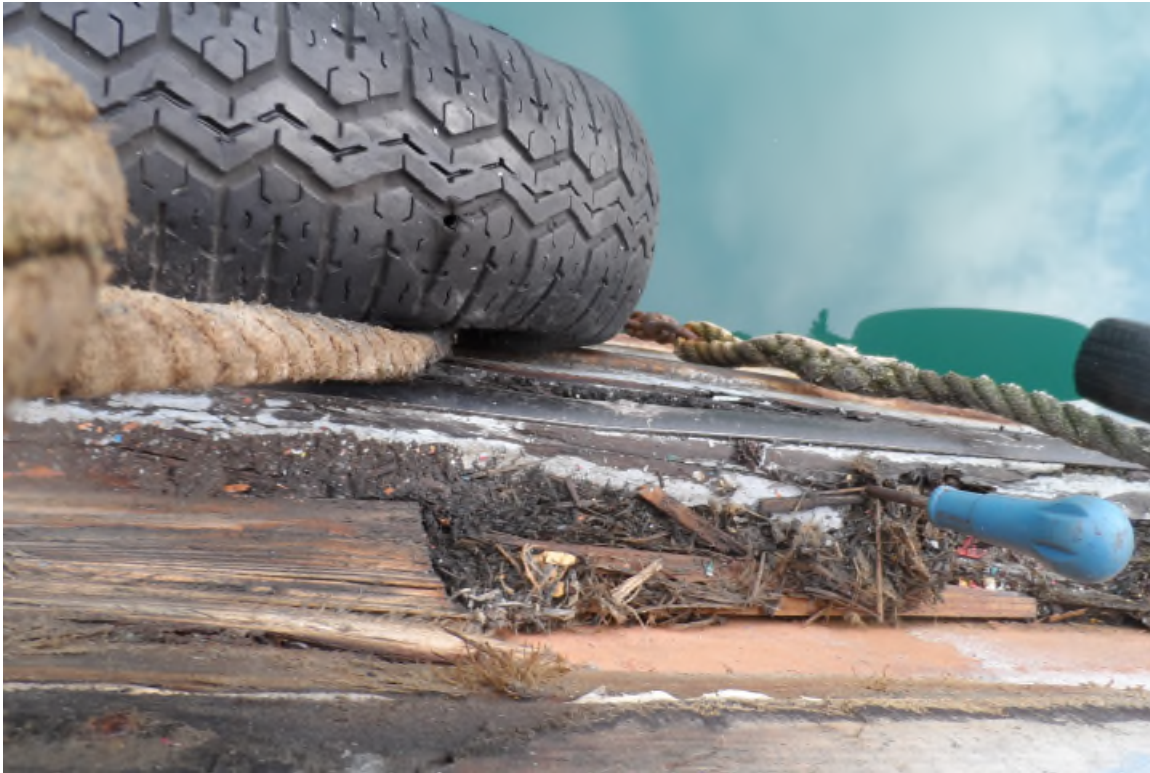
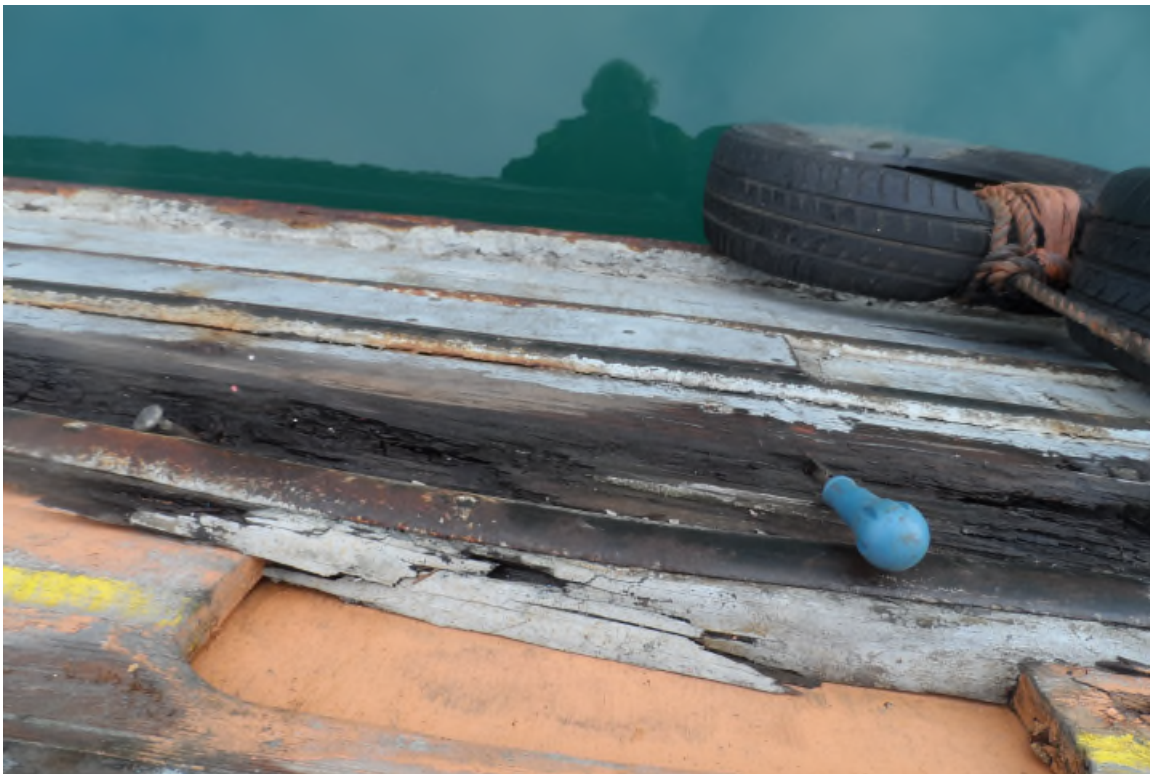
13.1 Deck planking

- i) As well as accessible deck planking being spike tested from inside the under deck spaces the majority of the main deck was spike tested from above and a substantial amount of this was found to be rotten with the caulking in very poor condition or missing.
- ii) The after part of the main deck had been clad and it was not possible to check any of the planking beneath the cladding only accessible parts from within the vessel.

13.2 Gunwales and bulwarks

- i) The majority of the gunwales and bulwarks were in very poor condition with large sections of the bulwarks completely rotten away with the adjacent section of gunwale in very poor condition.
- ii) The bulwark and gunwale sections along the sides of the contribute to the longitudinal strength of the vessel and their very poor condition will therefore have reduced the overall strength of the vessel.
