R. Pearce & Co.

HULL STRUCTURAL CONDITION REPORT

1	NAME	:	EXCELLENT
	Class	:	Wooden Fishing Vessel
	Type	:	Netter
	Gross Tonnage	:	75
	Registered length	:	23.18m
	Built	:	1931

16th December 2014 Afloat at Newlyn, Cornwall.

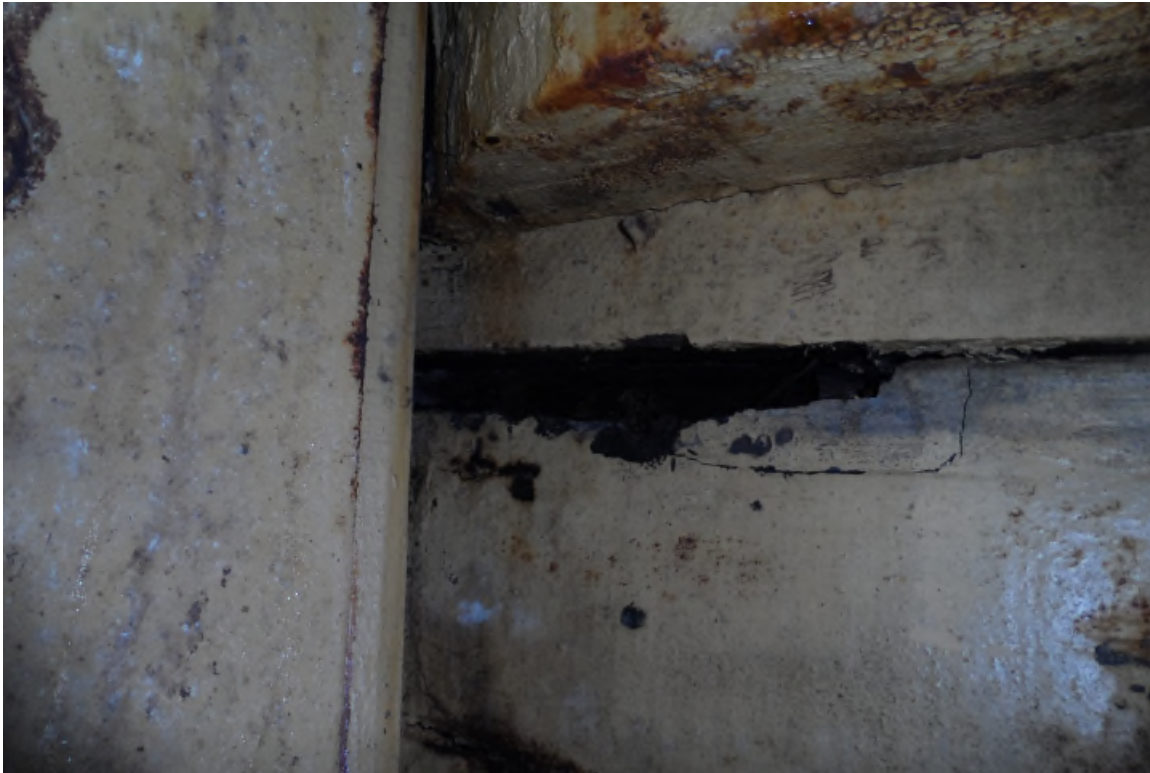
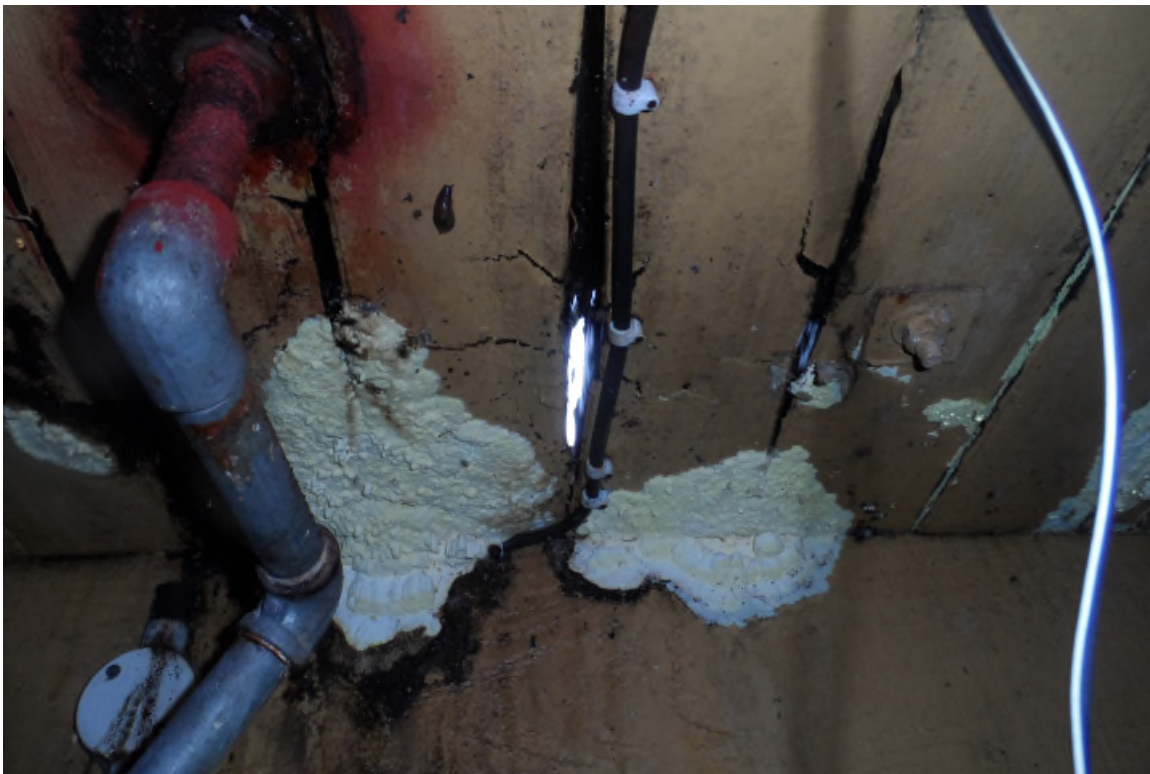
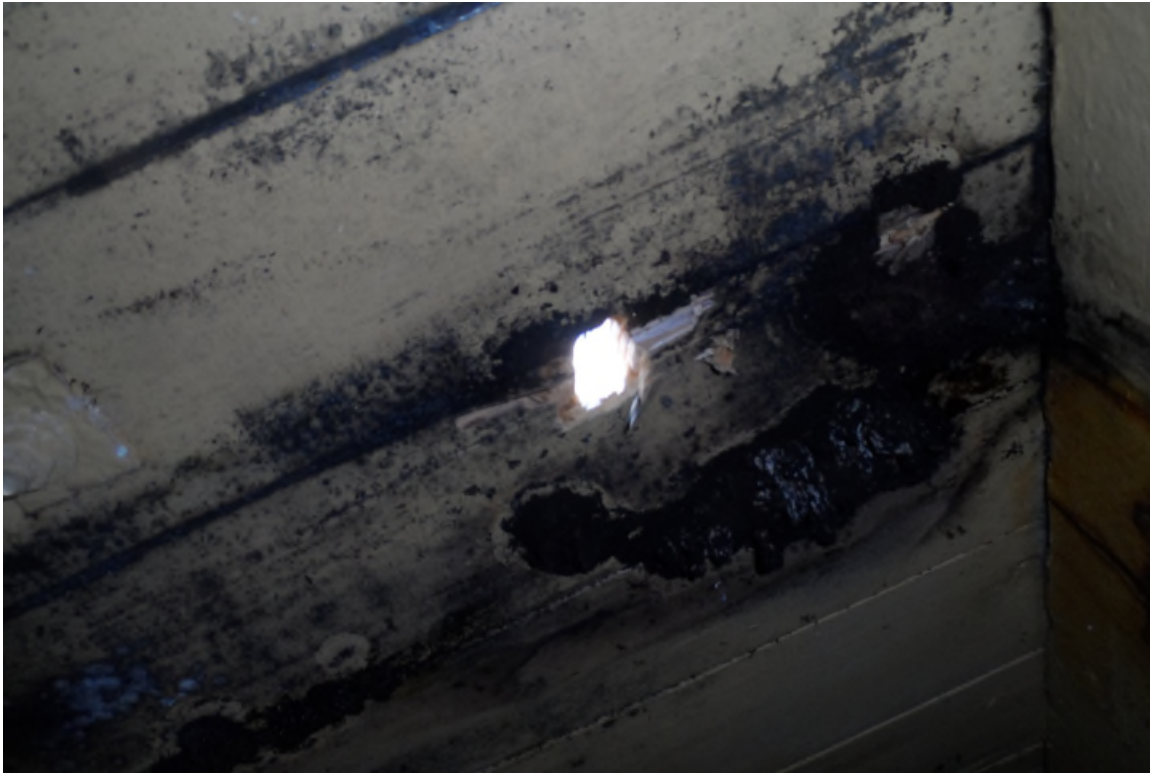
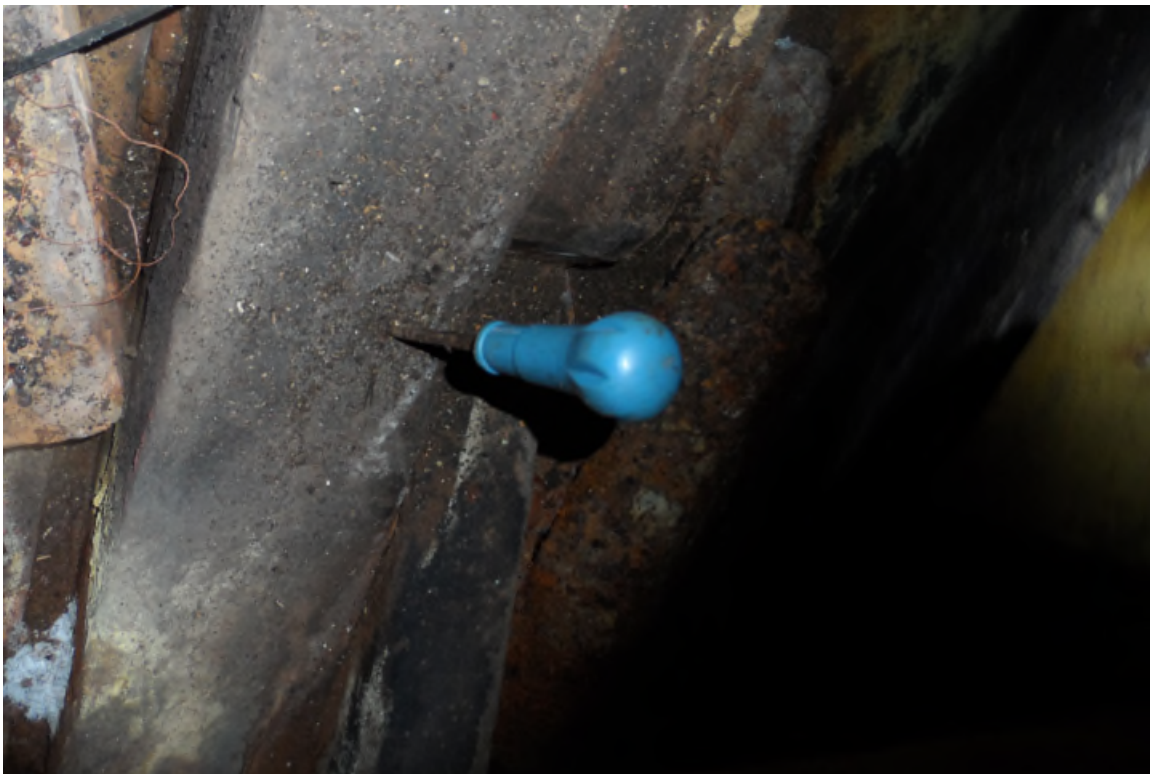
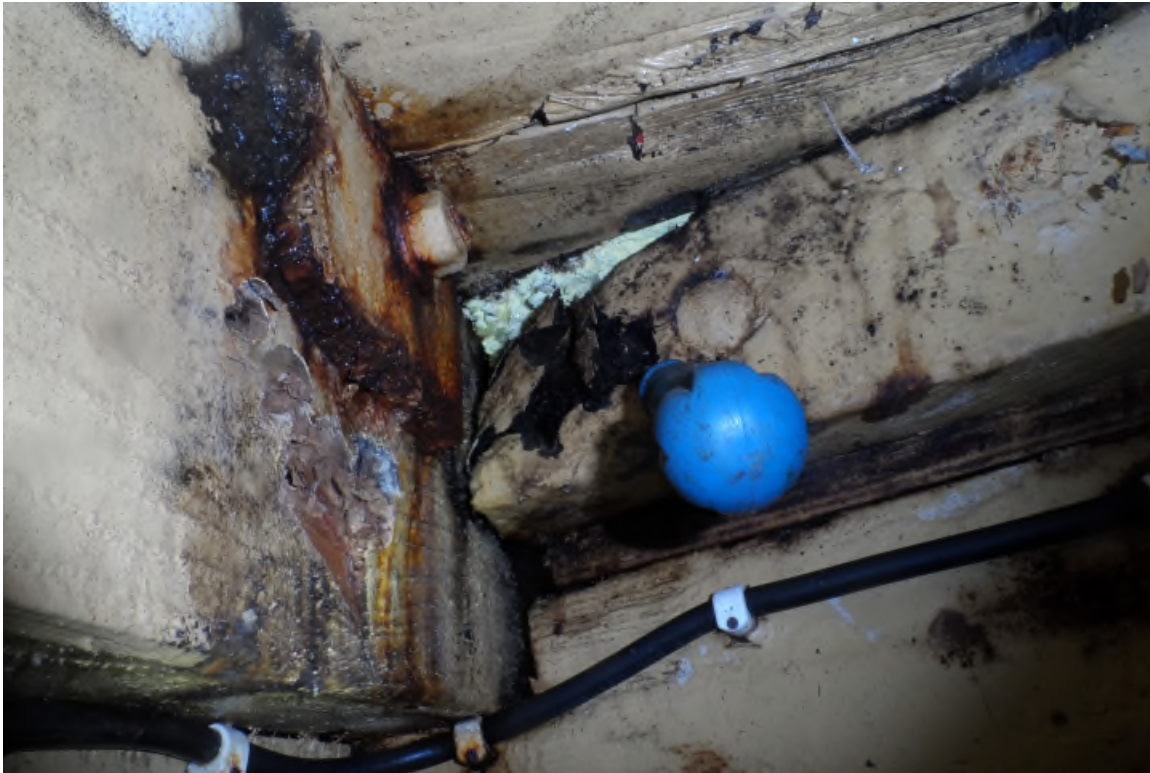
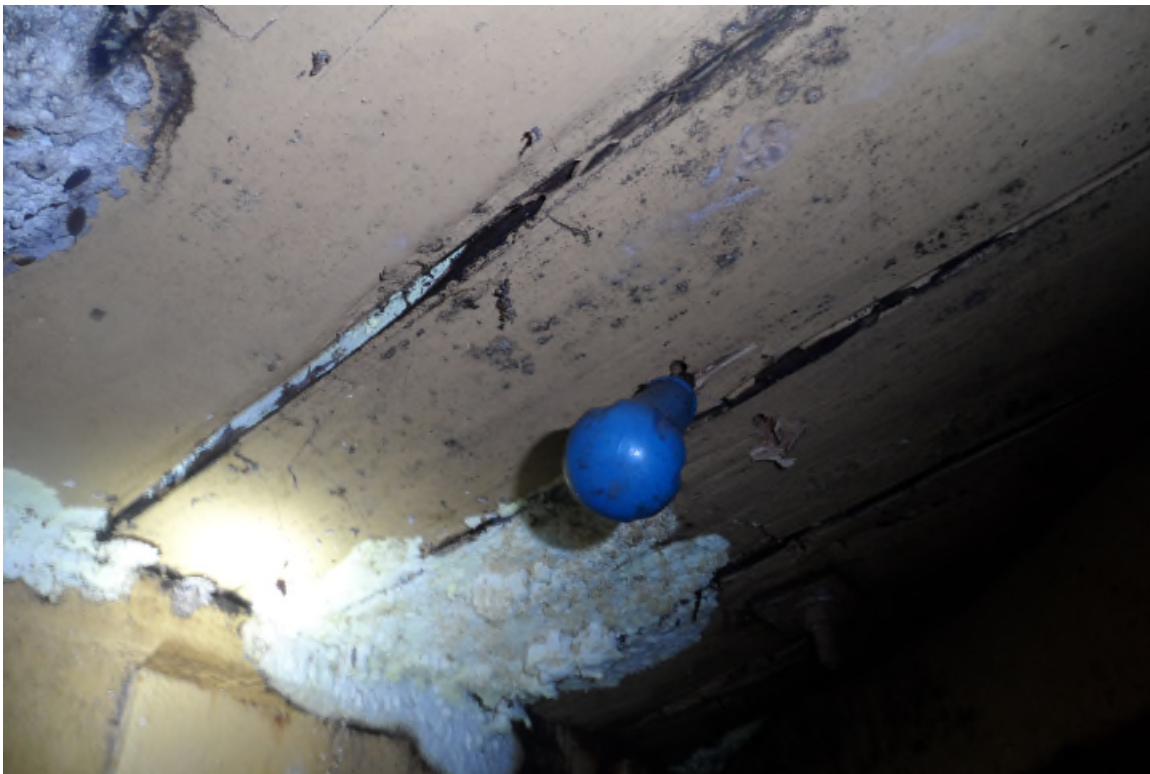
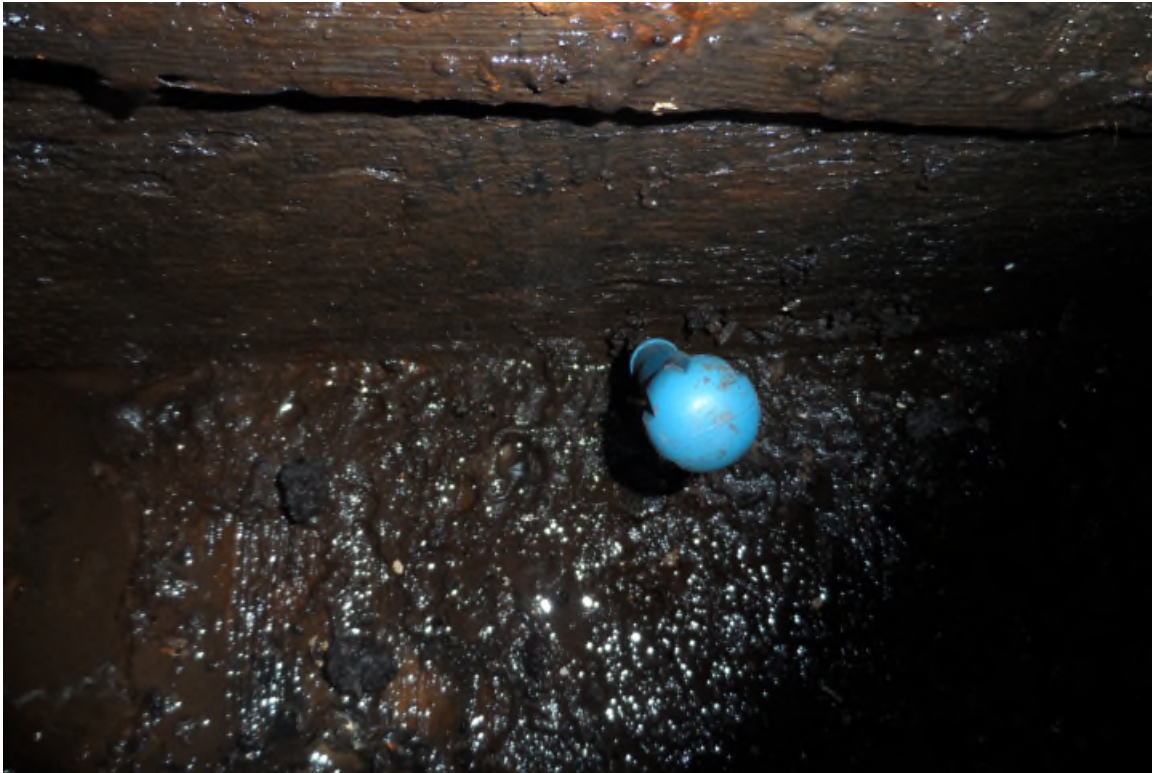
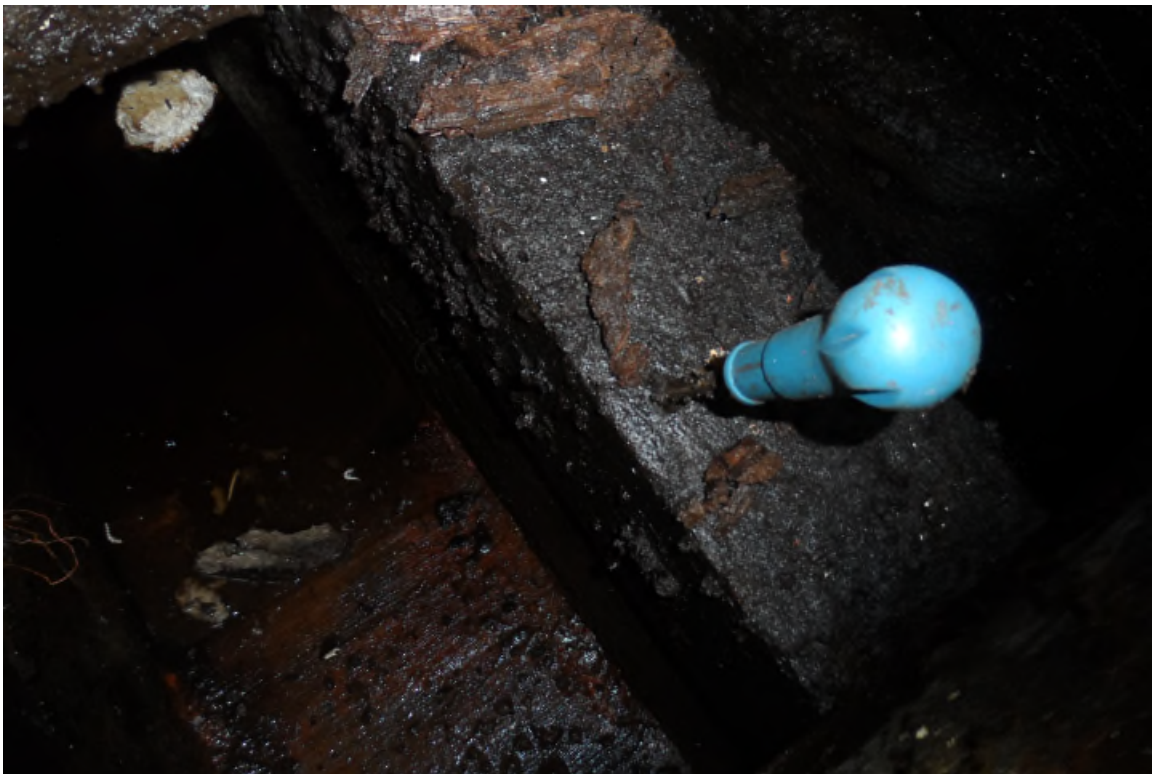
i) Forward store

Visible parts of the planking examined and the majority of accessible parts spike tested for softness – Some plank ends joining the stem timbers very soft with one plank rotten to the extent that a section could be dug out. The majority of the frames were found in reasonable order with some small areas of softness in the bilge area. The ends of the under deck beam at the aft part of the space were very soft with the port side suffering from dry rot rather than wet rot, the adjacent lodging knee's were also soft. A very large number of the deck planks above this space, especially around the hatch, were rotten through with large amounts of caulking missing and daylight visible from within the space.

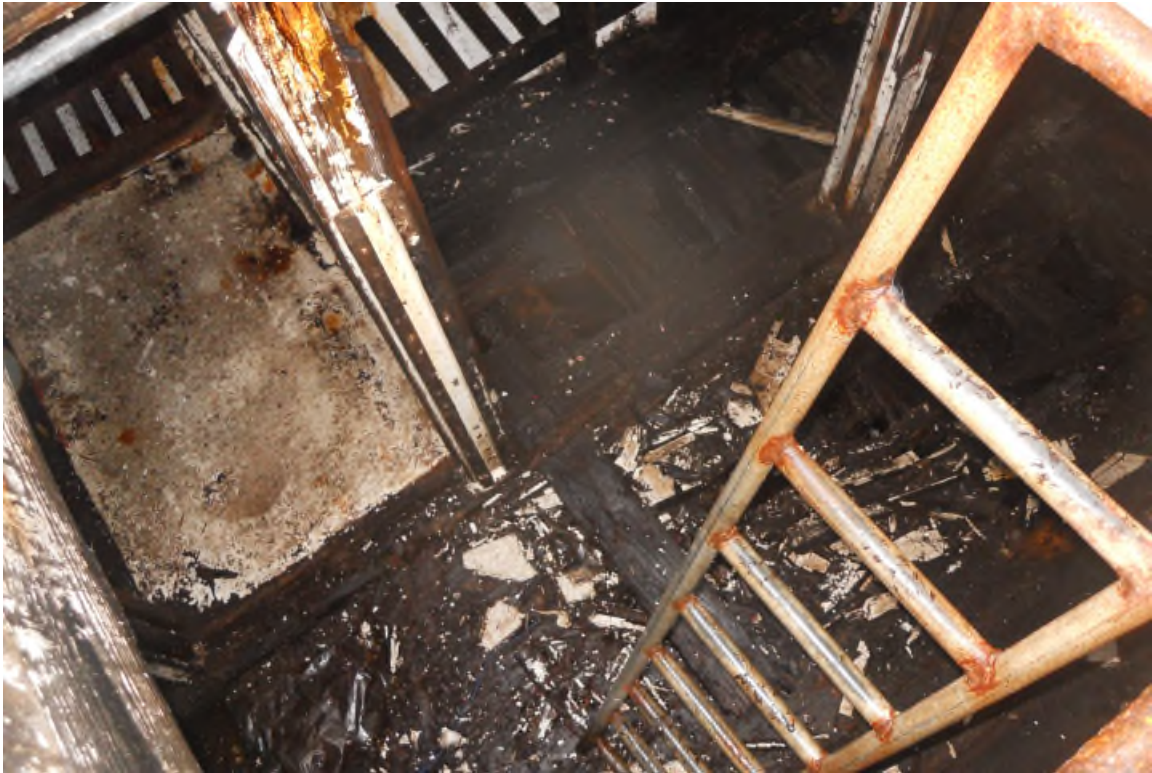
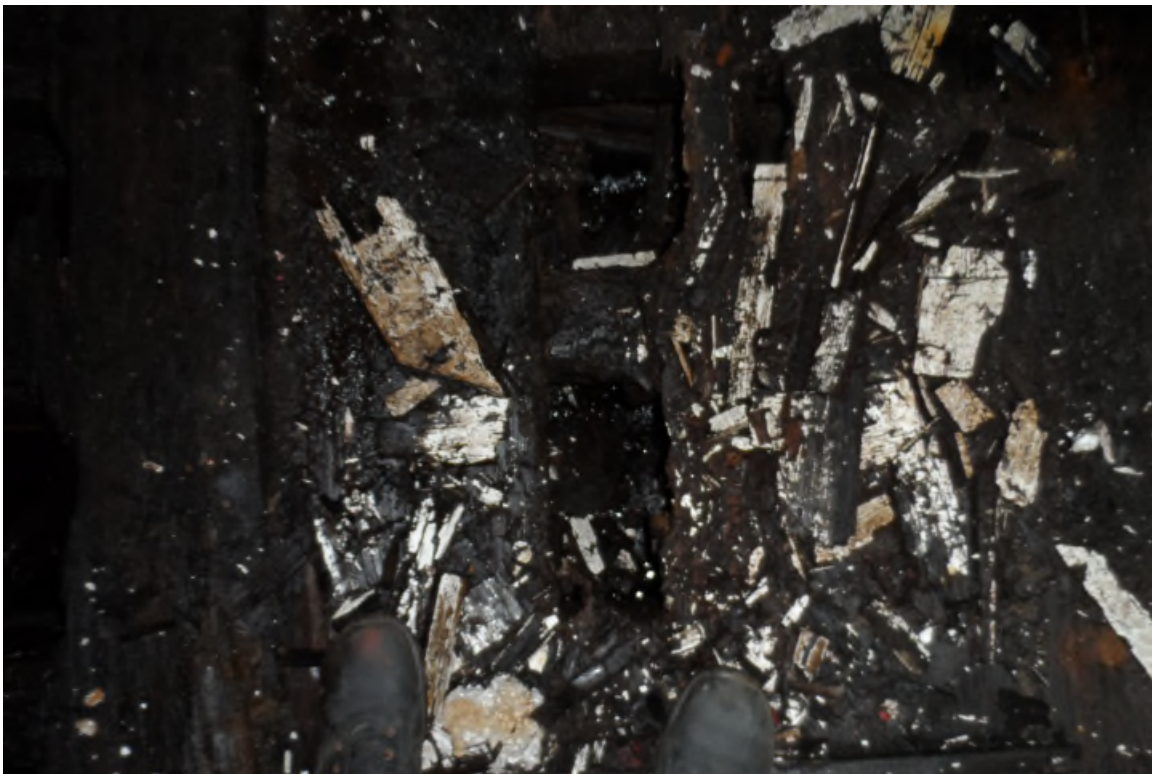
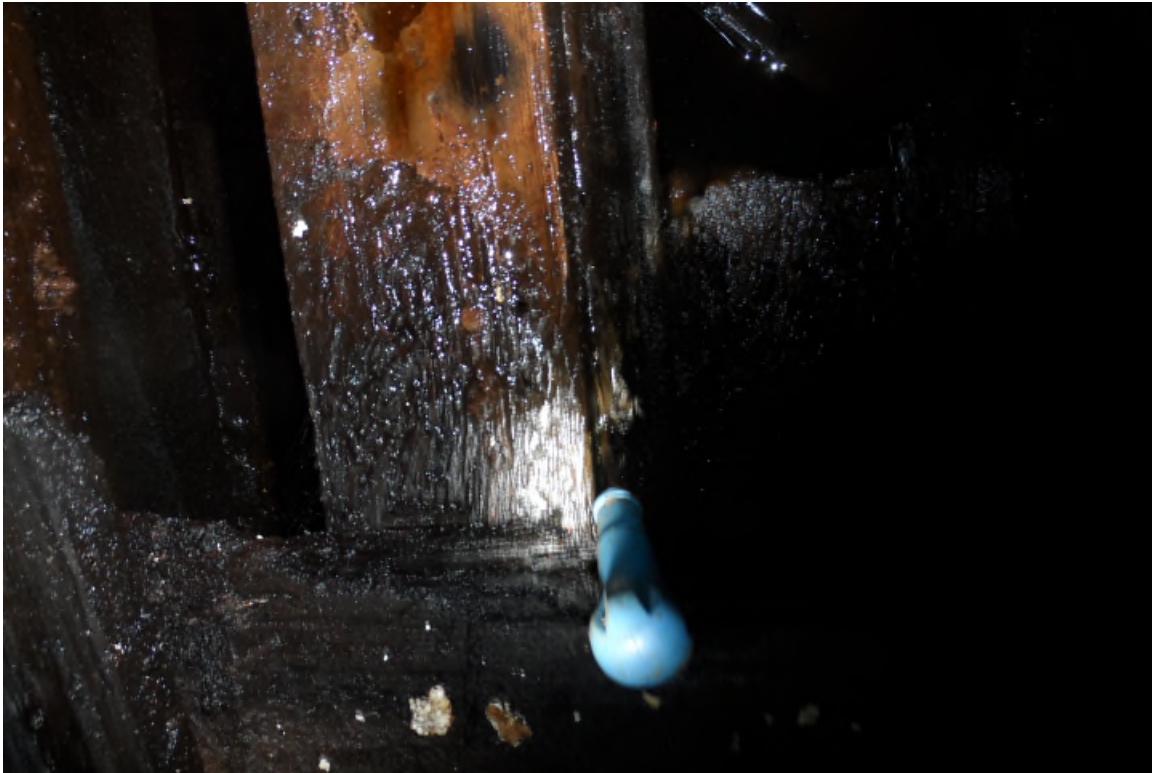
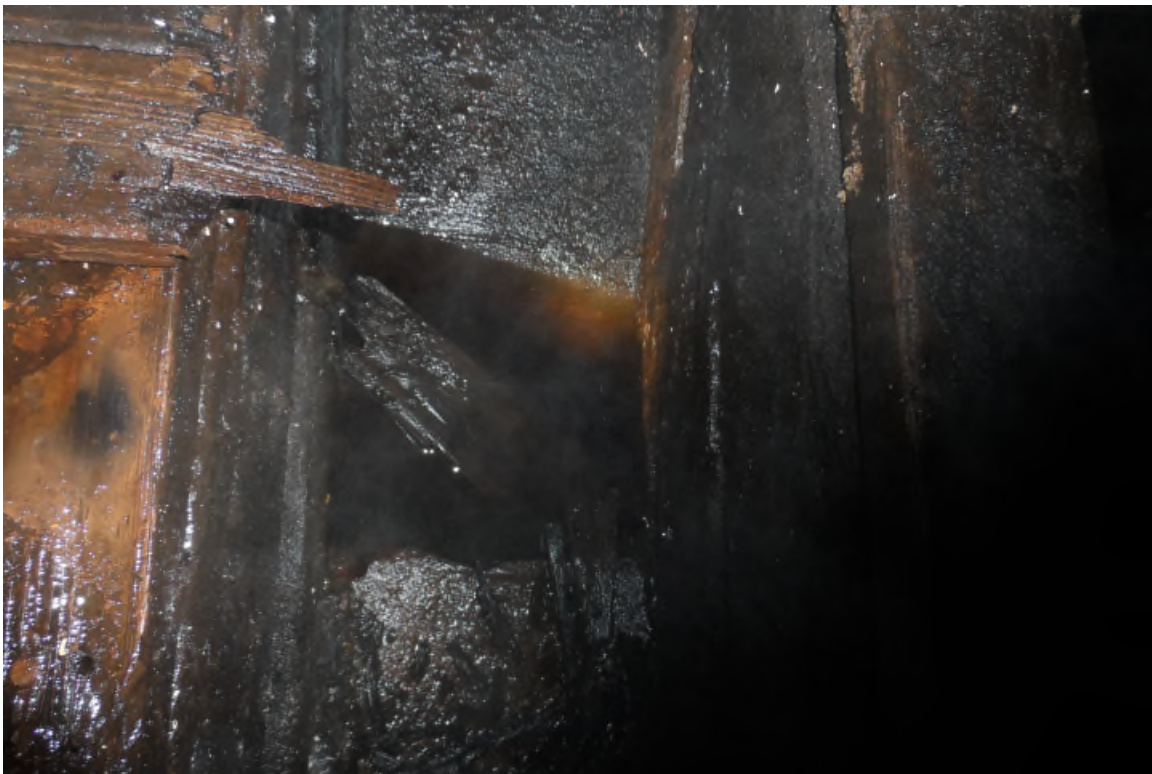
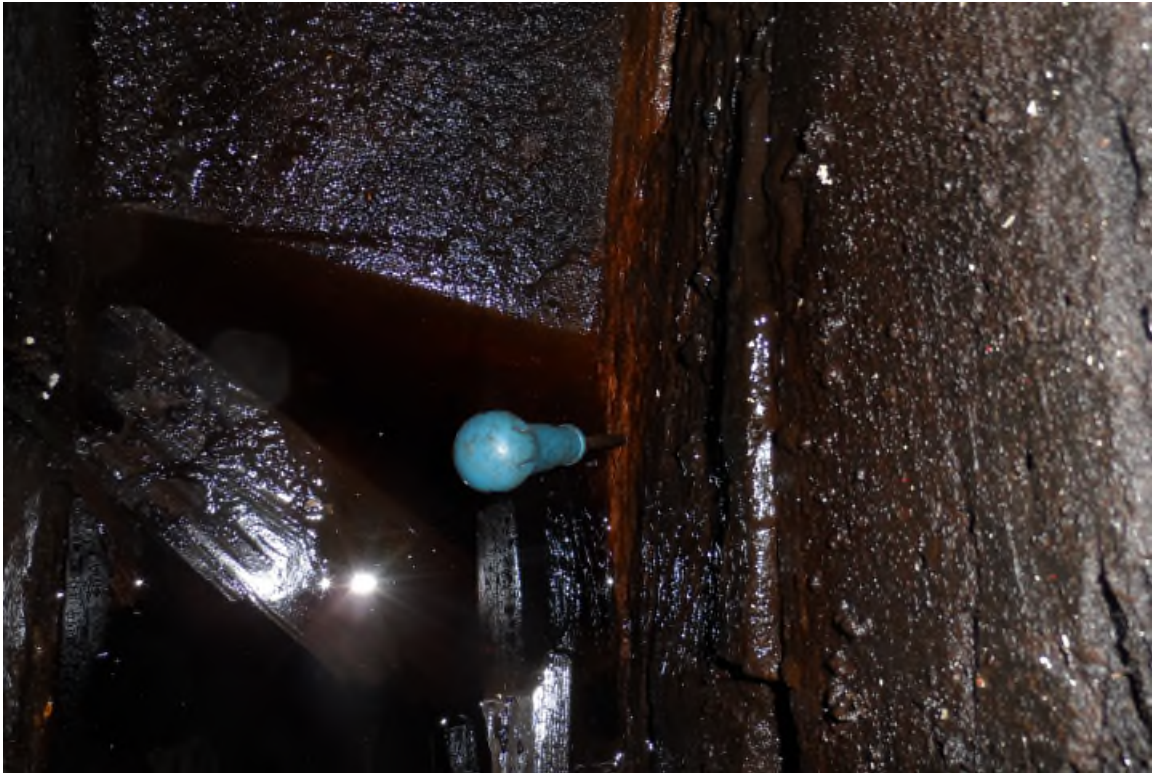
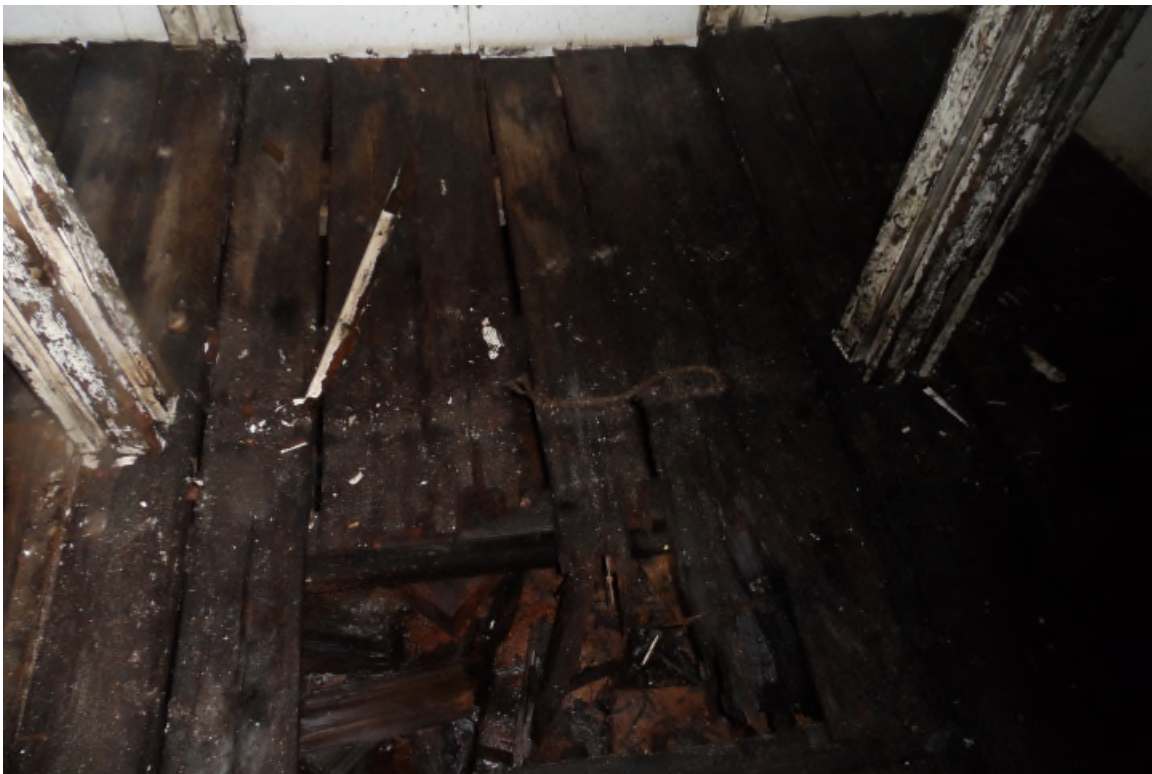
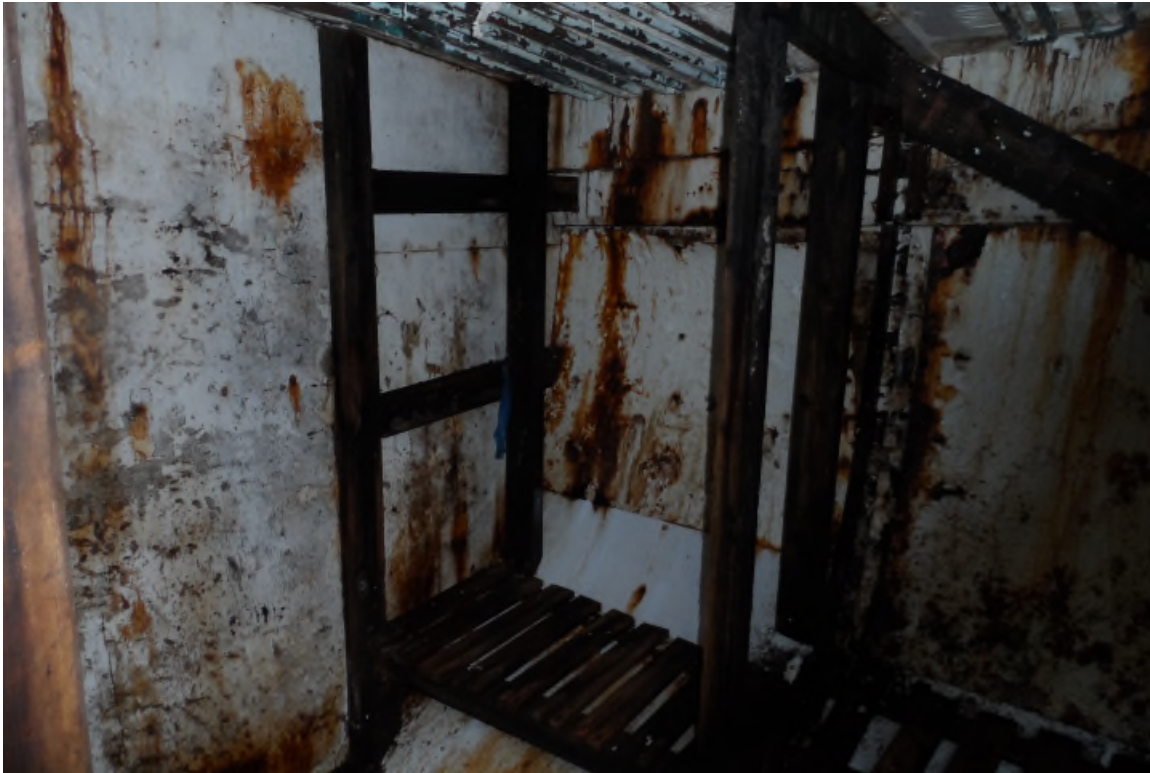
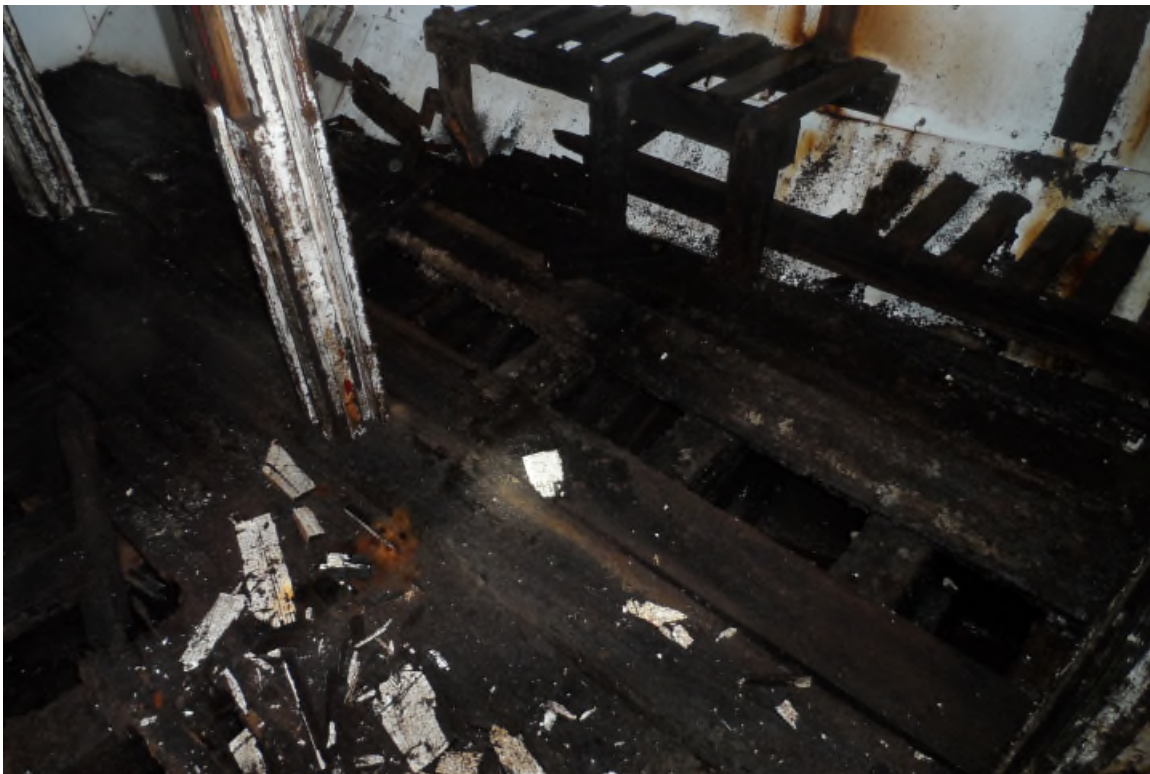
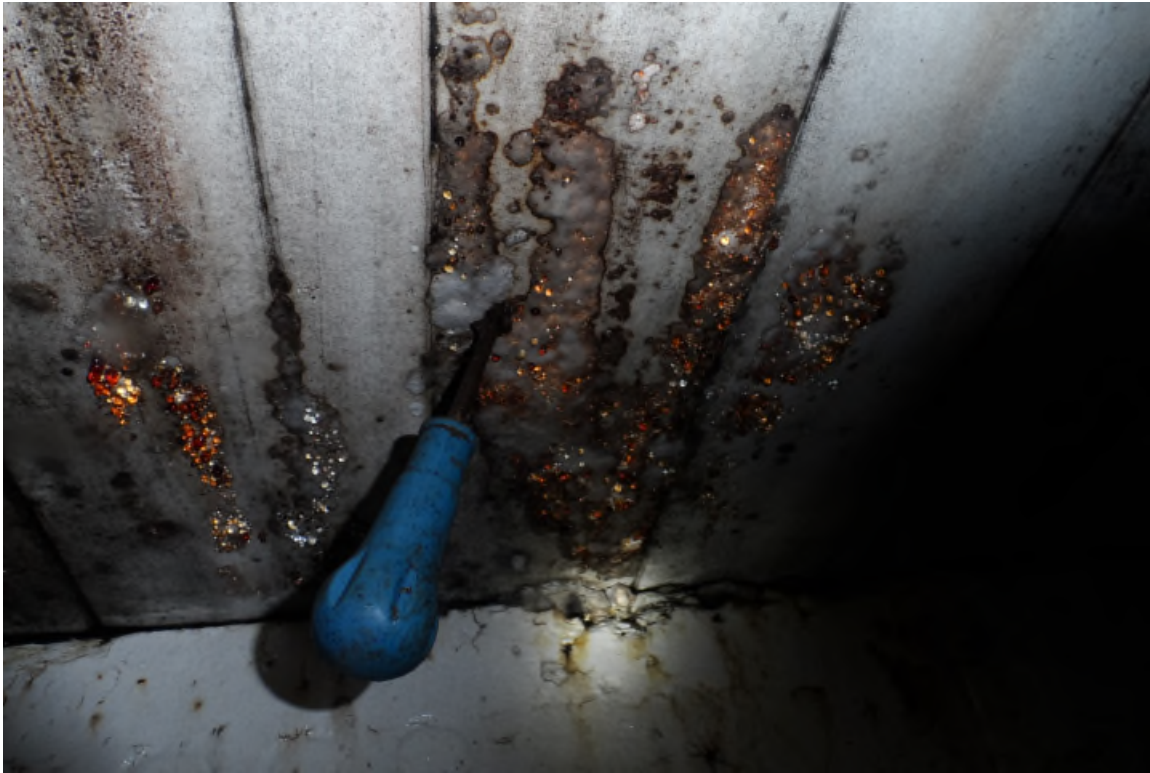
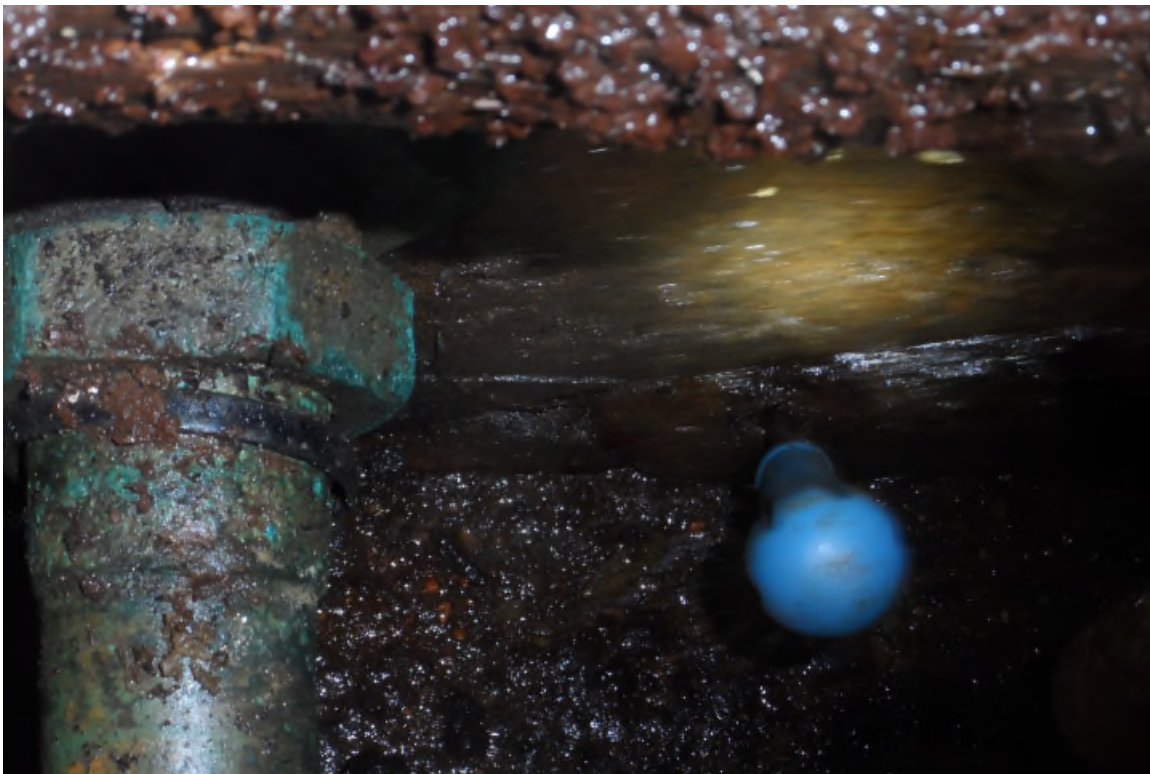
ii) Fish hold

The deck planking in the bottom of this space was in a very poor condition having either completely failed due to rot or in an unsafe condition and not safe to stand on in unsupported areas.

The majority of the upper parts were lined but where the internal structure was accessible this was very wet and some areas spike tested were very soft.

Due to the unsafe nature of the internal deck planking only the after part of the internal structure in the bilge area was close up examined. At the time of our survey the fish hold had been pumped out but there was a small amount of what appeared to be a slightly toxic liquid in the after part of the bilge. Several frames were spike tested and where deck planking had previously been there were large areas which were very soft with wet rot.

Where upper parts of the space were accessible spike testing was carried out and whilst the main structure was generally fair a large amount of the deck planking, especially at the forward part, was very rotten with the caulking missing.
