R. Pearce & Co.

HULL STRUCTURAL CONDITION REPORT

1	NAME	:	EXCELLENT
	Class	:	Wooden Fishing Vessel
	Type	:	Netter
	Gross Tonnage	:	75
	Registered length	:	23.18m
	Built	:	1931

16th December 2014 Afloat at Newlyn, Cornwall.

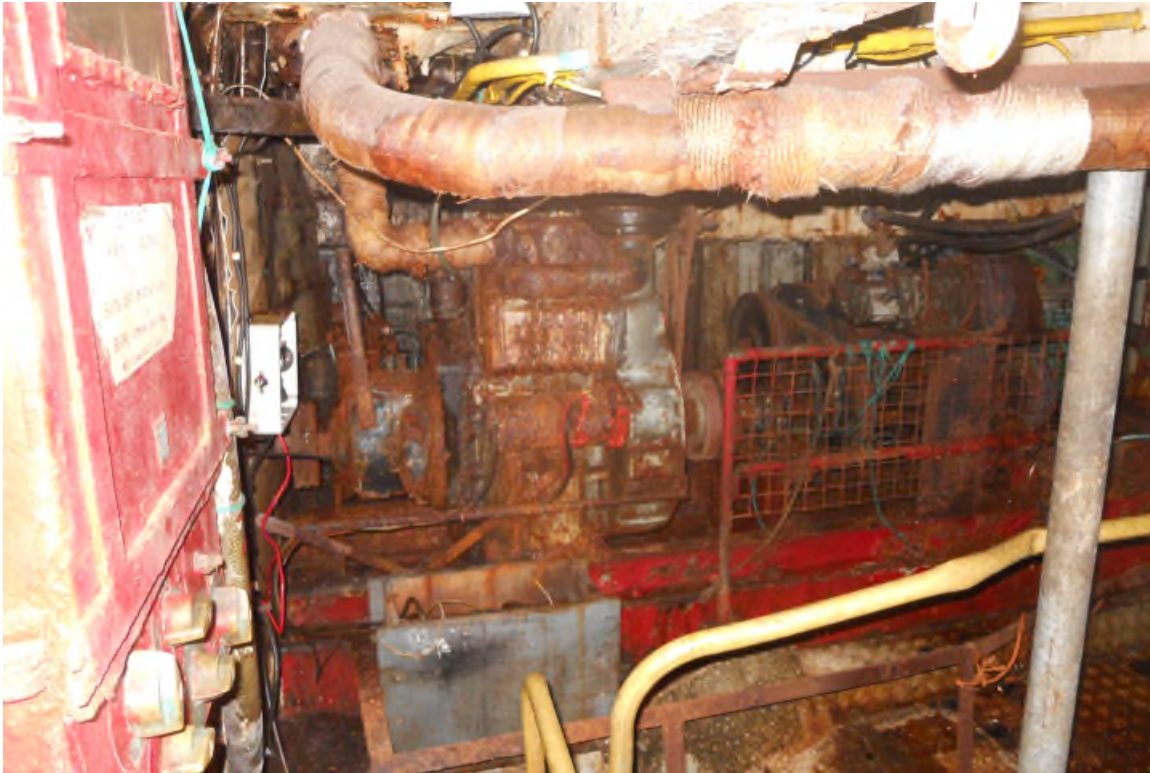
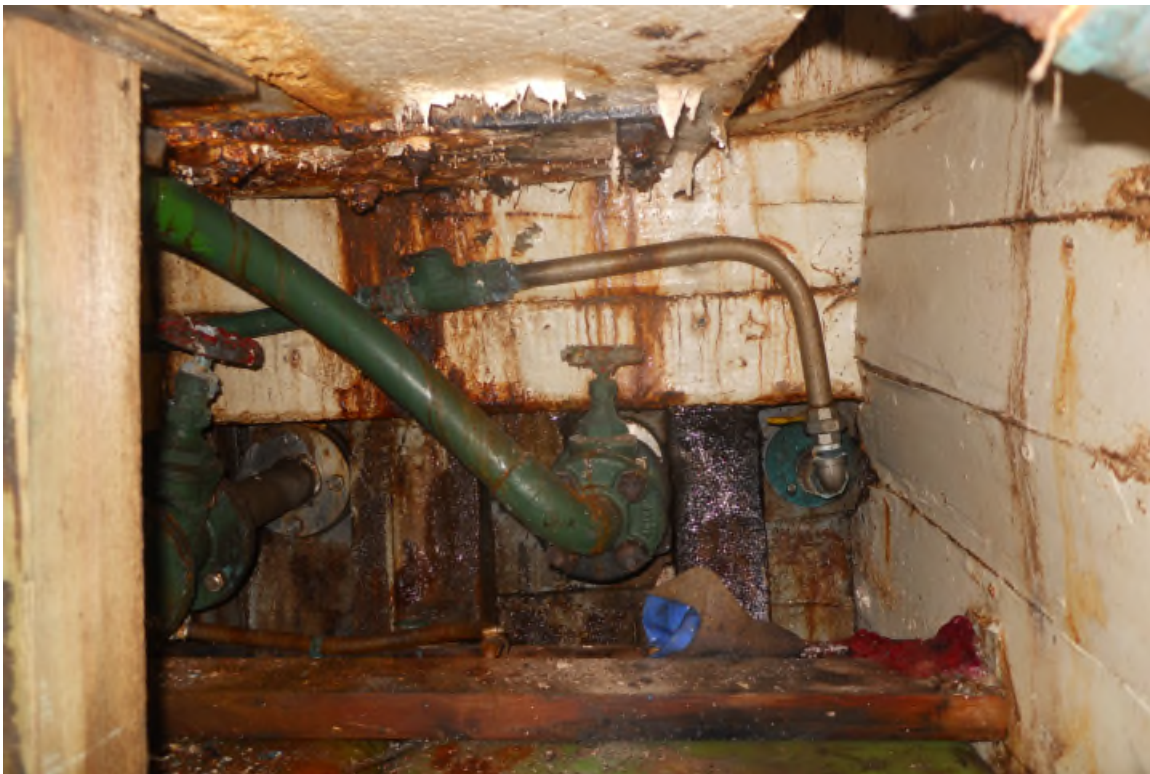
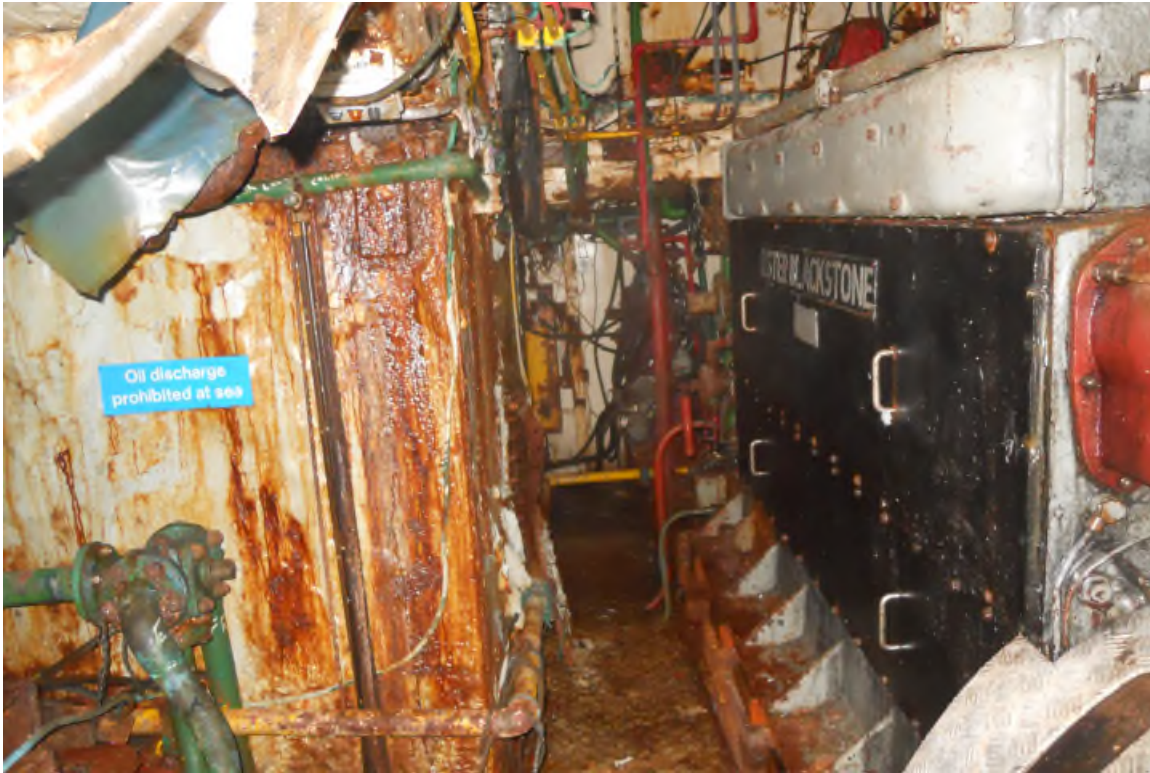
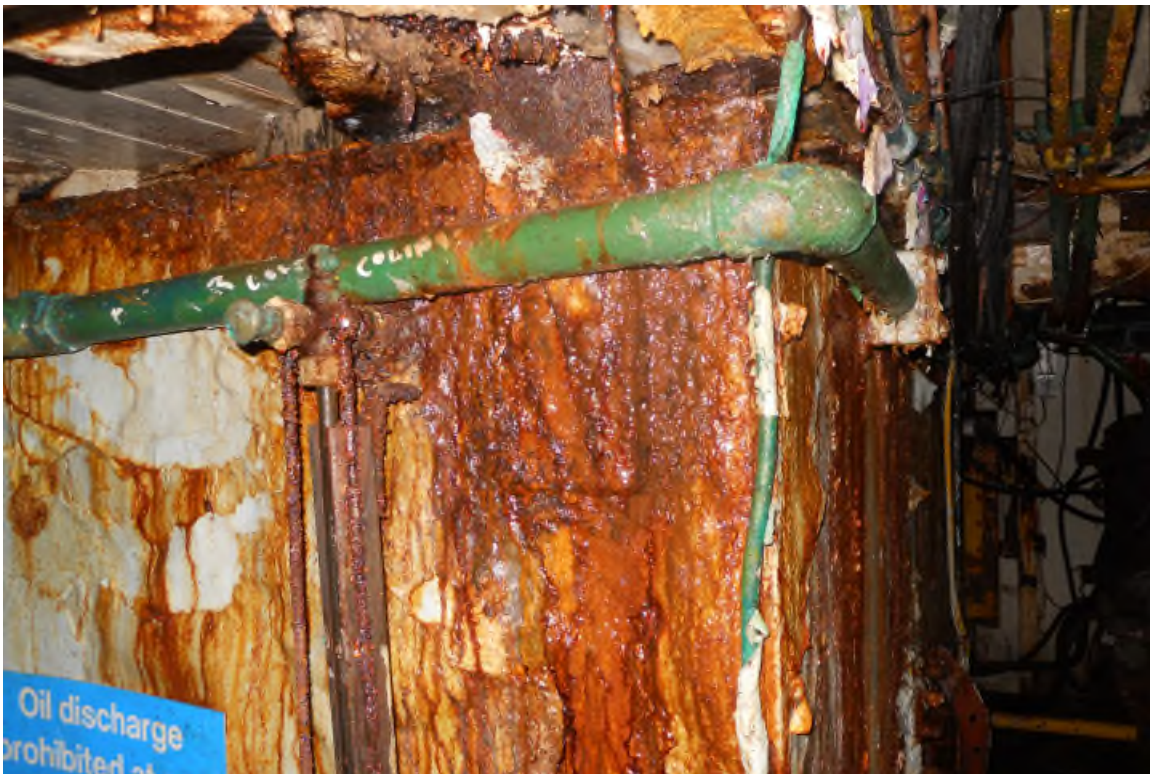
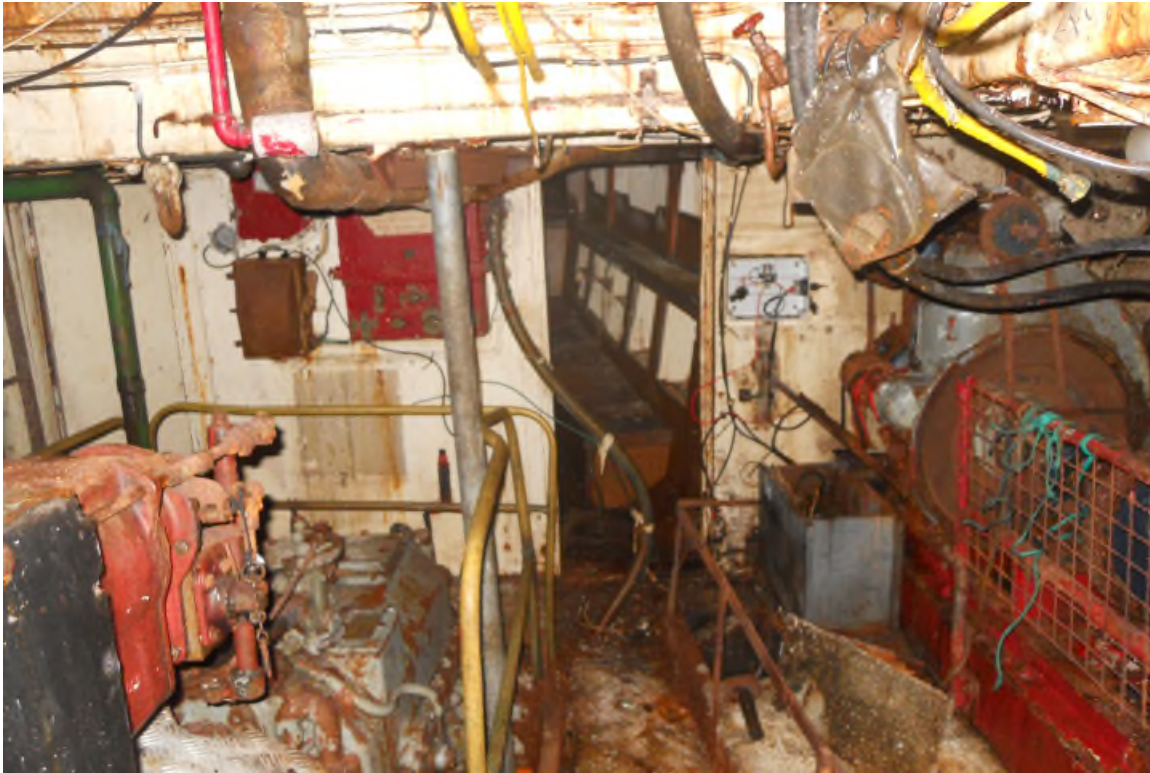
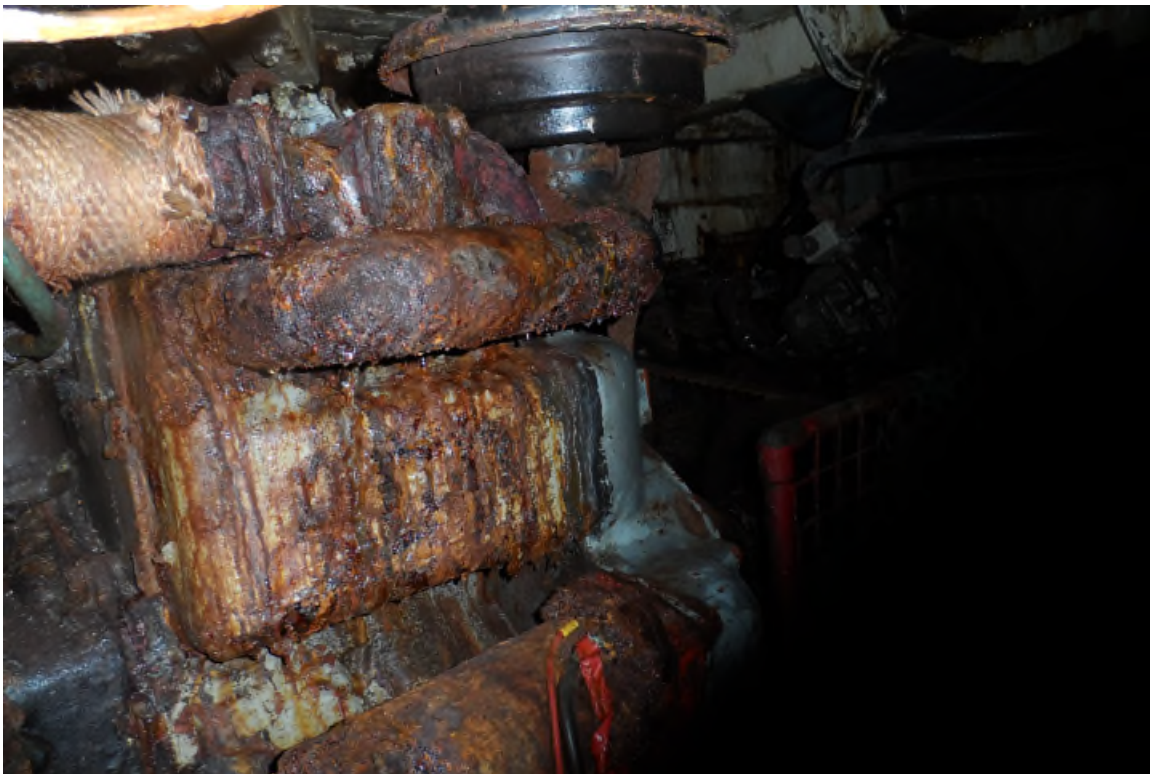
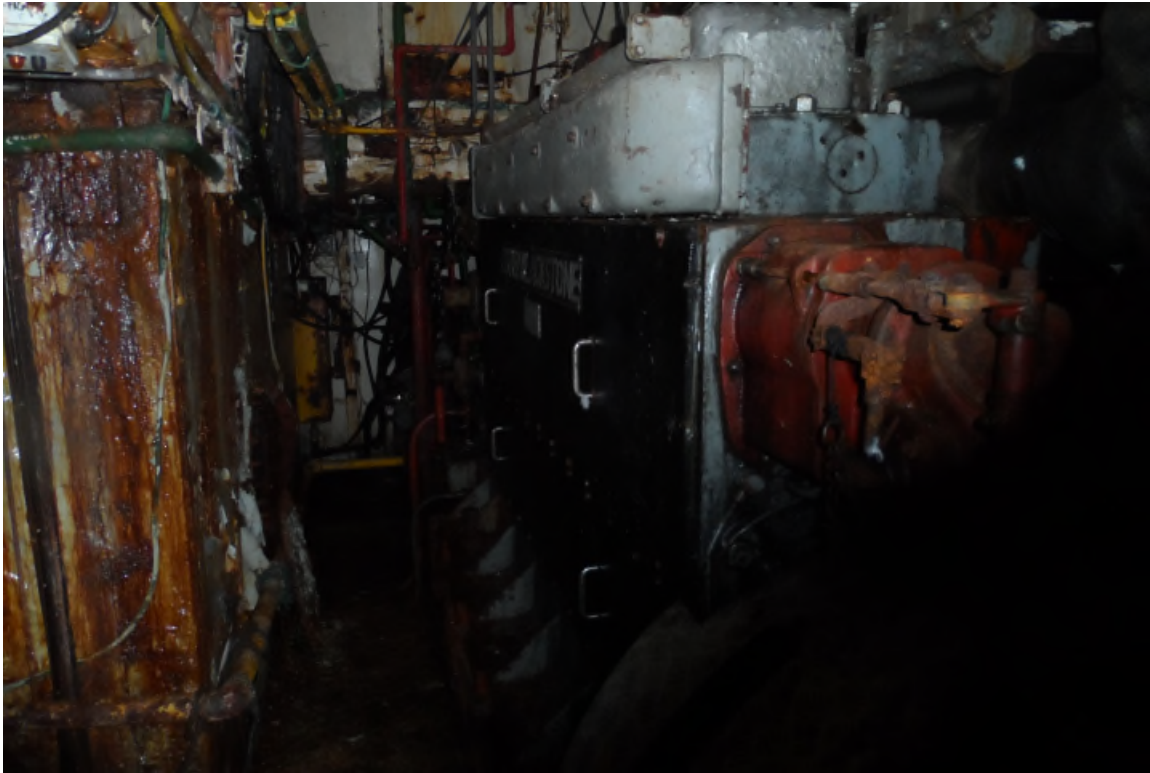
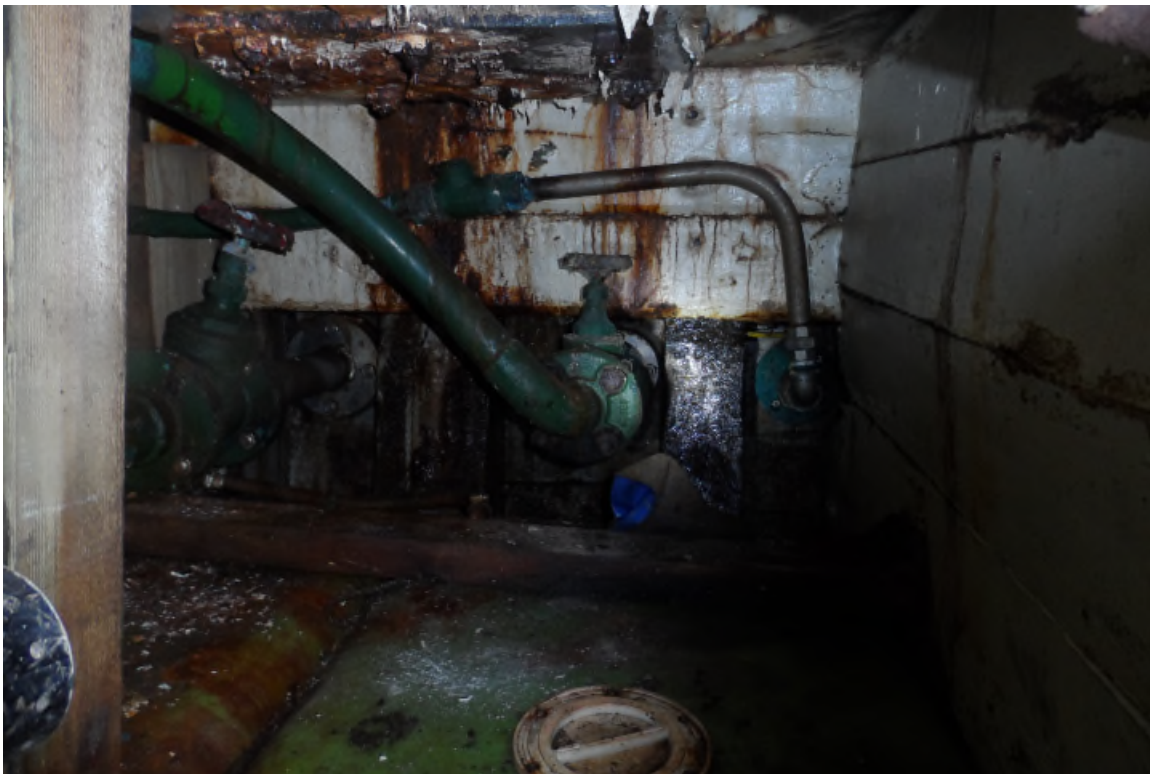
iii) Engine room

Access to the lower structure in the engine room was poor due to the machinery being in place but where spike testing was carried out timber that appeared dry was generally satisfactory but some of the wet areas were soft. The upper structure was lined in places with the upper accommodation above in the centre part but some of the areas in way of the deck edge were heavily rust stained indicating leakage from the upper deck with some soft timbers when spiked. Accessible deck planking was generally fairly hard when spiked but all parts were not checked.

Machinery, equipment, fixtures and fittings were not specifically examined as part of this survey but engine room machinery was noted to be heavily corroded with some fixtures and fitting in very poor

condition. We noted that the two fuel tanks had been emptied and cleaned with the manhole covers left off and these were in fair condition.

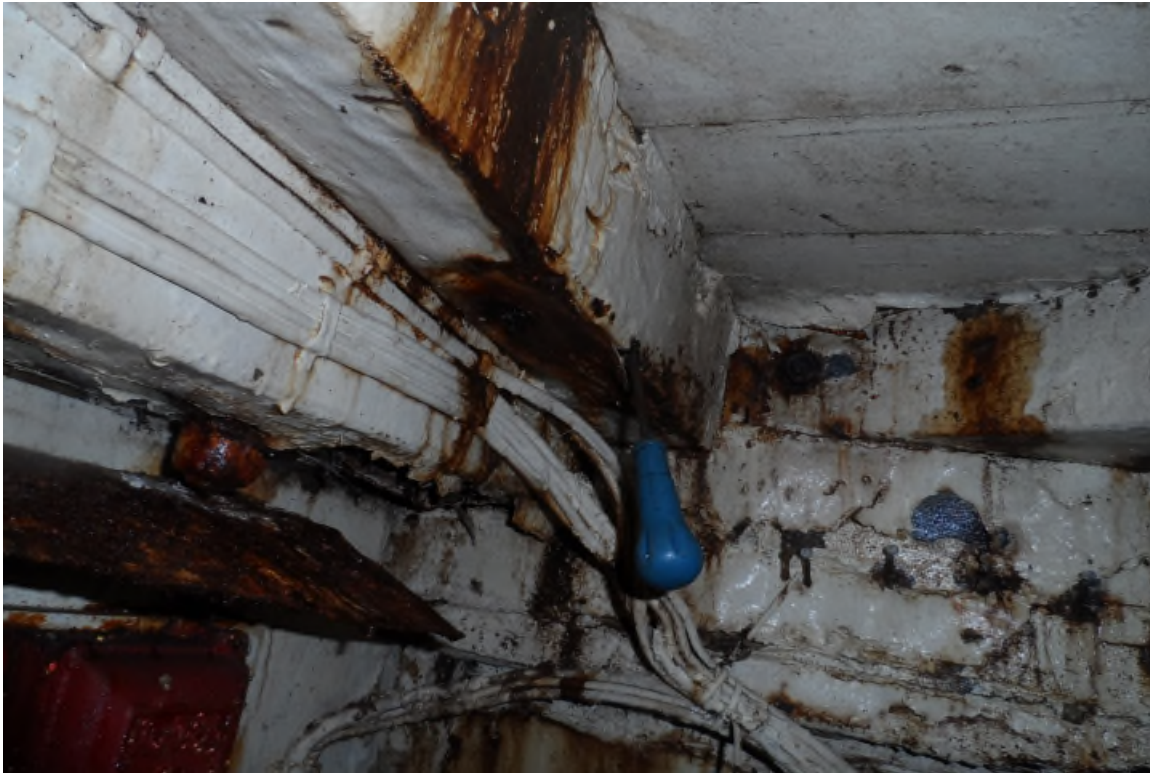
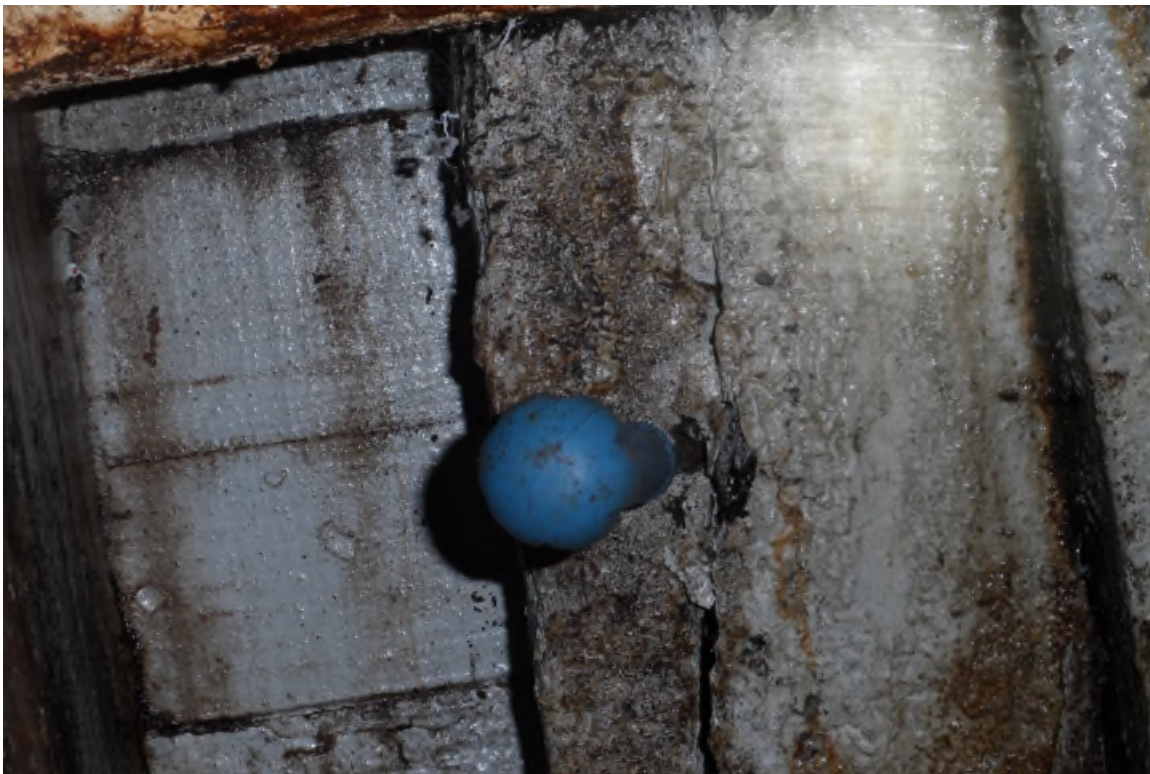
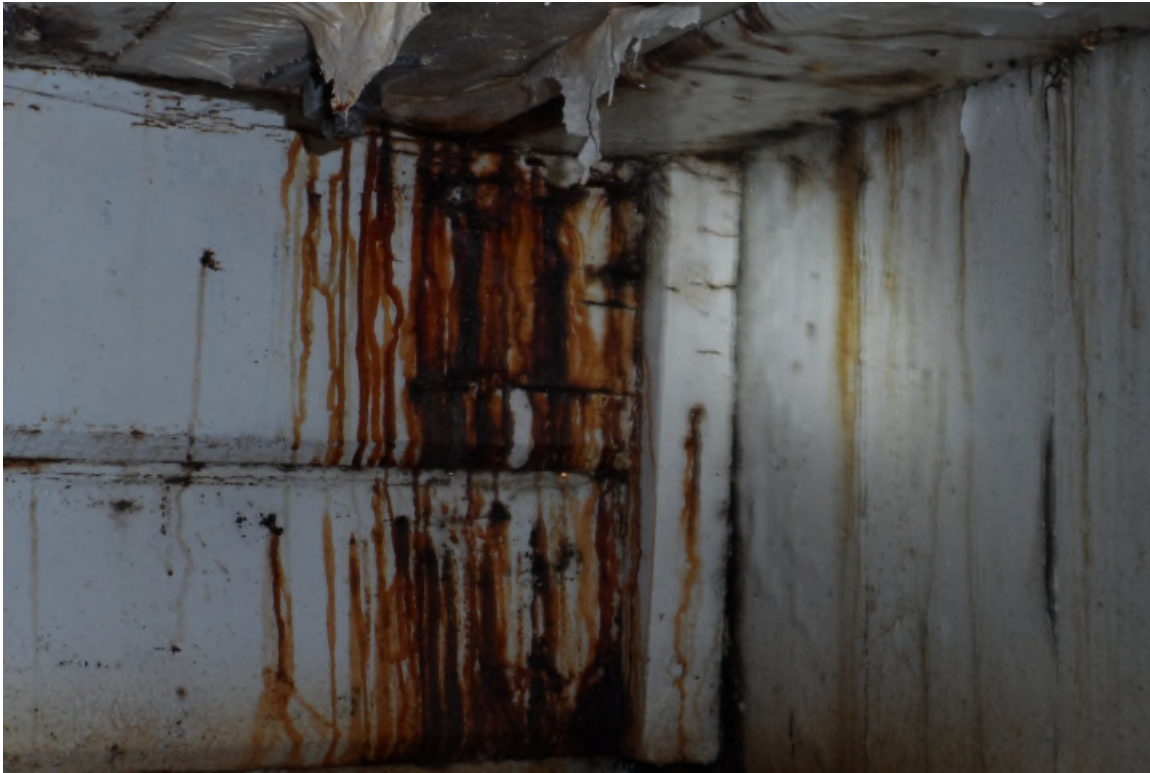
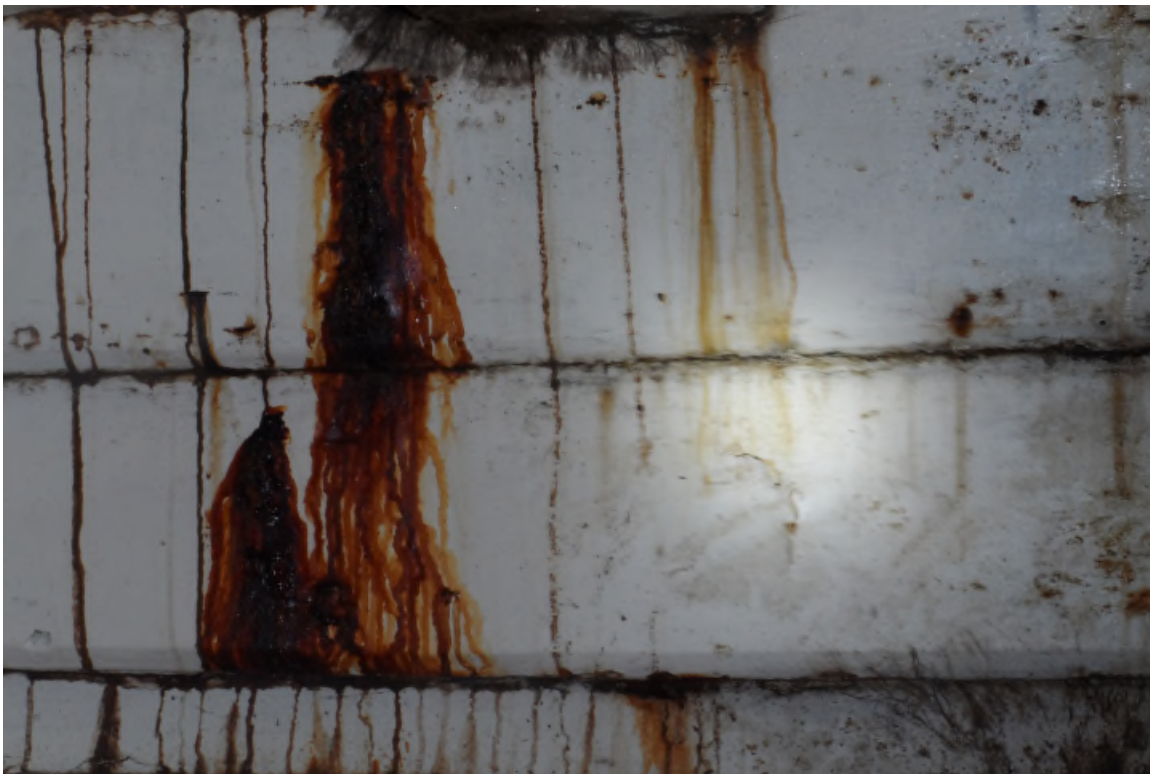
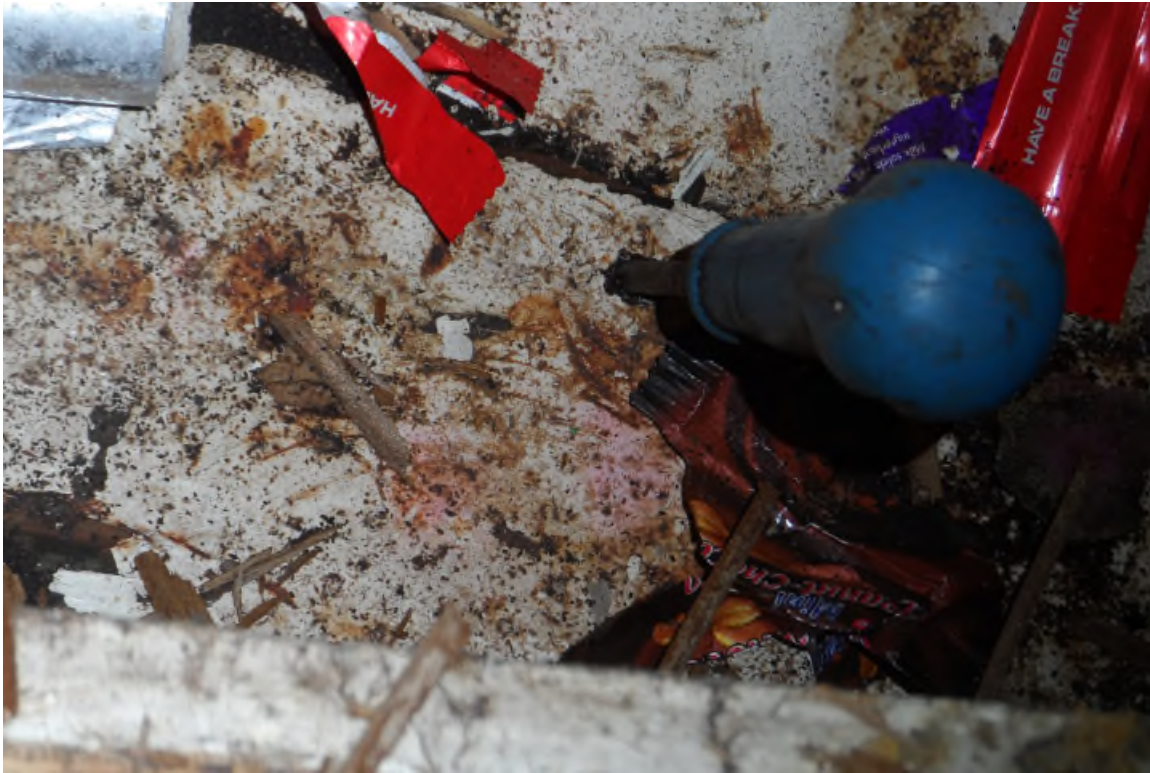
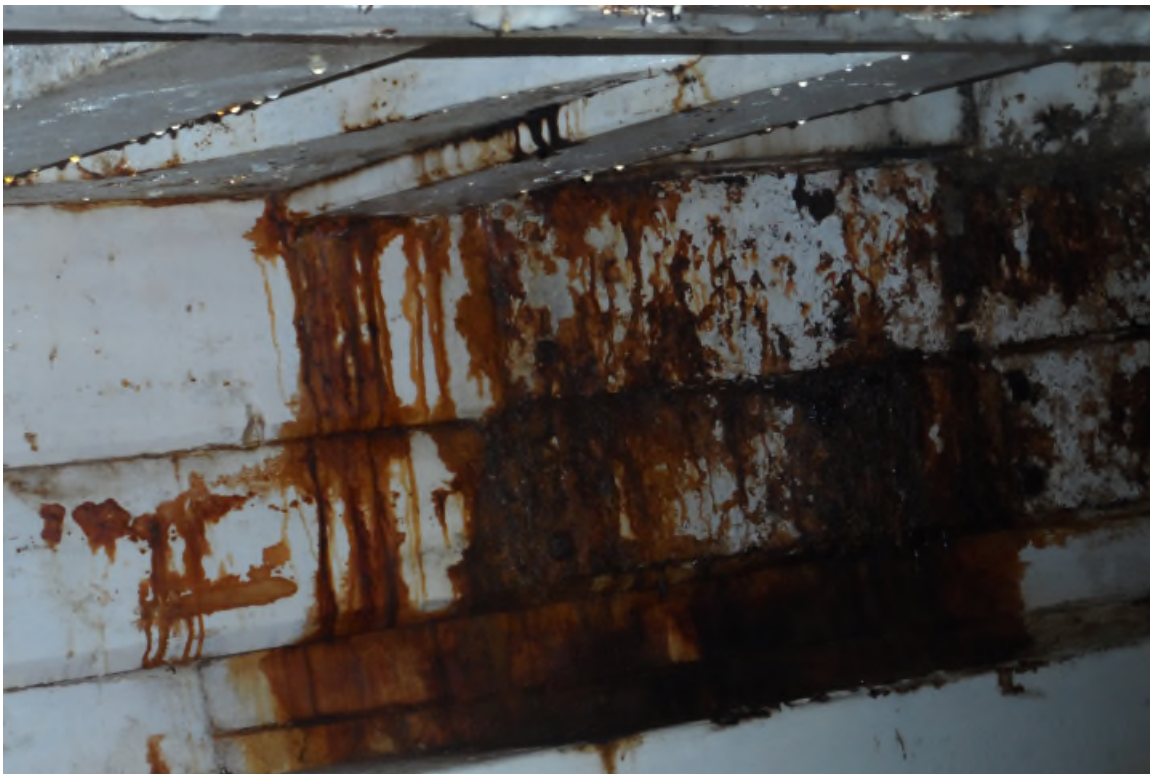
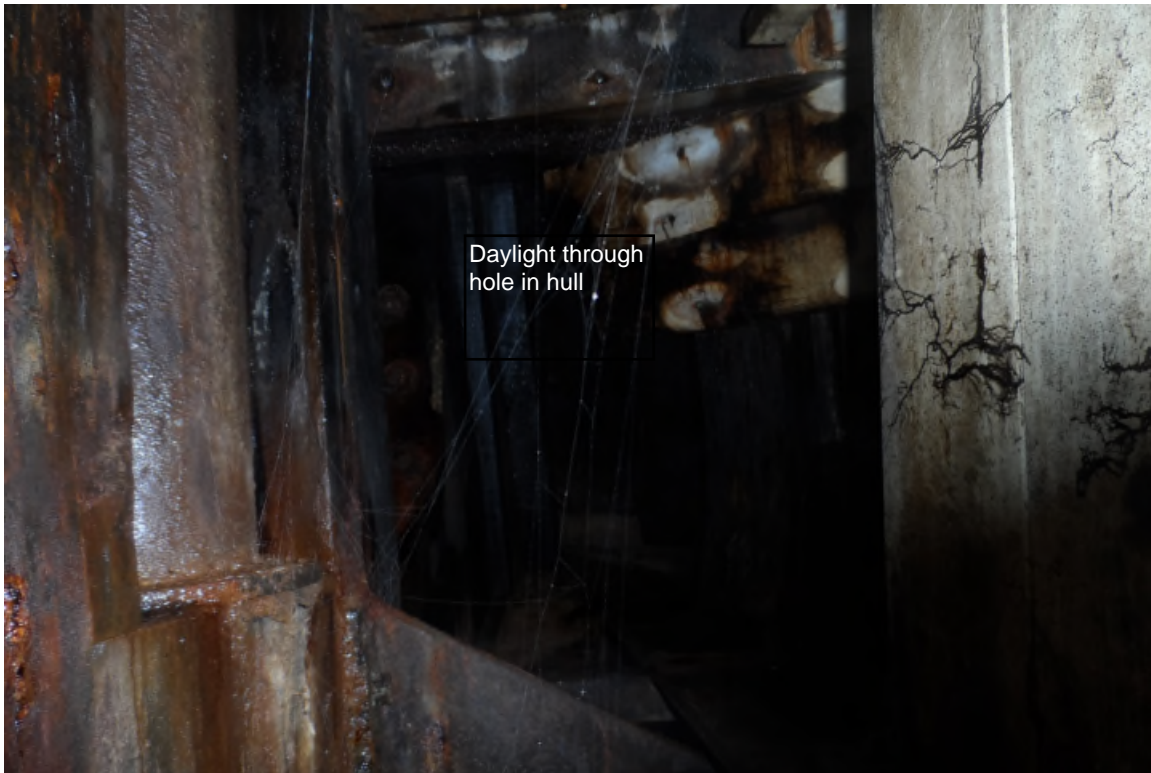
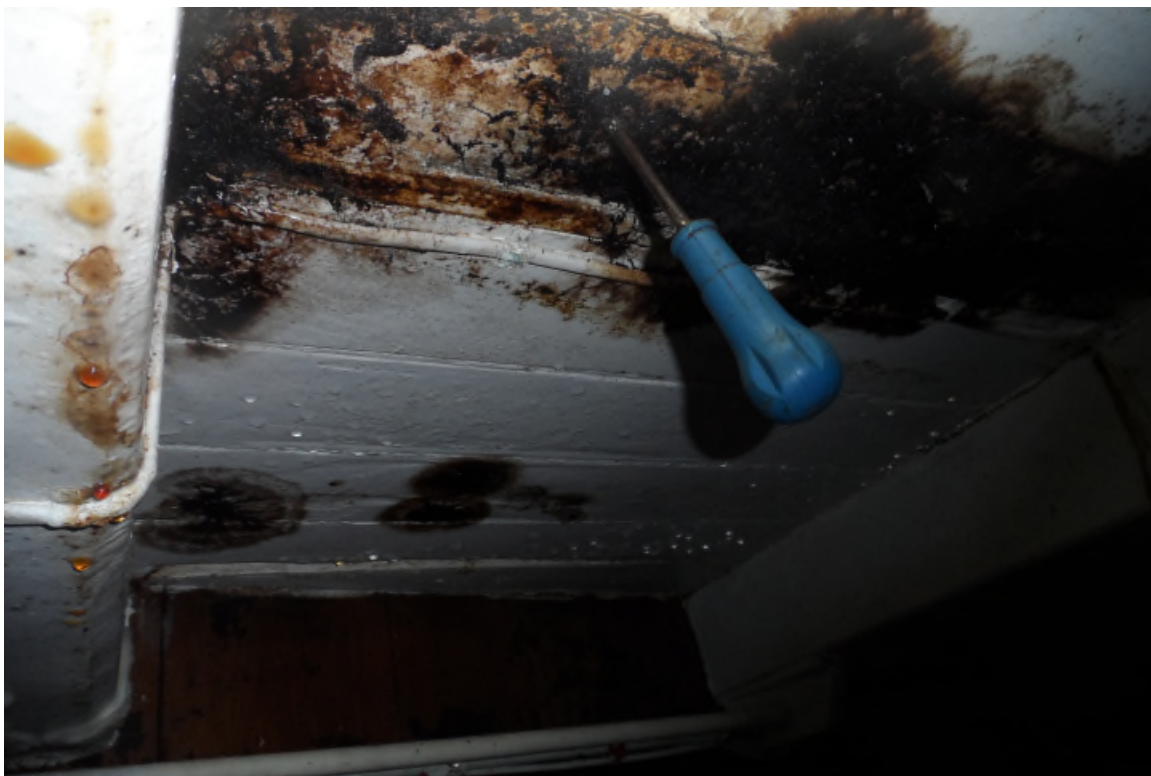
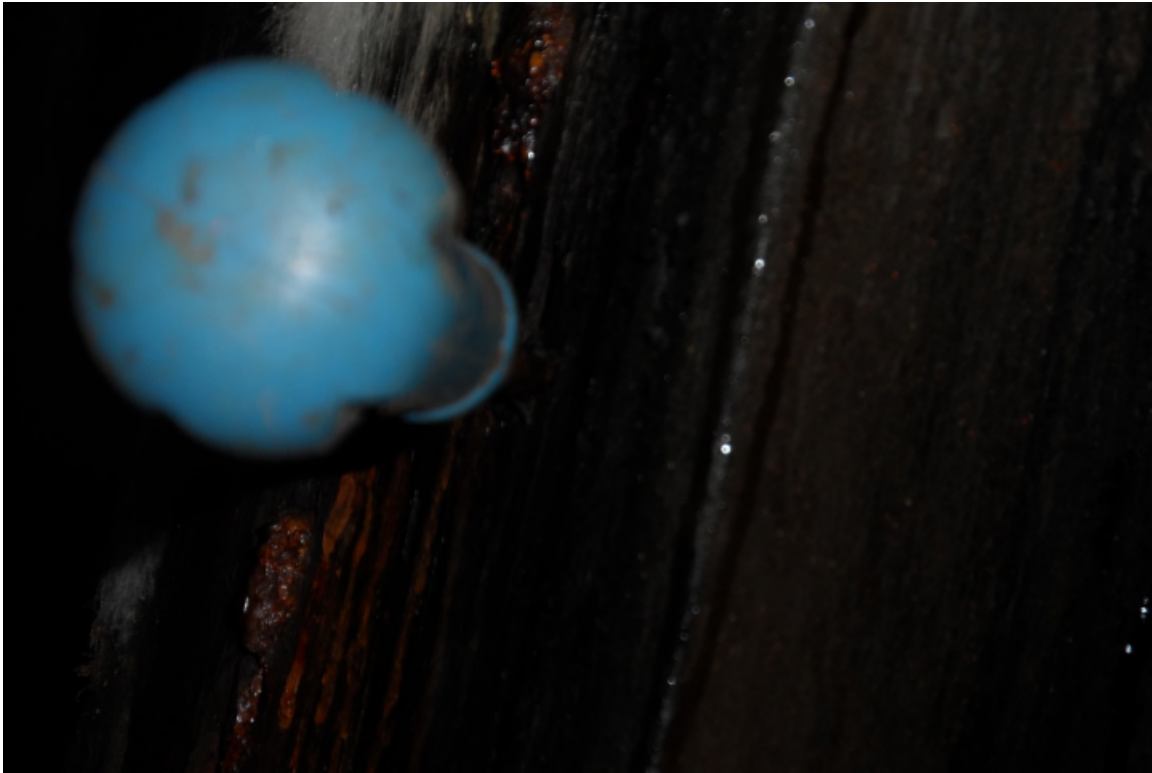
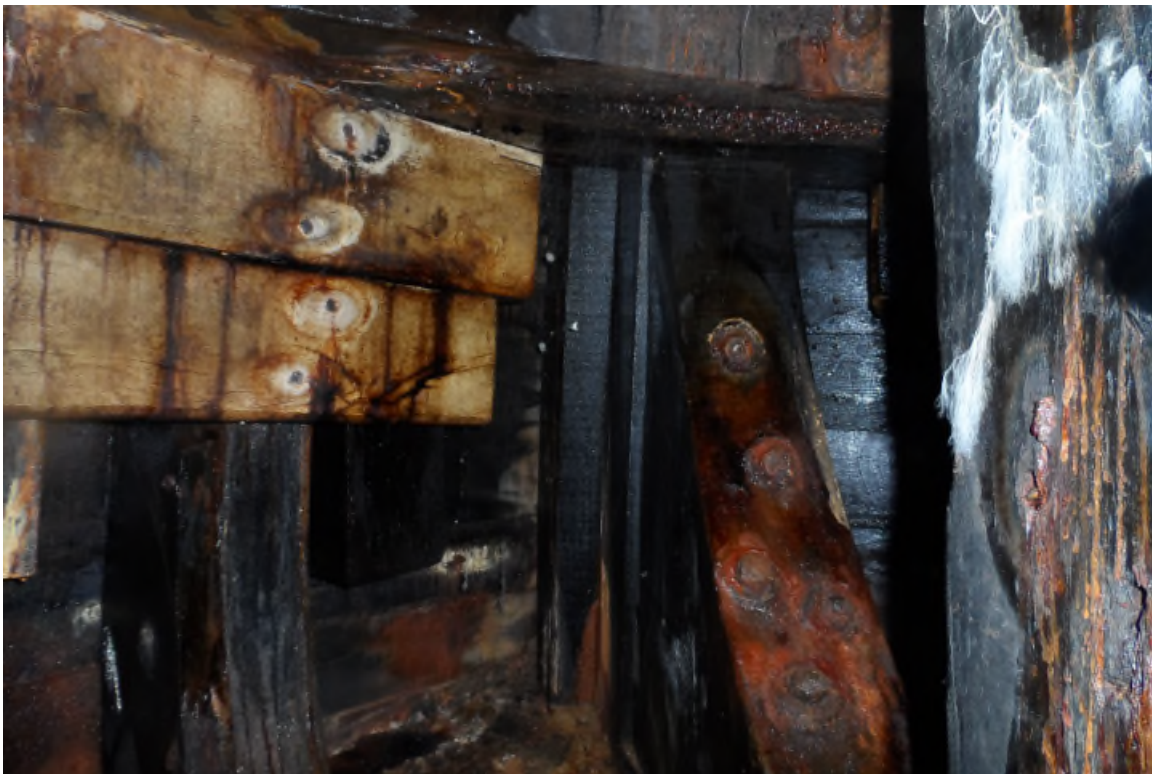
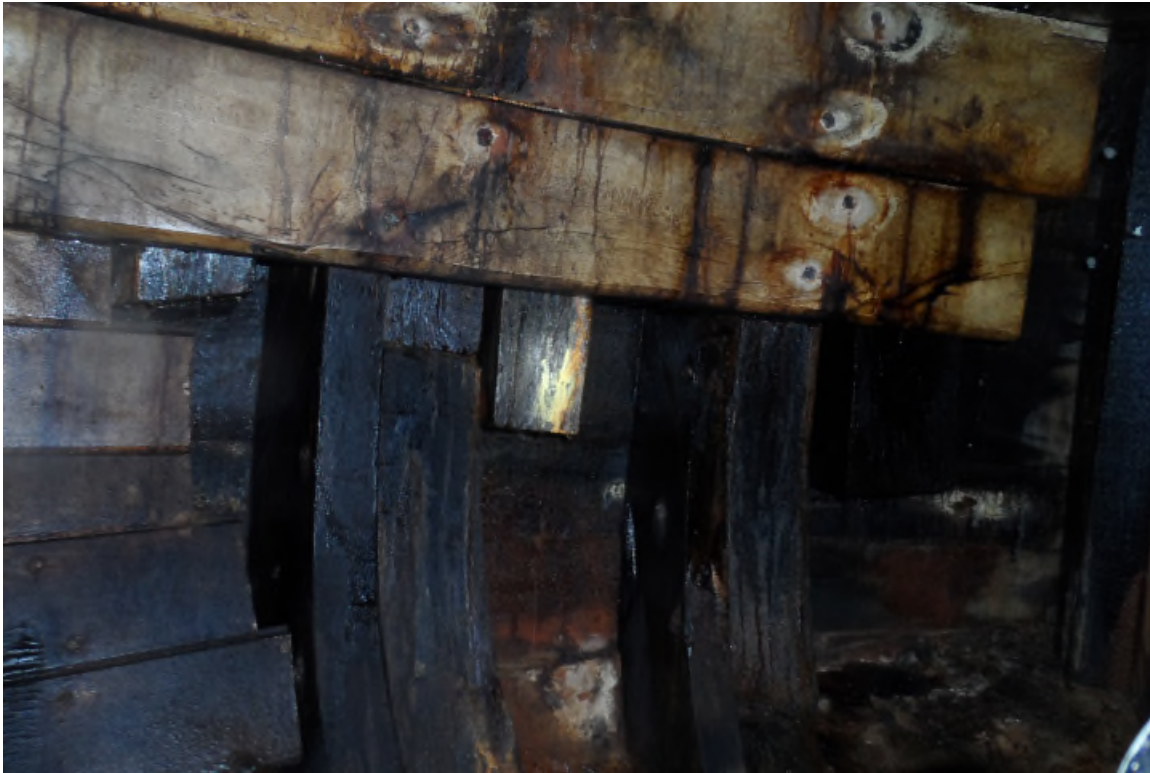
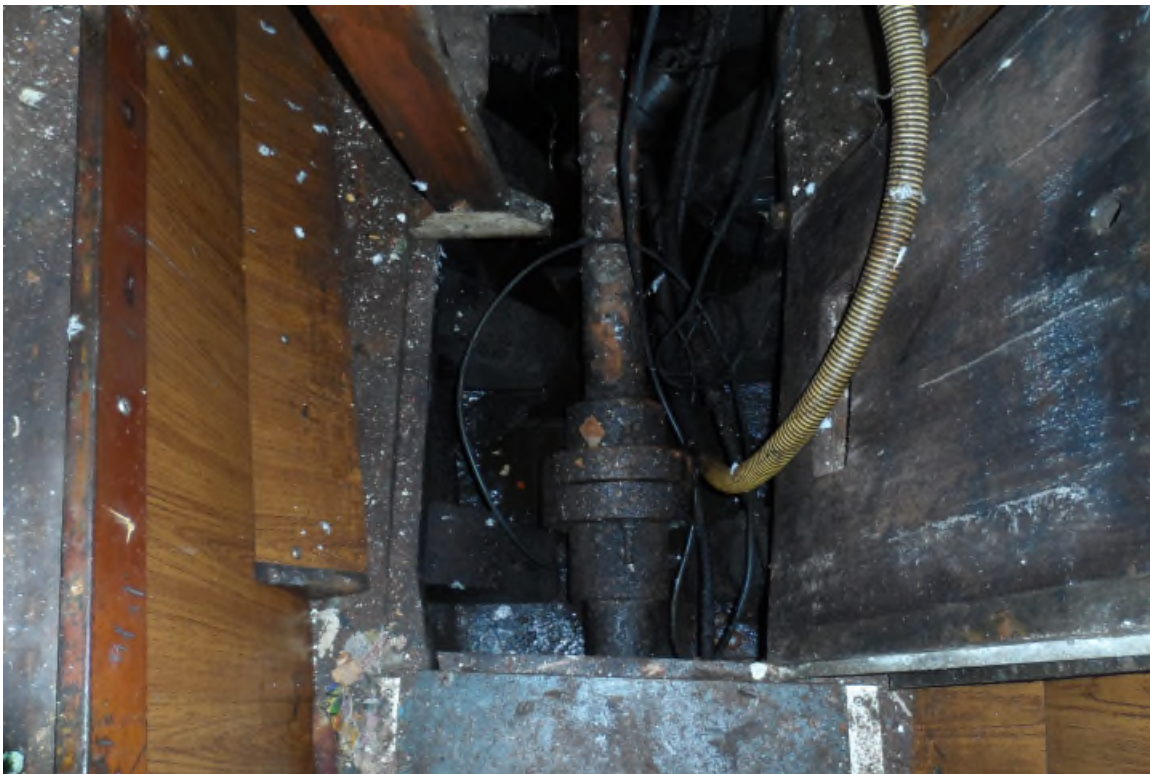
iv) Aft accommodation area

Access to the lower structure in the aft accommodation was fair but the sides were lined, where spike testing was carried out timber that appeared dry was generally satisfactory but some of the wet areas were soft. The upper structure was lined in places with the after part of the upper accommodation above in the centre part. Some of the areas in way of the deck edge were heavily rust stained indicating leakage from the upper deck with soft timbers when spiked. Accessible deck planking was generally fairly hard when spiked but all parts were not checked. Access to the very after part of this space around the rudder trunk was difficult but daylight could be seen through the hull planking as detailed above. Accessible parts of the main structure were spiked and some areas of rot were found. The main support timber forward of the rudder stock was in very poor condition being completely rotten in places.

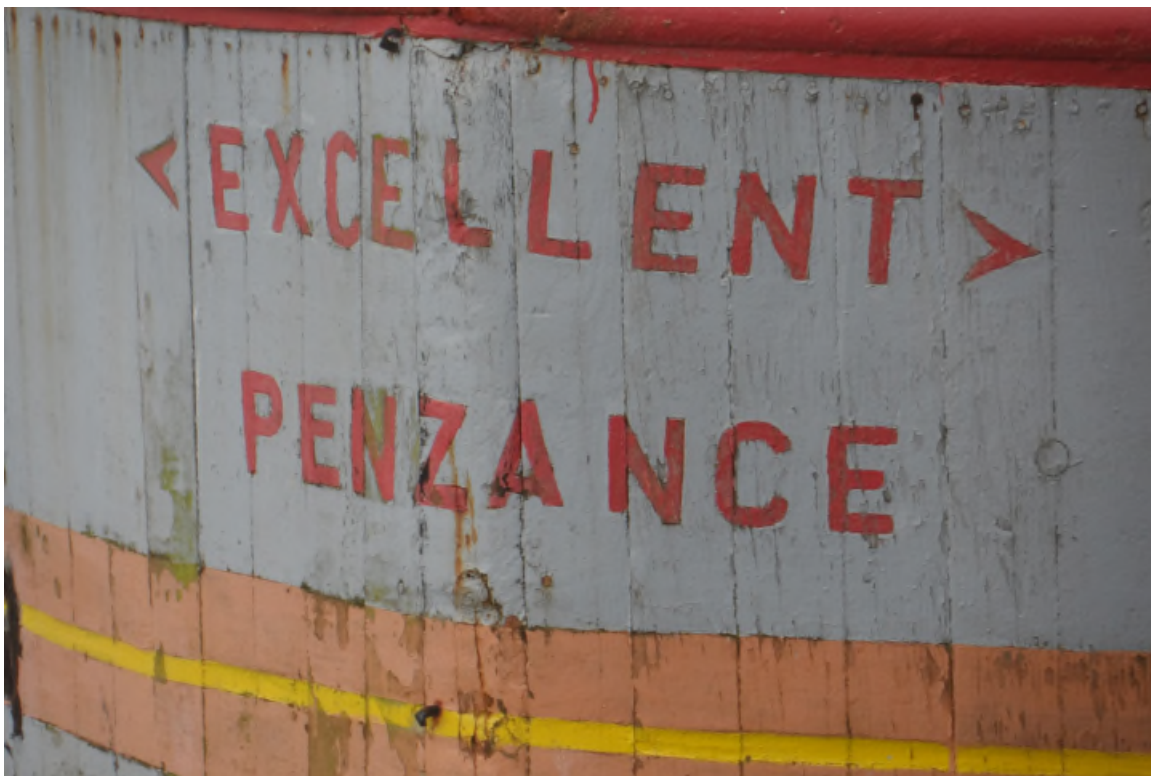
Transom.JPG

- i) Areas of rust staining over large area of the upper and lower hull indicating deterioration of the plank fastenings.
- ii) Heavy contact and rubbing damage, starboard side amidships, with exposed heads of fastenings and a large amount of the planking rubbed away.
- iii) Port side transom just above the waterline - hole through the planking with daylight visible inside the vessel.
- iv) Transom centre at change of section just above the waterline plank ends visibly damaged.
- v) Several sections of the belting just below the main deck very soft with large areas of rot.

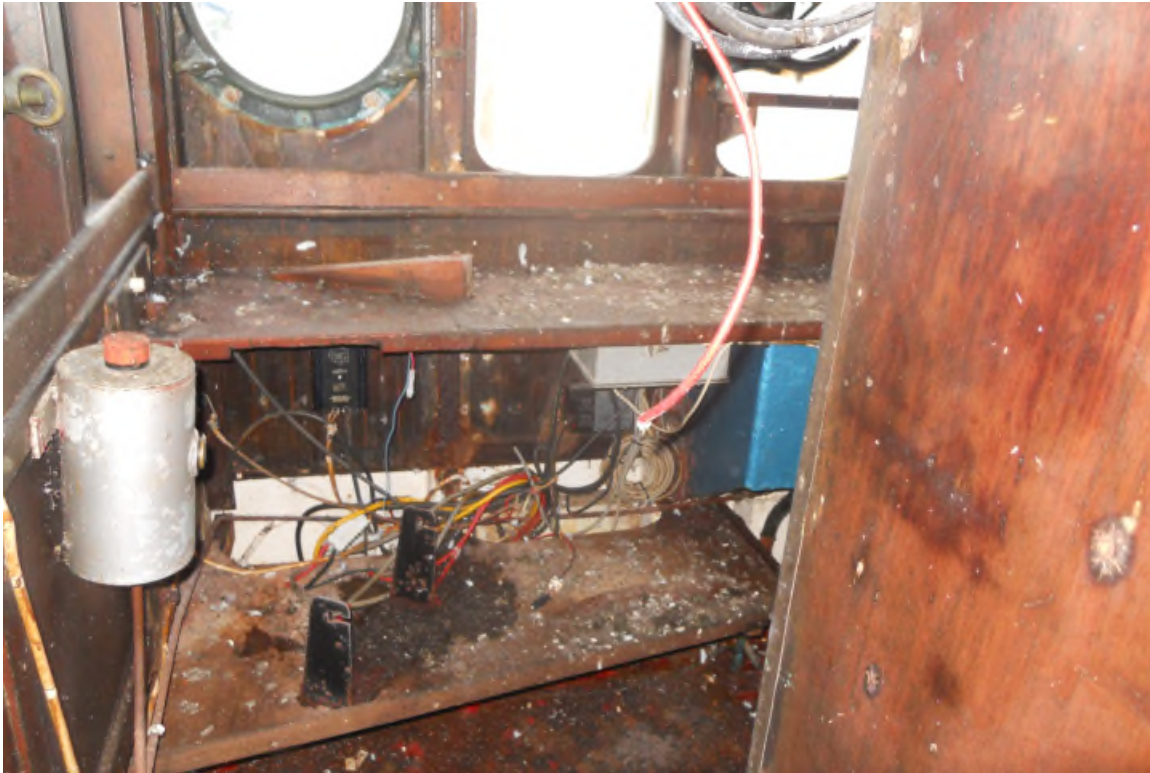
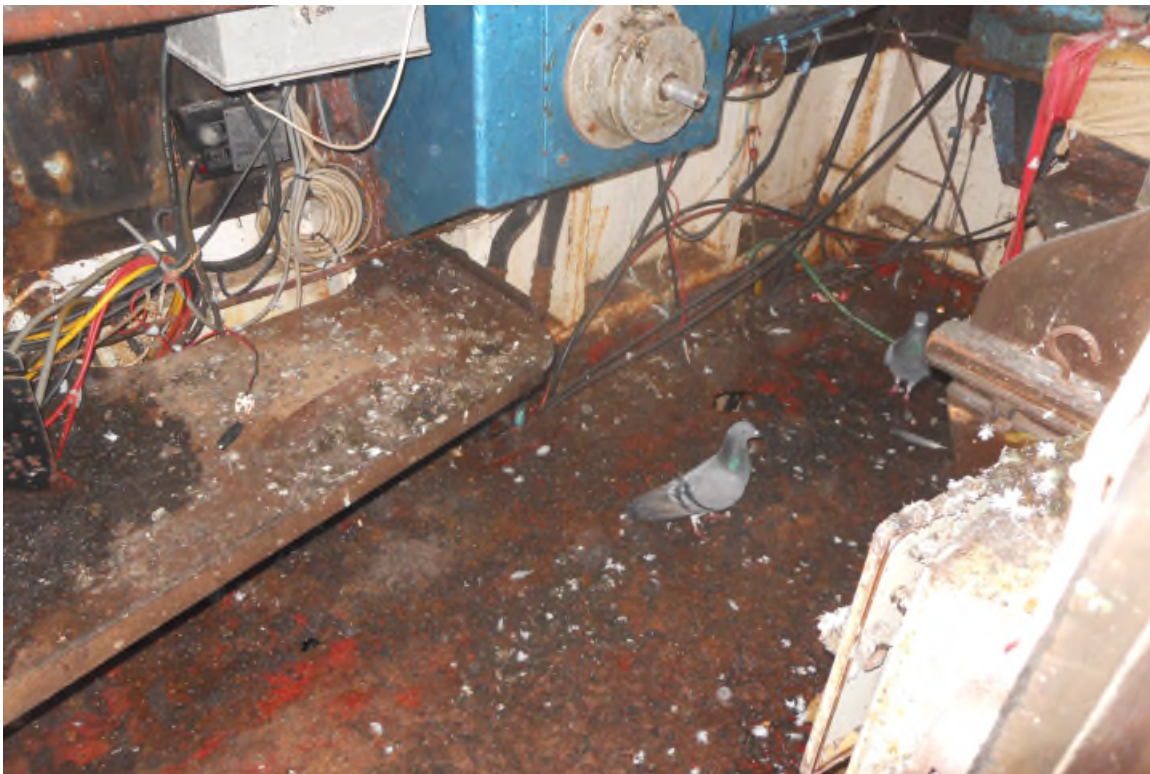
Internal spaces above the main deck (saloon and galley leading to the wheelhouse and Skippers cabin) were only visually inspected as part of a general examination. The lower spaces were in very poor condition having had a considerable number of birds resident for some time. The steel wheelhouse deck was noted to be corroded through in places.
