## The Reconstruction of Helen Smitton - Methods Employed to Overcome the Effects of Corrosion – By Malcolm Brown

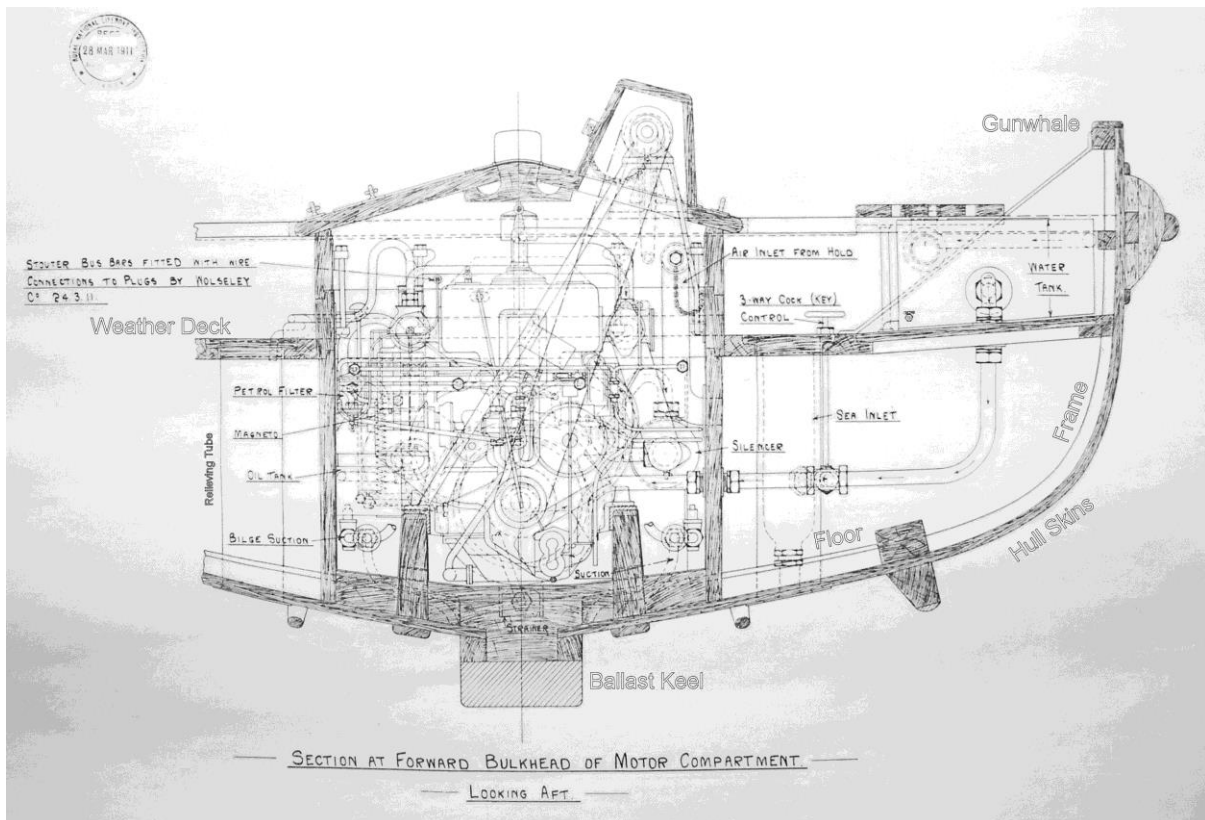
Fig.2 Cross-Section of the hull at the engine compartment.

She suffers from a number of major problems to her main structure caused by the choice of her original materials, poor maintenance and amateur modifications and repairs. By far the greatest problem that affects the hull is caused through bi-metallic corrosion to most of her iron and steel components and fastenings, and associated degradation of adjacent hull timbers below the waterline.

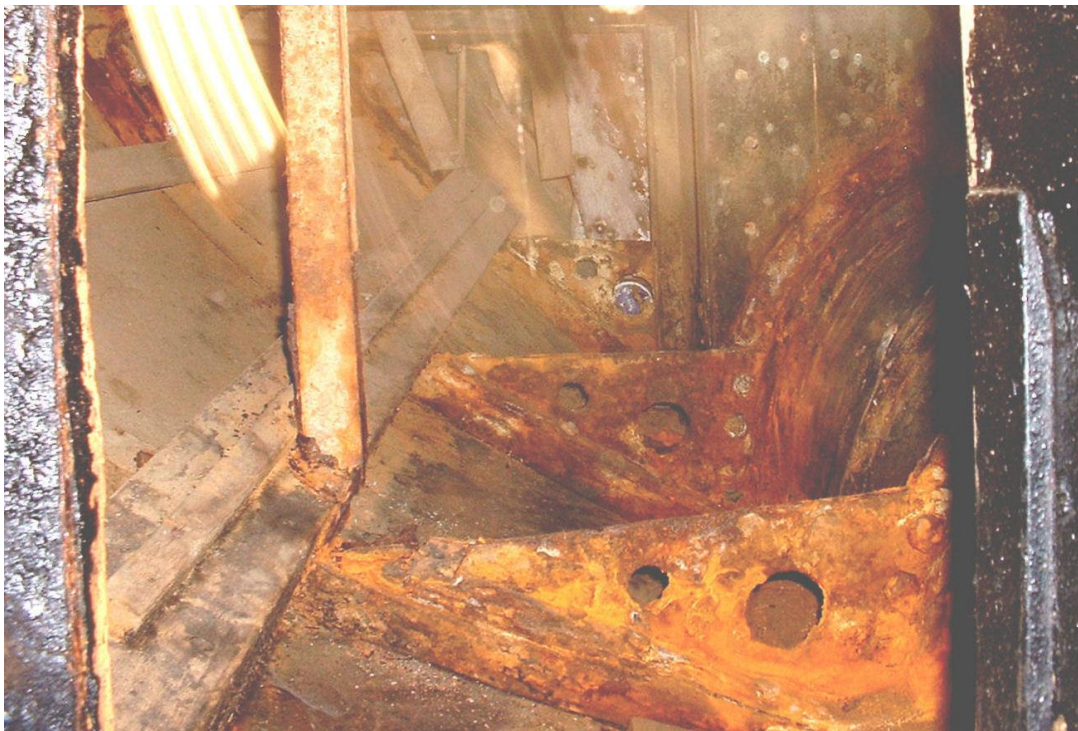
The effects of saltwater degradation are clearly visible throughout the vessel where dissimilar metals have been employed at the same location, such as between the steel floors and their fastenings of bronze. The bronze and copper throughout the vessel has remained in good condition whilst the steel, particularly in the bilges where seawater was present, has wasted away. The hundreds of naval brass screws that also secure the hull skins to the centre-line structure are in remarkably good condition and in most cases can be withdrawn cleanly, but under a magnifying glass they show pitting, so cannot be trusted. The pitting is most likely caused through de-zincification.

Fig.3 View of the mild steel floors on the starboard side of the propeller tunnel. Most of these floors disintegrated when tapped with a hammer.

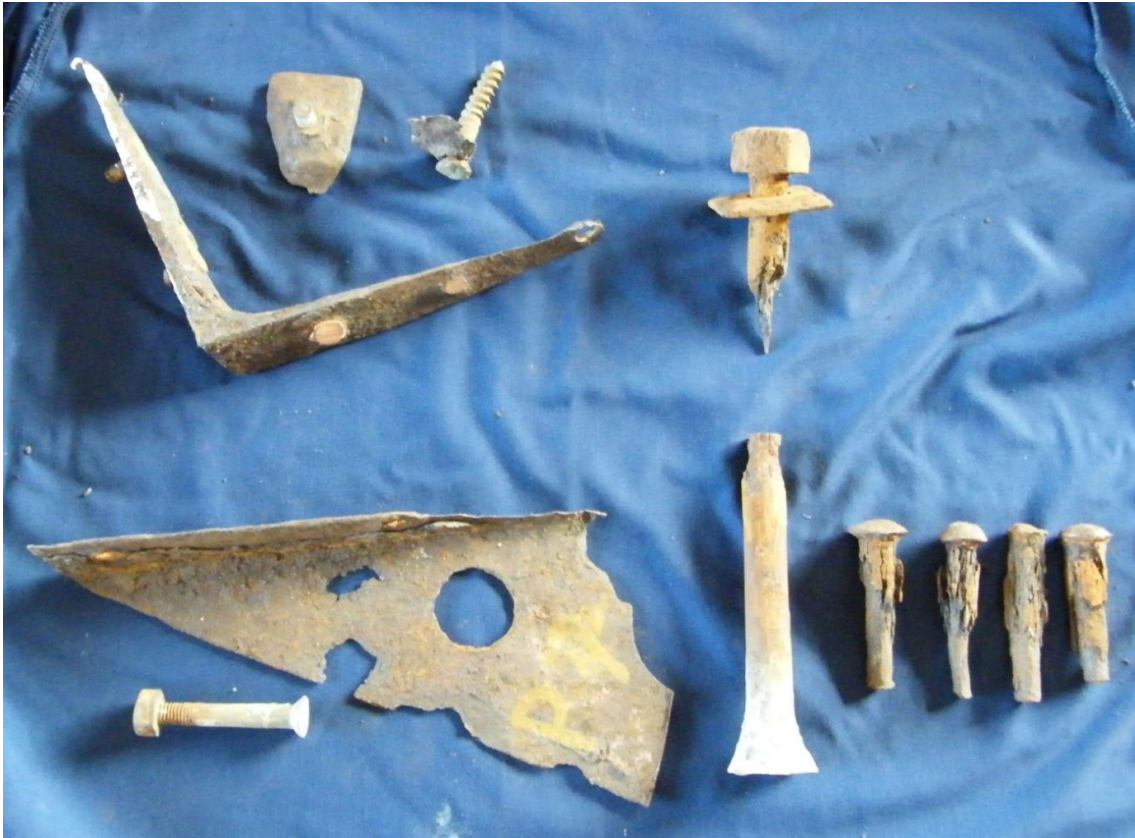
Fig.4a Fastenings removed from the hull. The items to the left indicate how fittings that are less noble, steel and iron, can corrode whilst their fastenings of copper and bronze remain intact. The large bolt is one of ten that secures the ballast keel to the hull. The mid section has corroded away. The four fastenings, bottom right, are wrought iron bolts removed from the gunwhales.

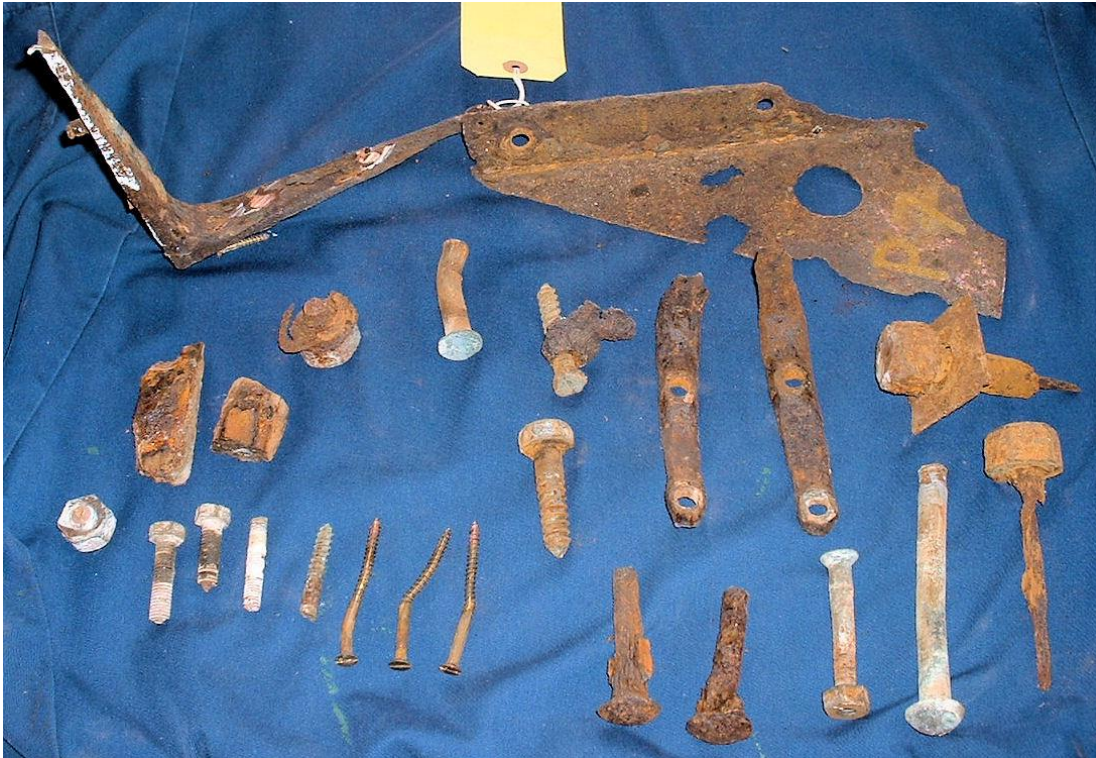
Fig.4b Further examples of corrosion. The bronze coach screw in the centre of the photograph and the naval brass woodscrew above it is a good example of fastenings that on first inspection appear to be ferrous but are actually coated in oxide from neighbouring corroded steel.

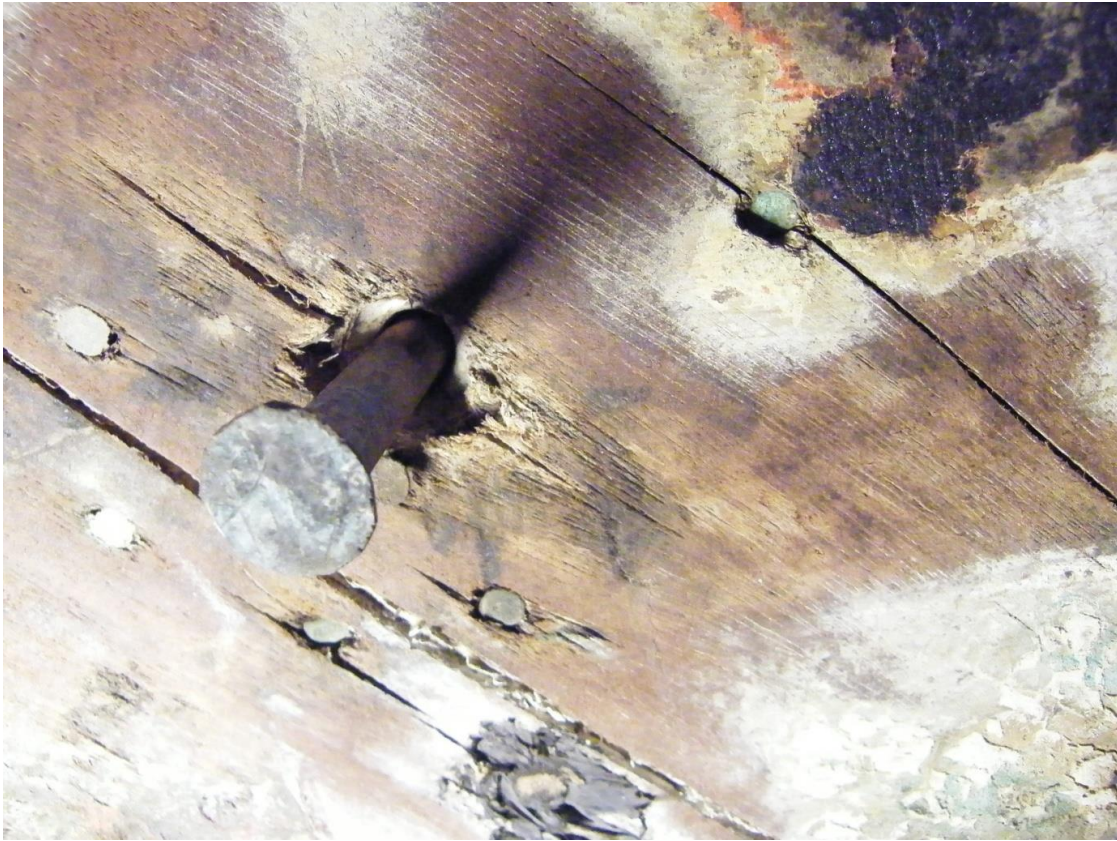
Apart from the obvious damage to the metal that is less noble, such as steel, what is noticeable is the change in the integrity of the wood immediately surrounding the more noble fastenings such as copper or bronze. The fastenings themselves have been protected by the less noble metal which, as a result, corrodes. The wood, however, has shrunk away from the fastening leaving it loose and in some cases the wood fibres have broken down leaving, in the case of mahogany, a furry texture. The wood often splits in the direction of the grain. Baker, when speaking about the corrosion of fastenings in wood and cathodic protection stated that there was:

The most time-consuming job as a result of the conditions mentioned above has been to repair and realign about one hundred large fastening holes passing through the hull. Because of the long-term deterioration of the fastenings and the mild degradation of the surrounding timber, the frames, floors and hull skins no longer lined up and in most cases the stopping (filler) covering the fastening heads is loose or missing.

Fig.7a A close-up view of one of the 3/8" diameter floor fastenings being withdrawn, showing the secondary effect of bi-metallic corrosion.

The degradation at each hole was in most cases mild but the overall effect weakened the hull. I could have overcome this problem by replacing much of the hull planking with another species of timber, as high class mahogany is no longer available, but this would have caused considerable unwarranted intervention and loss of original structure. Applying a method I have successfully used in the past, each hole was cleaned back to sound timber, coated with West System<sup>7</sup> 105 epoxy resin with 205 slow hardener and then completely filled using the same mix of resin/hardener with colloidal silica filler, mixed to a thick paste. Once set, the holes were re-drilled and new fastenings fitted. The original floor fastenings had countersunk heads but I took the decision to replace them with domed heads (coachbolts) which covered a wider contact area, overlapping the localised repairs mentioned above. In later years the RNLI used the same fastenings in high stress areas. This method of repair has the added advantage that each fastening now becomes largely electrically isolated from the surrounding timber by the epoxy resin which cuts down on stray electrolytic currents.

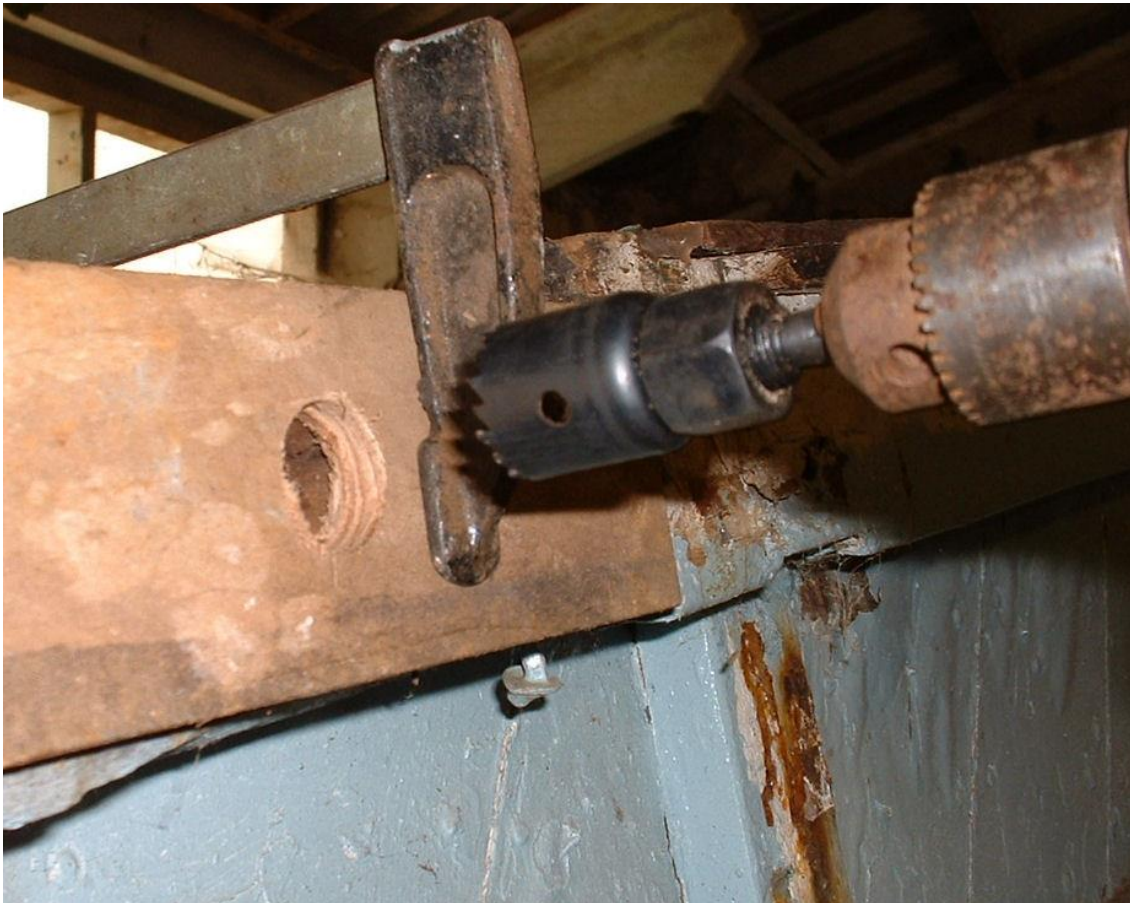
the sockets for the rowlocks, therefore the power of ten men rowing is transmitted to the hull via these timbers. Wrought iron, when confined in timber, corrodes beyond all recognition. It does, in effect, burst to twice its normal size and often splits the timber it is passing through. The fastenings cannot be driven out without destroying the timber so the whole length of the timber has to be replaced which, again, causes major disruption and loss of original fabric. To overcome this problem I use my “apple corer” method where a hole-cutter, held in a temporary guide without its central drill, bores out the timber just beyond the extent of the corrosion. The fastening is withdrawn and the hole plugged with a similar species of timber. A new fastening can then be fitted.

Fig.8a Core of timber around the corroded wrought iron fastening bored out with the help of a plywood guide.

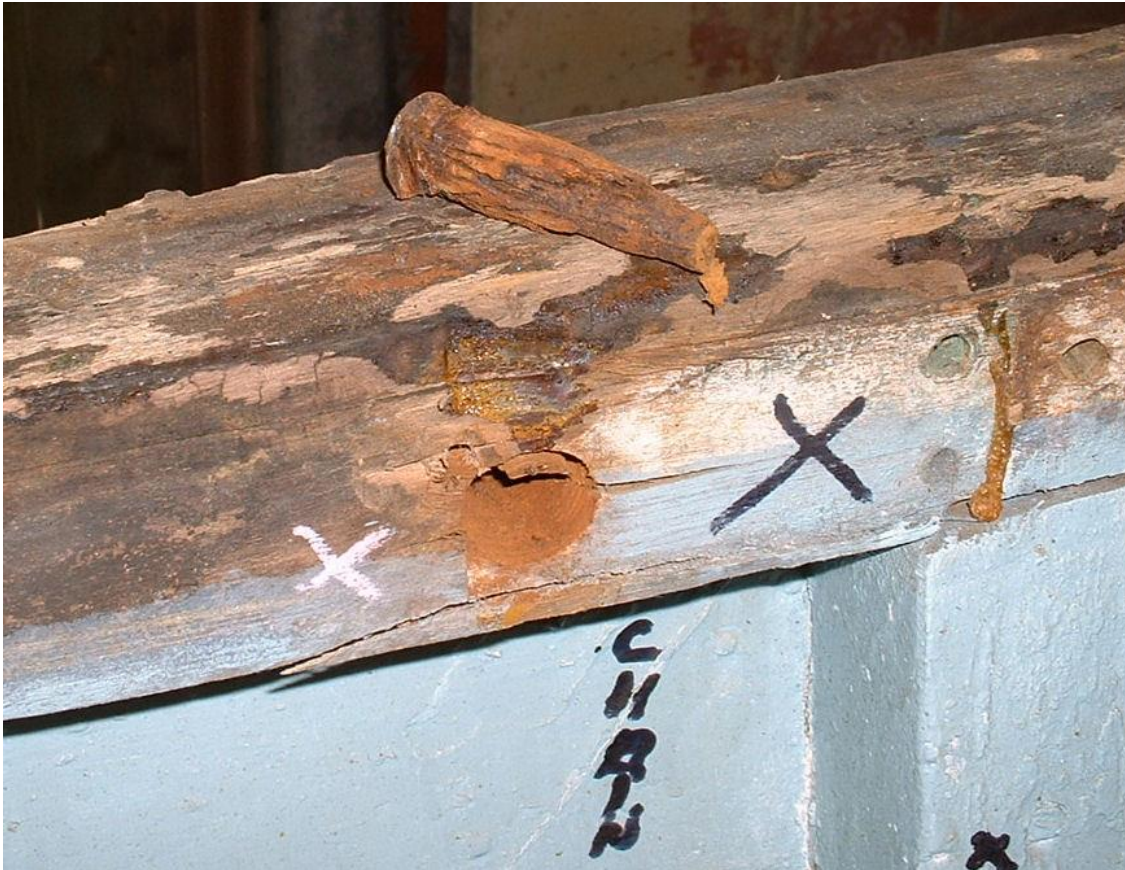
Fig.8b Corroded wrought iron fastening withdrawn
