Blog for July and the start of August 2020. Charlie Carman Return of the public

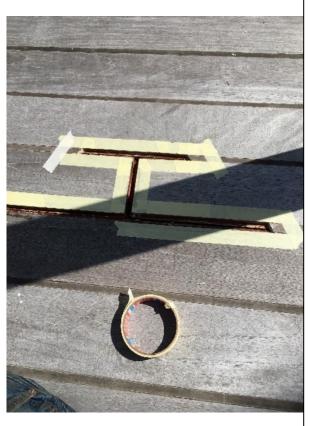
Learning to caulk on the main deck

This is much the same as caulking the hull, something I did back in February, but there are a few small changes. Here I was working on the Liverpool house roof deck, which had its own unique caulk to the rest of the deck. This is because traditionally it is where the sail maker worked, and white caulk was used to avoid any black marks being left on the sails as they were being repaired. We use a like for like modern alternative here called white Sikaflex.

Here you can see where I have marked, cut and clawed out the caulk that needed to be removed. With the seam being dry, due to the great weather of late, I then used masking tape to run down the border of the seam, cleaned it with Acetone and applied a specific primer for the caulk to accept the wood. I then laid out bond breaker tape along the bottom of the seam. This was to prevent the caulk from sticking to the bottom, which if pulled from three directions (as the wood expands and contracts) will split the caulk and allow water through. The bond breaker tape means the caulk is only pulled in two directions, which significantly reduces the amount of strain present.

Finally, came the clean-up stage which involved using a pallet knife to smoothen out the caulk surface and make sure it was a tight fit into the seam. This is where the masking tape came in handy, for pulling off excess caulk. At the very end yellow tape is used to mark out the area, and to (hopefully) warn people not to step on the fresh caulk.
