Conservation Plan
for the splendid (Clipper Ship)
CITY OF ADELAIDE, A.1 Built 1864
791 TONS REGISTER. 1,500 TONS BURTHEN,

Conservation Plan

19 February 2012

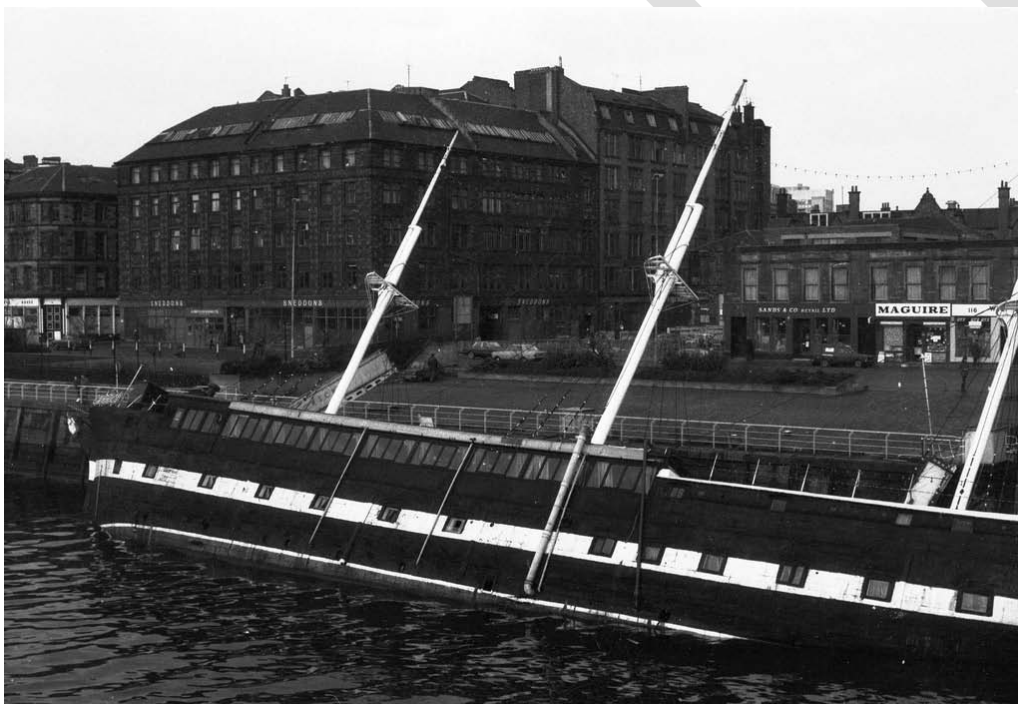
Figure 1: The Carrick (*City of Adelaide*) partially submerged on the Clyde River.

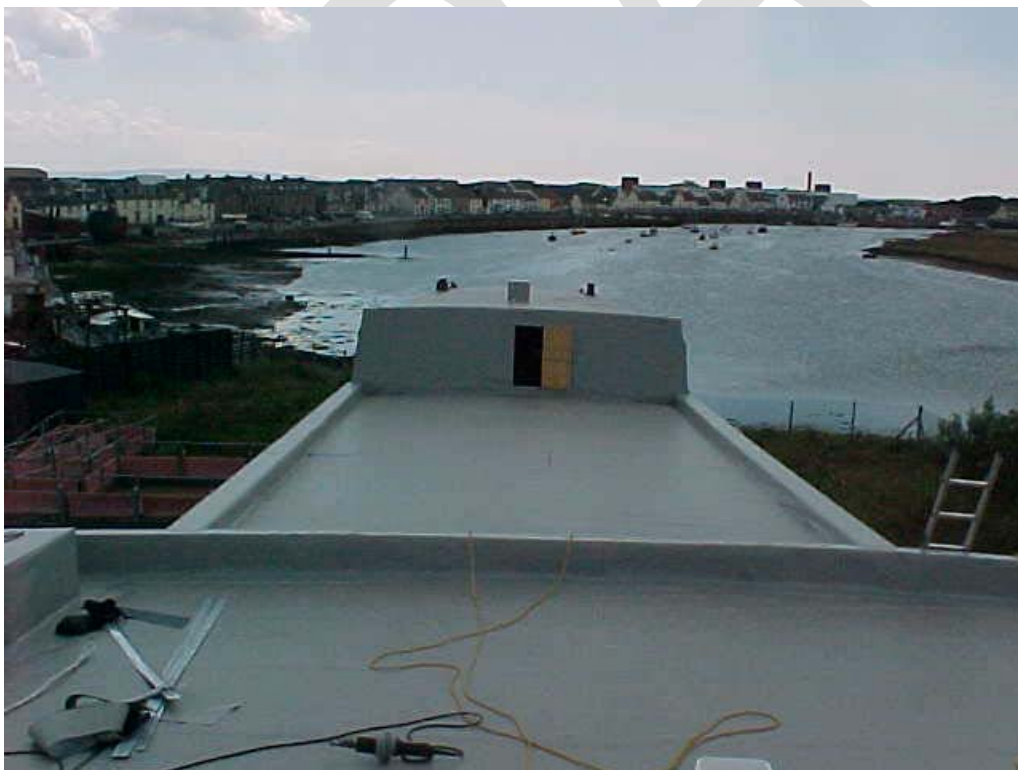
A protective cover was installed on the *City of Adelaide* in Scotland. While totally out of character for a heritage ship, it is a necessary 'medicine' to stabilise the ship.

Figure 2: The Protective Cover Installed in Scotland.

To remove the protective covering would require a costly renovation of all of the upper deck areas to make them water proof and able to manage any storm-water. It must be conservatively presumed that funds will not materialise for such work in the short term, or ever, and the covering will be a long term feature on the clipper.

With the covering also comes risk of wood rot occurring beneath the covering. Ongoing monitoring and maintenance will be necessary.

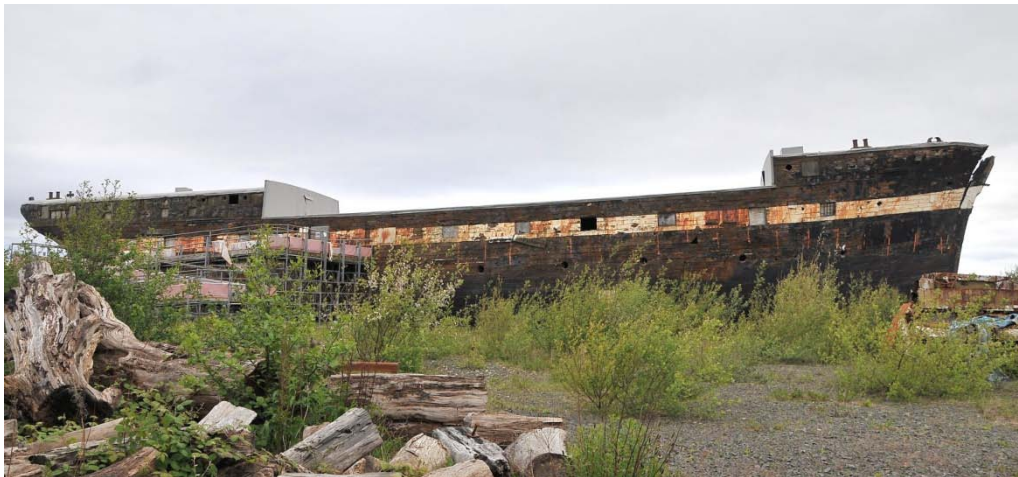
The present cosmetic appearance of the *City of Adelaide*, as shown in Figure 4, is unappealing to the broader community. Only a relatively small percentage of the public see beneath the poor cosmetic appearance and comprehend the historical significance of the ship, and its relatively good underlying structural condition. Its appearance also detracts from organisations wishing to have their brands linked to an eyesore.

Figure 4: External cosmetic appearance of the *City of Adelaide* in May 2009 (David Cook).

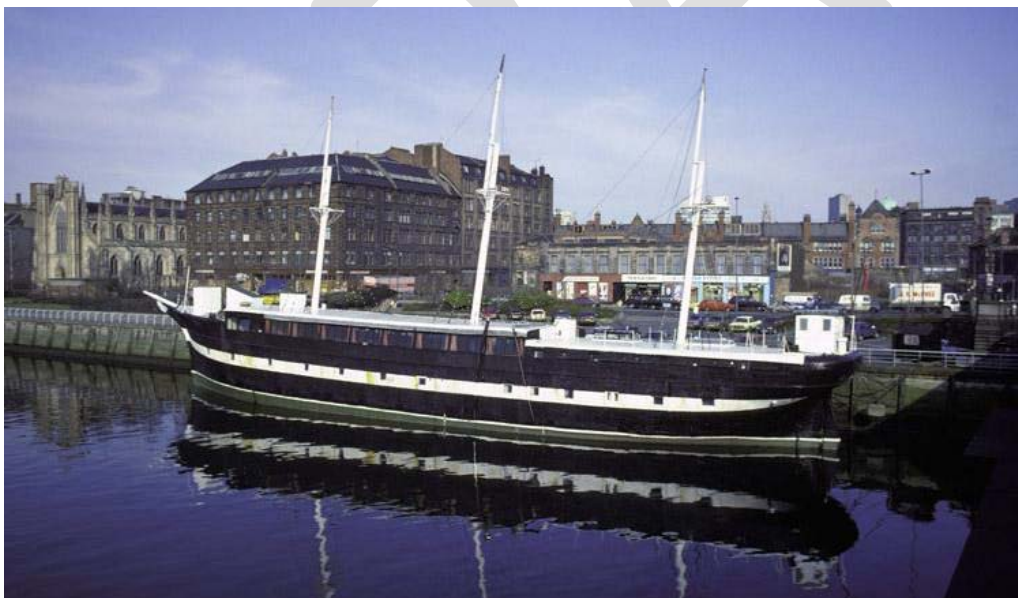
As clubrooms on the River Clyde in Glasgow as recently as the late 1980s, the cosmetic appearance of the clipper was maintained in modern times as shown in Figure 5. Even then, the black and white scheme does not reflect the original paint scheme.

Figure 5: As the *Carrick* on the River Clyde in the late 1980s (Gordon Hardy).

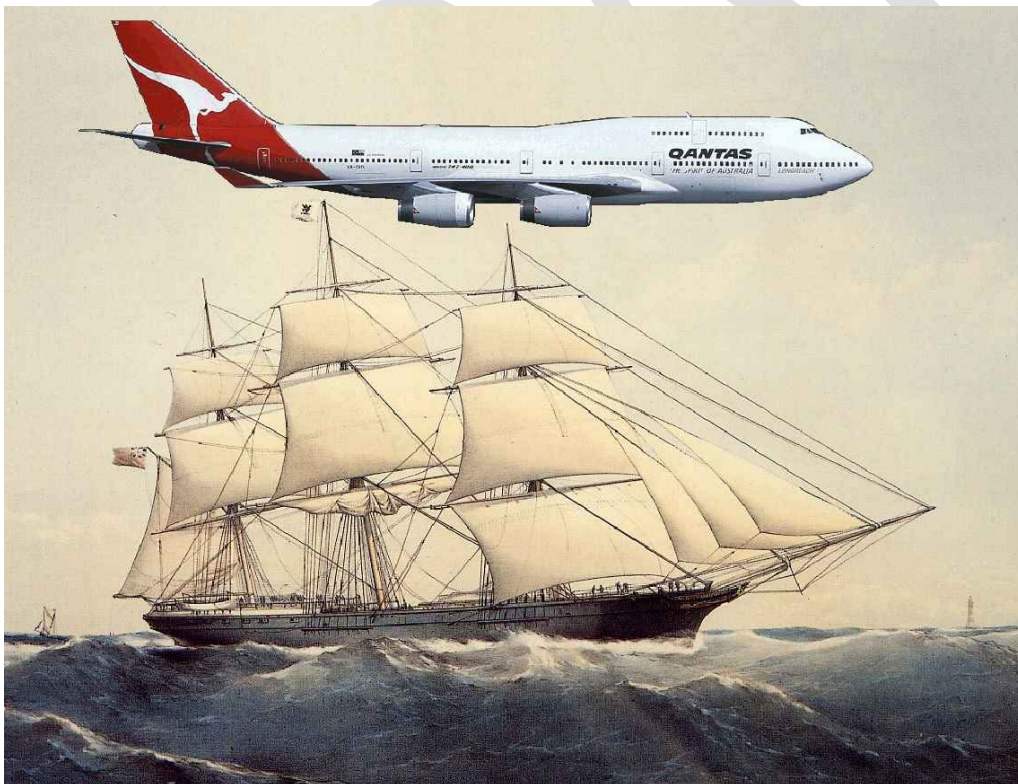
- Length (Overall) 74.4 metres (when rigged)
- Length (Hull) 53.85 metres
- Breadth 10.14 metres
- Depth 5.64 metres

Figure 6: To-scale comparison of QANTAS' *City of Adelaide* 747 and the clipper *City of Adelaide*.

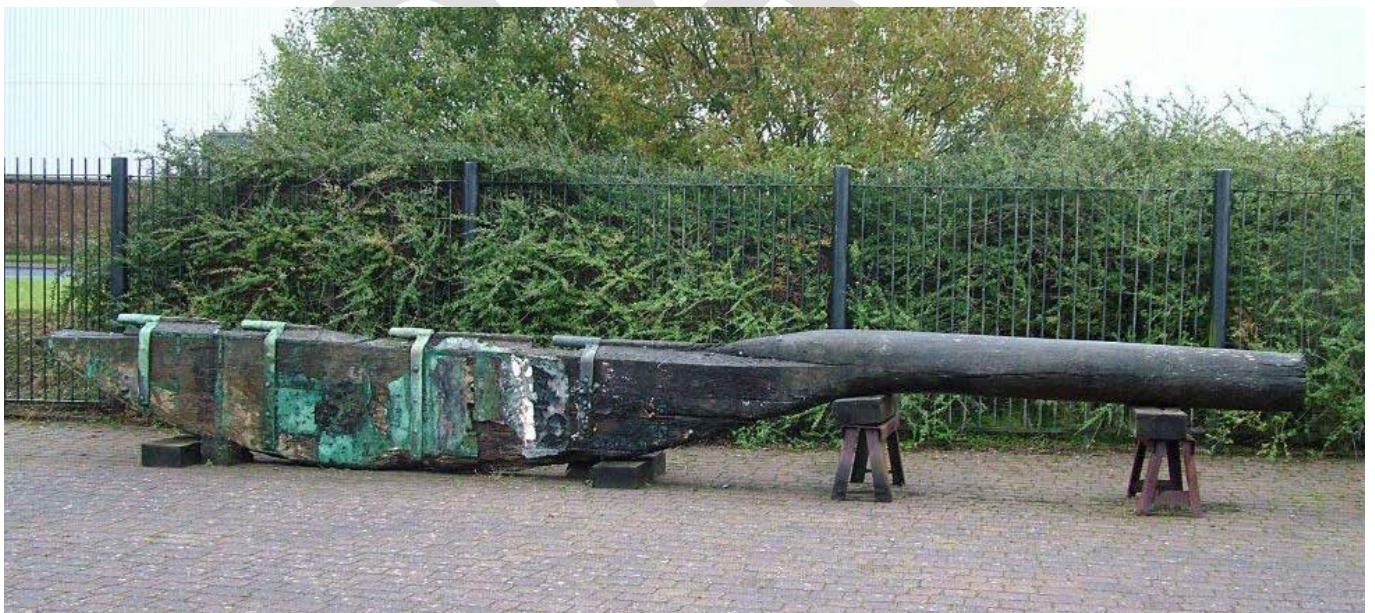
No single piece of wood large enough for the main piece could be found for the replacement, so it was made from two pieces of grey ironbark, scarphed together, and fitted with brass fittings. Captain E.D. Alston subsequently took the ship back to England via the Cape Horn without mishap. Like the ship, the rudder still survives, and represents a major accomplishment for the shipwrights of Adelaide at the time.

In 2005, Queensland Department of Primary Industries and Fisheries (DPI&F) scientists helped British archeologists to confirm that the surviving *City of Adelaide* rudder, much damaged by time and seawater, was the one built in Adelaide in 1877. The scientists were able to confirm that the rudder was scarphed and made from Australian grey ironbark proving it to be the 1877 rudder.(4)

Figure 11: *City of Adelaide* Rudder at Irvine Scotland, 2010 (Richard Smith).

The replacement rudder remained in use for the rest of the clipper's working life, removed only in 1990 when the *City of Adelaide* was prepared for the move down the Clyde from Custom House Quay to Princes Dock.

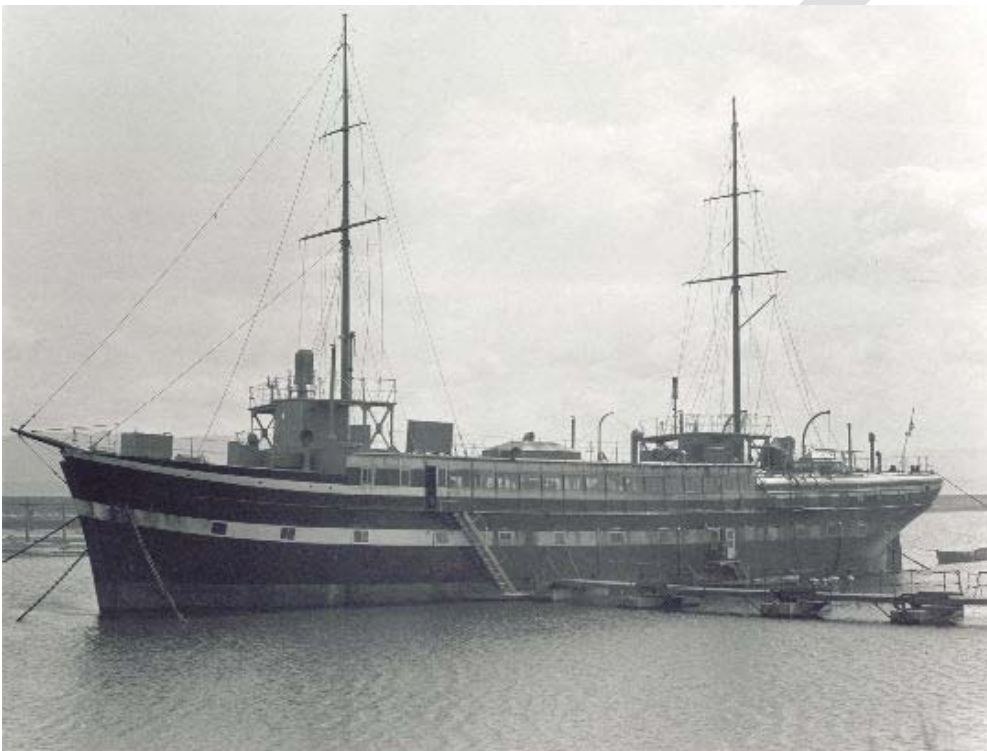
Again the conversion did not, as far as is recorded, require major structural alterations to the essential hull form. The two main alterations were the installation of an orlop deck within the hold and the complete roofing over of the upper deck, along with the construction of two flying bridges and two short signal masts – see Figure 14.

Figure 14: *City of Adelaide* after Conversion for Admiralty Use.

Circular ports were cut through the planking to admit light to the orlop deck. These were to prove to be a vulnerability in the ship's later years, as they were close to the waterline.

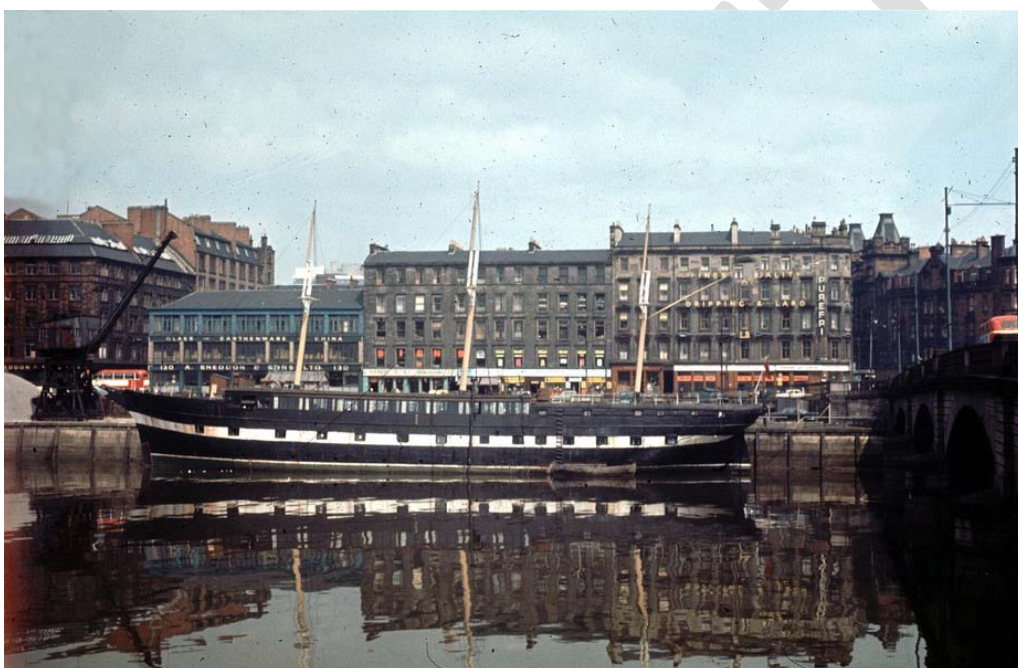
Figure 15: *Carrick* as Clubrooms in the 1960s.

When the *Carrick* was converted to clubrooms in 1948, the principal alteration was the fitting of replacement masts. These masts were constructed of alloy metal and were shorter than the correct size for the original rig, also carrying fewer cross spars, so as to minimise risk of top-heavy weighting.

After fitting out, *Carrick* was towed further up-river to a berth at Custom House Quay, just above Jamaica Bridge. A plaque on board commemorated the opening ceremony of the Club, which was carried out by Admiral of the Fleet Andrew Cunningham, 1st Viscount Cunningham of Hyndhope. The ship stayed there until January 1954 when the Clyde Navigation Trust decided to move it to the opposite side of the river at Carlton Place – see Figure 15.

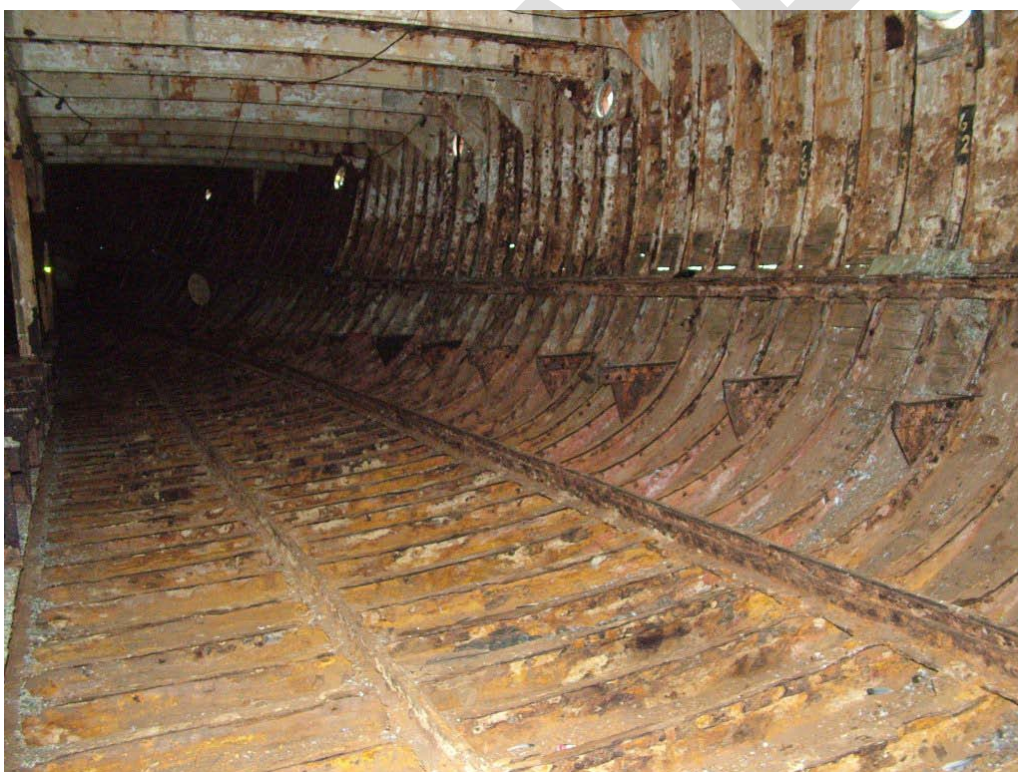
Comparison of the hull itself, which has been cleared of all later fittings, with documentary evidence of the accommodation has enabled accurate identification of the original layout. Of particular note within the whole structure is the ironwork, which is remarkable in its completeness, condition and quality. The hull provides an important and excellent opportunity for the detailed study of 19th century shipbuilding techniques, craftsmanship and design.

Figure 16: The *City of Adelaide* Iron Framework in 2010 (Richard Smith).

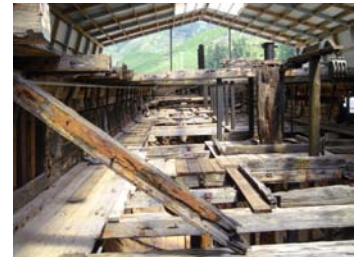
Figure 19: Inside the *Edwin Fox*.

- **Preservation:** keeping part or all of a vessel's fabric as far as possible in its existing state and retarding deterioration. Examples of projects involving the 'pure' preservation of historic ships include the *Edwin Fox* in New Zealand (Figure 19), *Vasa* in Sweden, and the *Mary Rose* in the United Kingdom. The *Edwin Fox* is a particularly good example for the *City of Adelaide* as will be expanded upon later in this Plan.

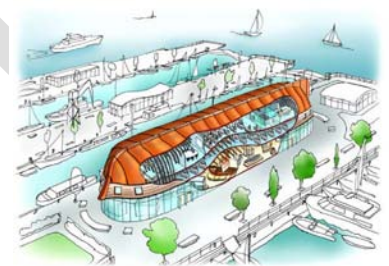
- **Adaptation:** modifying a vessel to suit a proposed new use. For example, Figure 20 shows a concept from a UK Engineering firm to adapt the *City of Adelaide* hull by turning it upside down and converting it to become office accommodation.

Figure 20: UK concept for *City of Adelaide* (Beckett Rankine & Buro Happold).
